# Forensic Examination of Truck Repair

Dr Edward Brell BSc MEng PhD

This report discusses truck repair work some of which was requested by Mr Gary Waterman of Car-bunc Pty. Ltd. and the repairs carried out on a Mack Truck Model R600 (the truck) currently located at the premises of in Chinchilla Queensland.

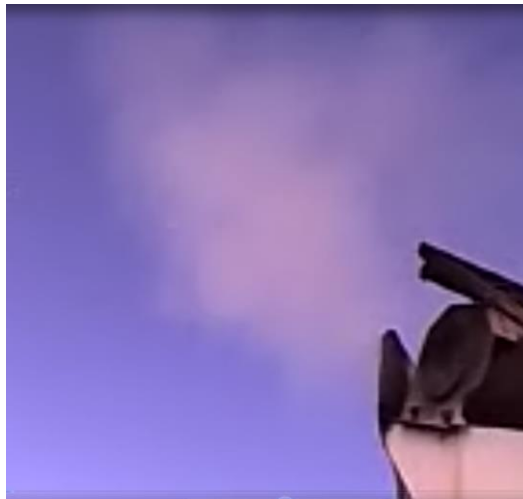
**Figure 2 – Heavy white smoke (after delivery of truck)**  
(Screen capture of video supplied by Mr Waterman)

6. When the truck was taken to Queensland Transport (22/08/2012) the white smoke in Figure 2 was observed and was the basis of the defect notice. Black smoke during acceleration was not evident at this time.
7. The engine was making a “chuff chuff” sound after delivery of truck.
8. The engine exhibited less power than prior to handover of the truck.

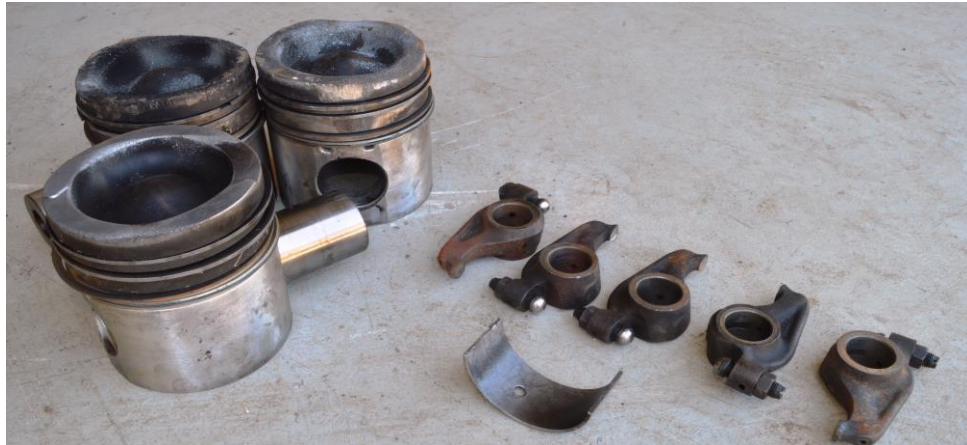
- After some discussions three pistons, five rocker arms and two big-end bearing halves were produced and held out as the replaced parts. These are shown in the photo taken by the author and posted to Figure 3.

Figure 3 – Photo (by the author) of parts held out as the replaced parts.

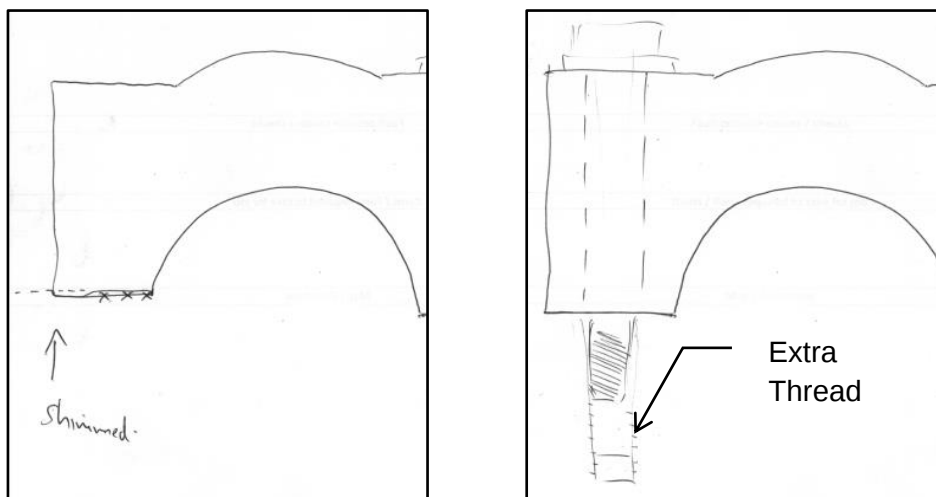
- Mr Parker explained that a face of a main bearing cap was damaged where shown in Figure 4 as X X X.
  - Mr Parker then informed the damage was caused by normal engine wear.

- This surface was then filed down to the dotted line and replaced with a shim to balance with the opposite non-filed surface.
- Mr Parker also explained with the help of the sketch what was meant by “got used longer bolt” in his invoice report.

- “There was a crack in the engine block that prevented from achieving the required torque value for the bolt” he informed.
  - A longer bolt was sought to engage with deeper thread (extra thread).

Figure 4 – Explanation Sketches (by Mr Parker)

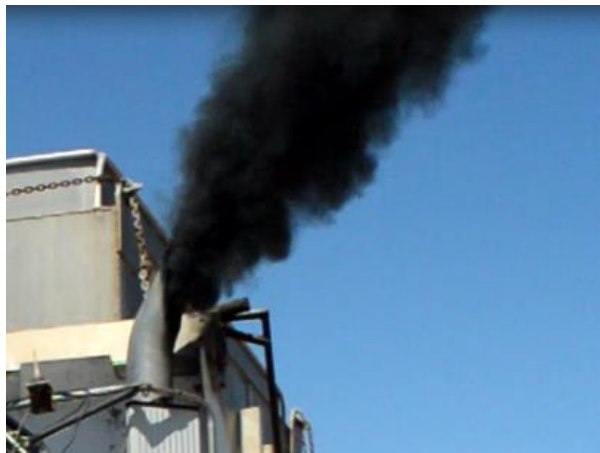
- 5 The author observed thick plumes of black smoke at start-up and during acceleration of engine speed from a lower revolution count (RPM) to a higher RPM. Figure 5 is a screen capture of movie taken by the author.

**Figure 5 – Thick black plume of exhaust smoke during start and acceleration.**

The malfunction of this device causes emission of large plumes of black smoke when depressing the accelerator pedal to maximum. (See Figure 5)

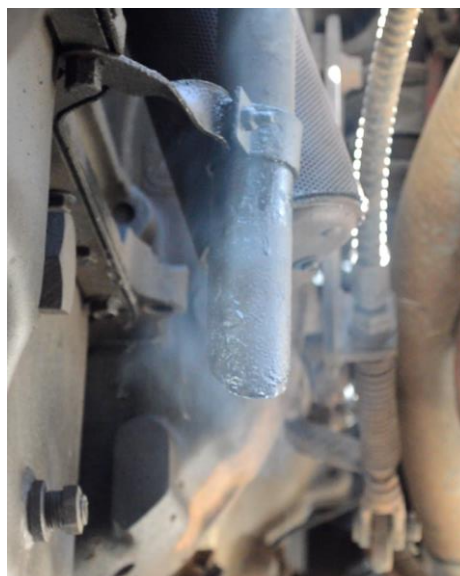
After 10 minutes of running the engine the breather pipe started to blow thick white emissions also (Blow-by). Figure 6 is a screen capture of movie taken by the author.

**Figure 6 – Breather pipe emissions showing white smoke.**

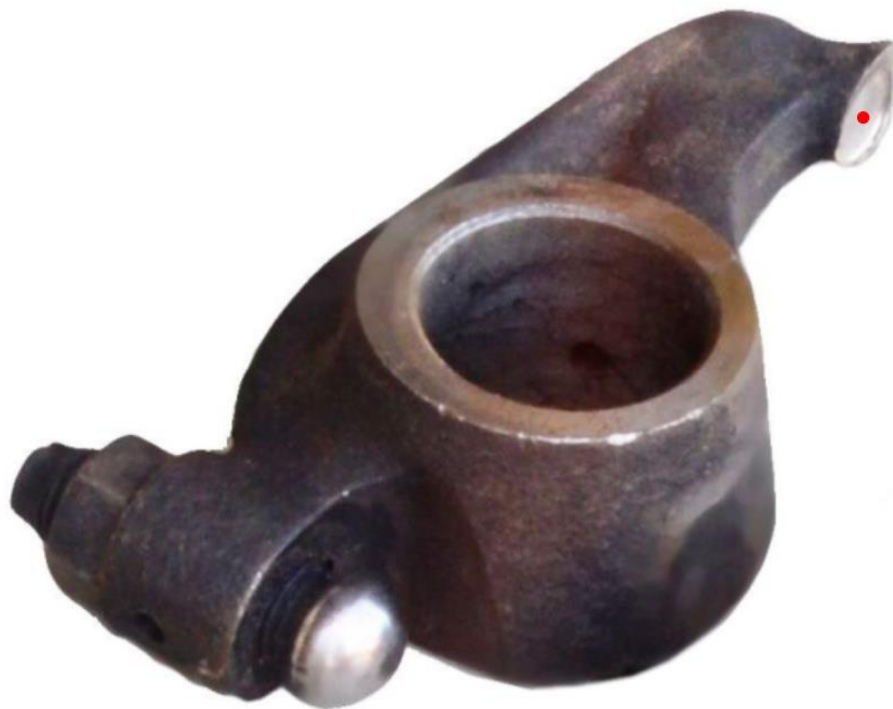
A superficial inspection of the rocker arms revealed deep wear on the contact surfaces highlighted by the red dot in Figure 7. This may be the result of prior grinding and associated removal of the flame hardening during a prior repair.

The depth of wear and shape of wear would have effectively prevented feeler gauges from finding the gap.

Figure 7 – Examination of a rocker arm highlighting wear by red dot.

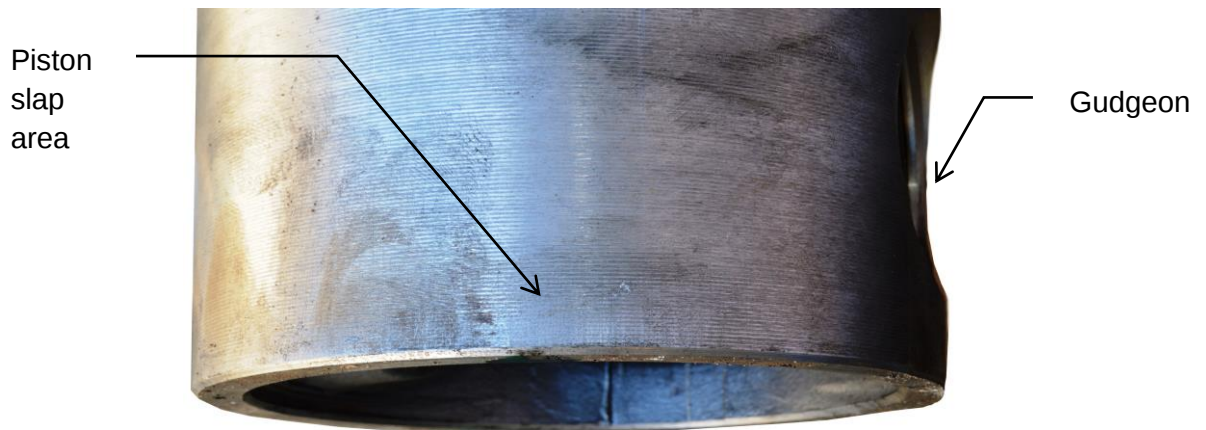
Figure 8 is a photograph taken by the author with background removed for clarity (by the author). Pistons were measured across two diameters and disclosed no ovality indicating little or no wear. It would be expected that in the piston slap area of the piston periphery (left and right of the gudgeon) one might find some wear.

Instead, the cylindrical surfaces of the pistons examined showed the original machining marks indicating little or no wear.

Figure 8 – Examination of piston showing original machining marks.

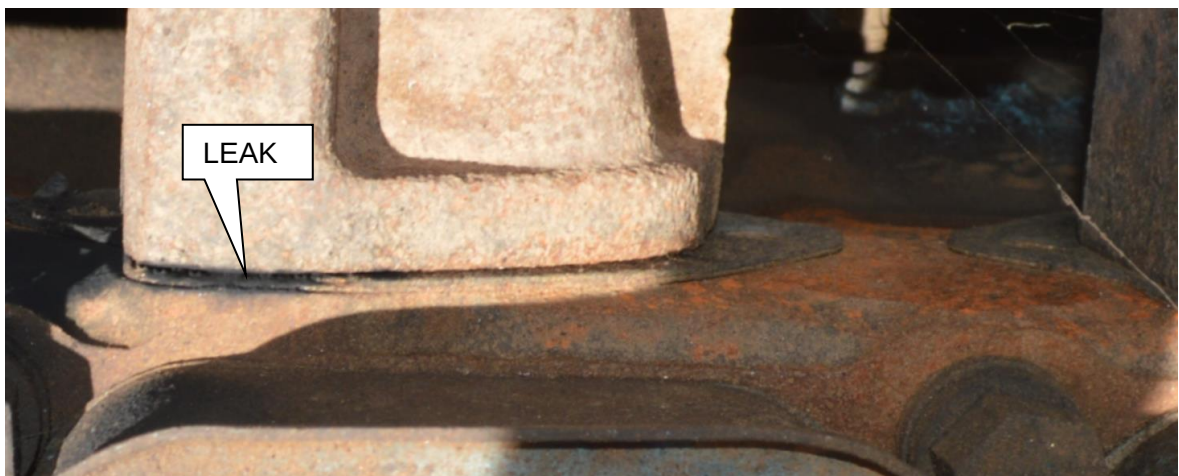
Figure 9 – Photo taken by the author highlighting exhaust gas leakage.

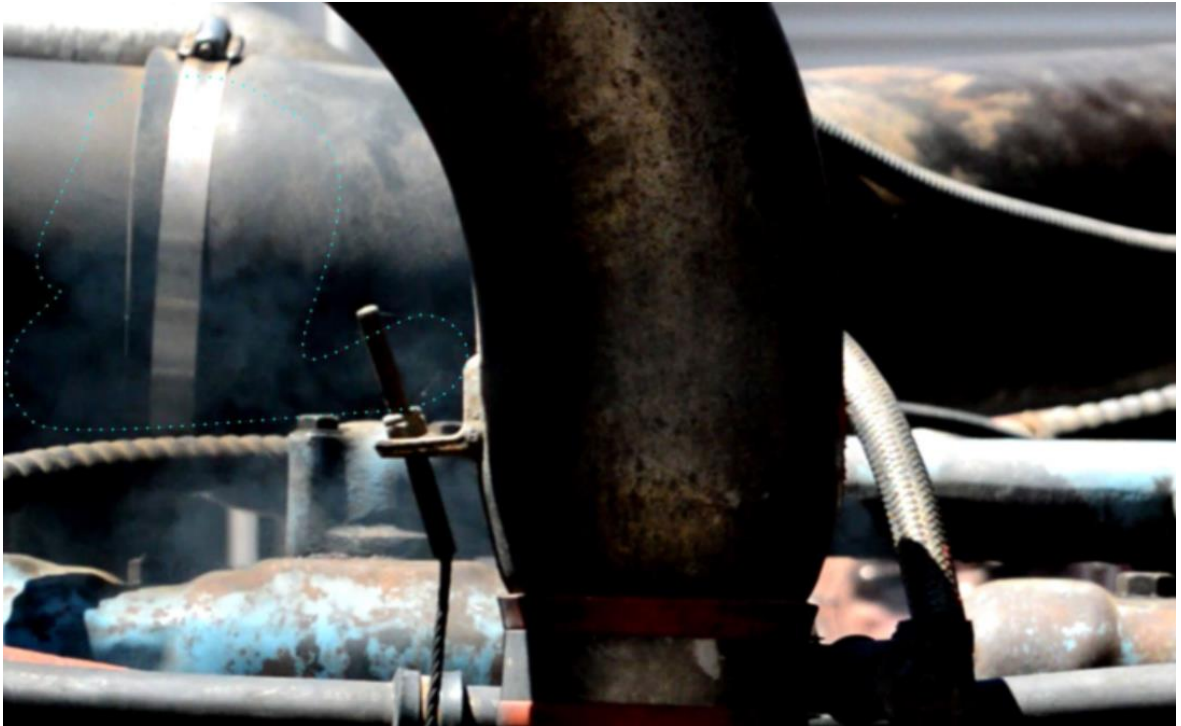
The exhaust manifold gasket leaked shown smoky in the left-hand side of Figure 10. This photo is a screen capture of a video taken by the author.

**Figure 10 – Exhaust manifold leakage showing white smoke emission.**  
(Screen capture of movie taken by the author from kerb-side)  
(Dotted outline of smoke by author)

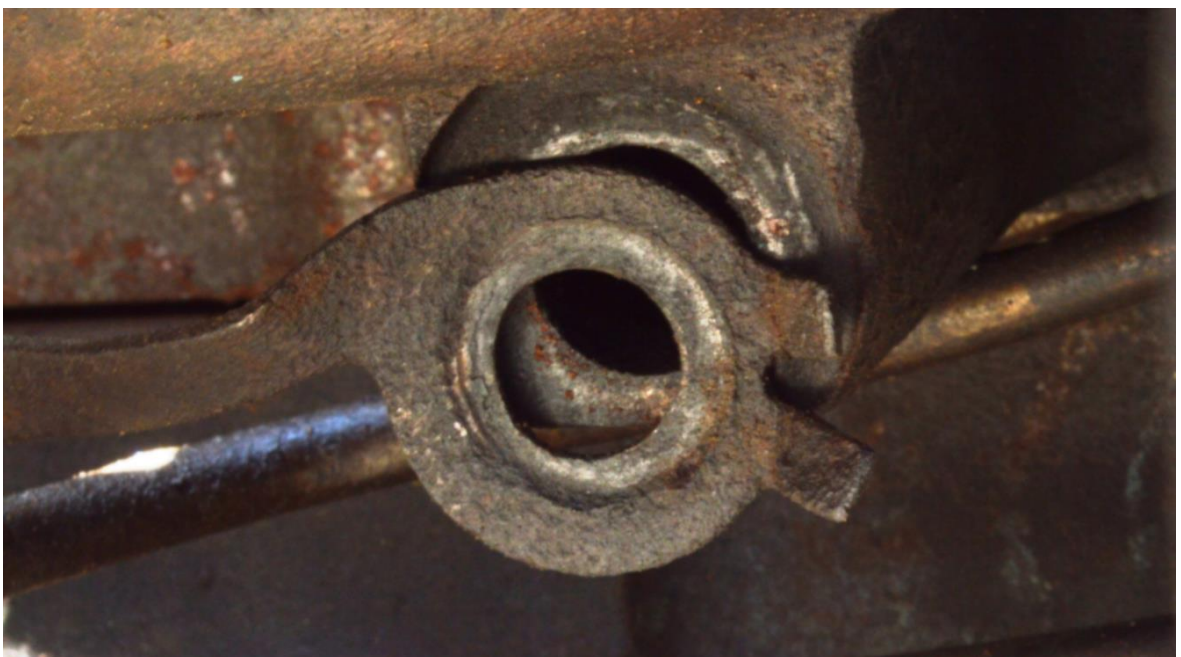
Figure 11 shows a photograph taken by the author of a stud which had not been replaced. Noteworthy is the tab washer which indicates a burnish mark from recent removal of this missing bolt.

**Figure 11 – Exhaust manifold stud missing**

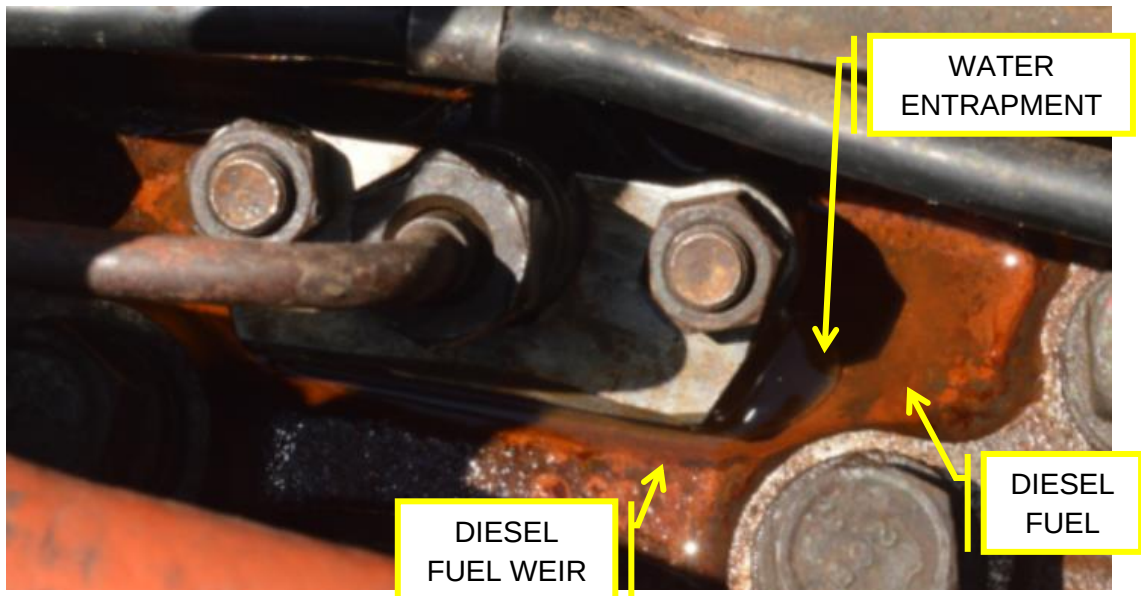
Figure 12 – Diesel fuel leakage

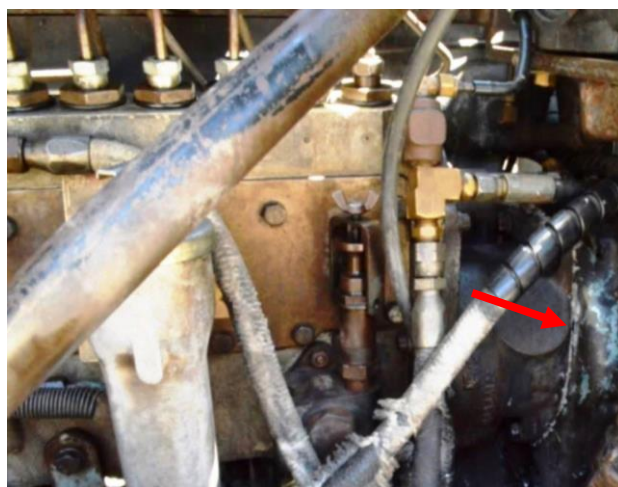
- 10 The mounting flange of the injector pump requires gasket to seal the faces against the engine block. This is highlighted by a red arrow in Figure 13. Application of a Silastic style of gue is a valid procedure only as a temporary fix.

Figure 13 - Using gasket glue instead of a proper injector pump gasket.  
(Photograph and highlighting with red arrow by author)

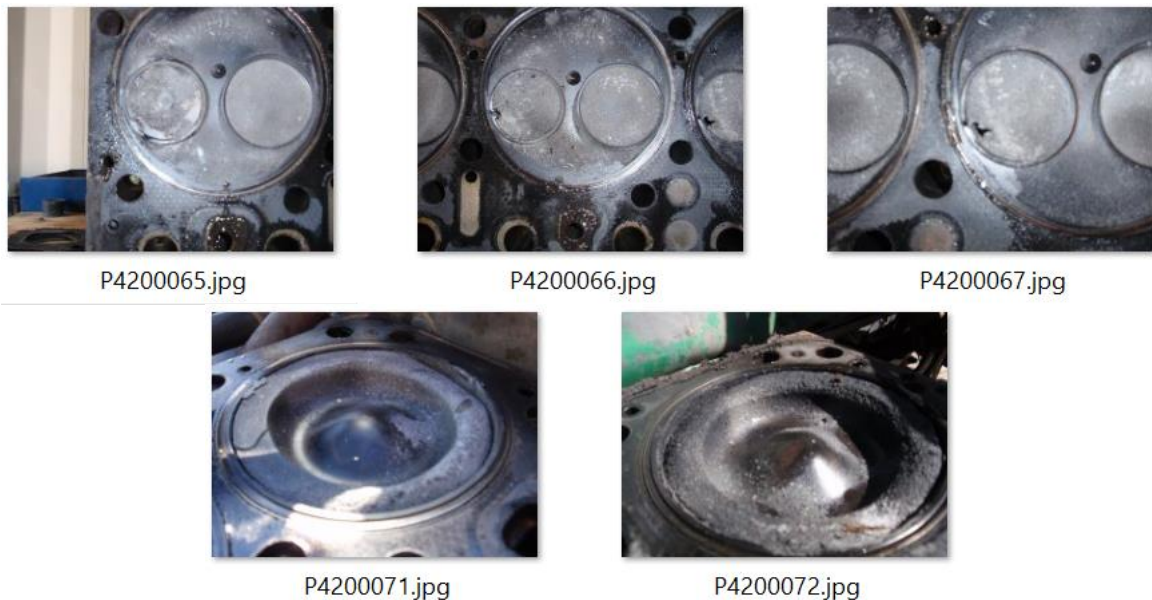
Figure 16 - Photographs supplied by Mr Parker.

The burnt holes in the exhaust valves are highlighted by red arrows. Blue arrow highlights burnt piston. It should be noted that the cylinder heads shown are relatively clean. So too is one piston. The significance of this will be discussed under the relevant hypothesis.

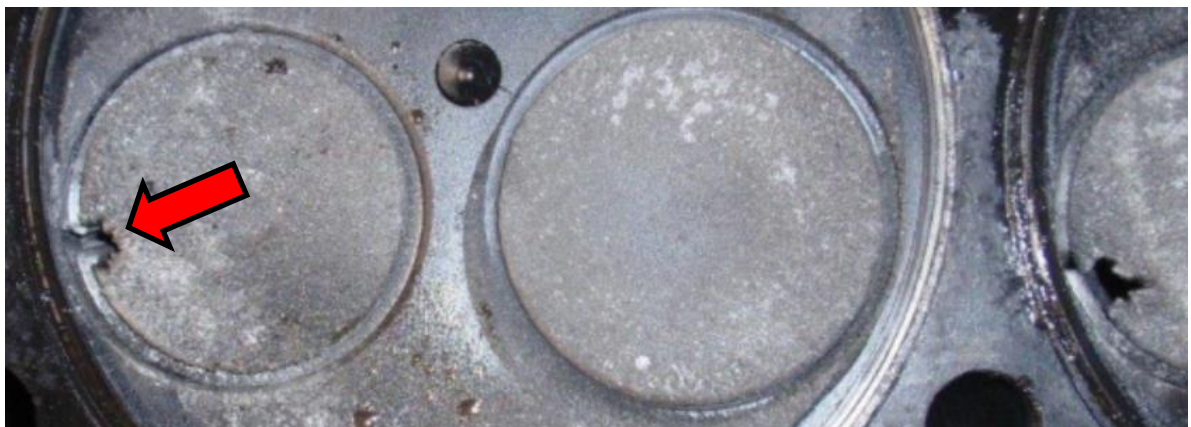
Figure 17 - Close-ups of burnt exhaust valves.

It is worth noting in Figure 17 that the surfaces were clean in regard to Carbon build-up.

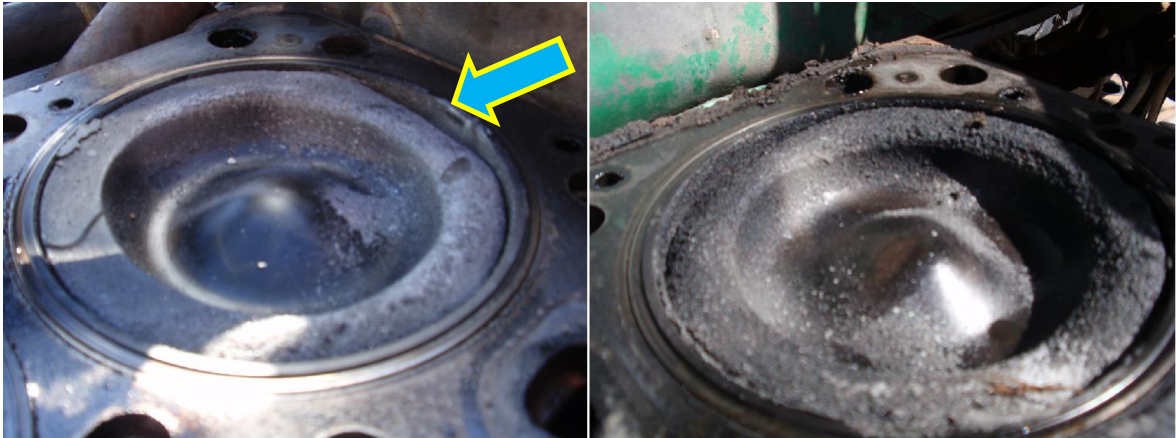
**Figure 18 - Close-ups of piston photographs.**

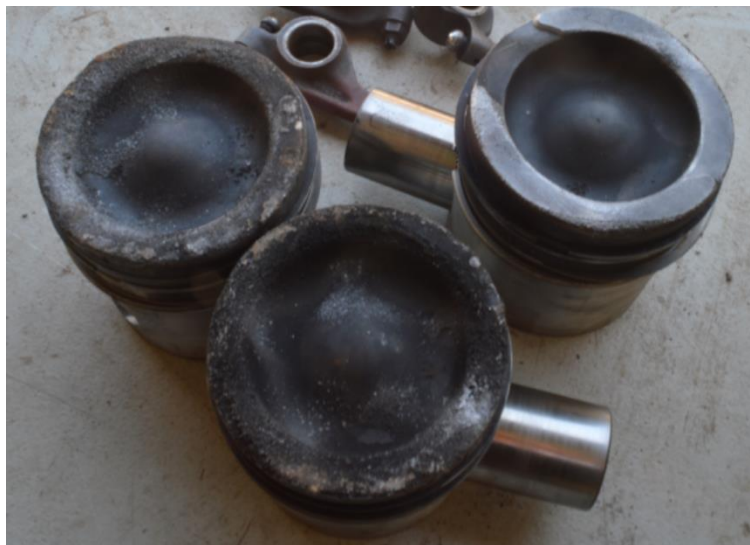
Figure 22 is a photograph taken by the author of the parts held out to be the replaced parts. It shows two pistons dirty with Carbon deposits and one piston clean. This strongly suggests that a starting agent was used. It is noted that the three other pistons were not offered for inspection.

**Figure 22 - Photo by the author of replaced parts**

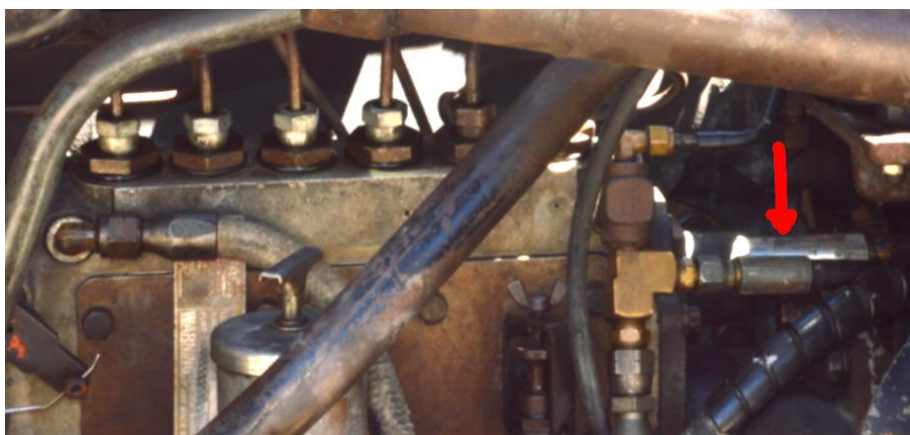
Figure 28 is a photograph taken by the author of the injector pump and puff control device which can be identified as a shiny cylindrical object highlighted by the red arrow.

**Figure 29 - Puff control device highlighted by red arrow.**

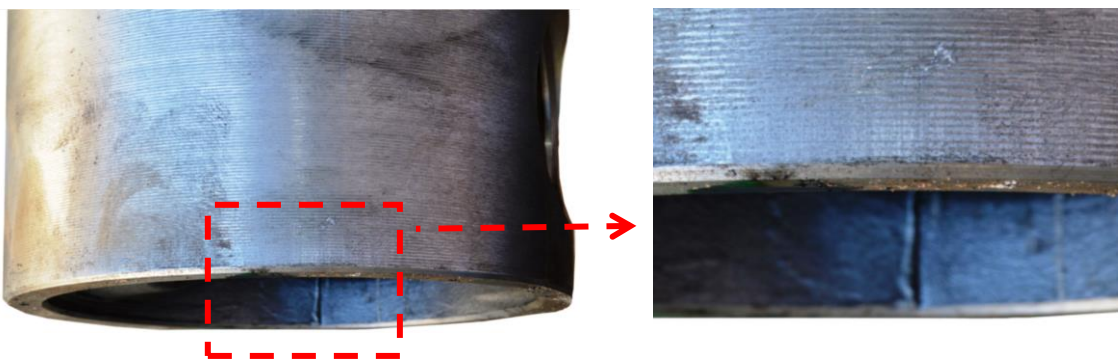
The pistons observed at the premises of Car-Bunc and held out as being the pistons removed from the subject truck showed no signs of wear indicating that they had relatively recently been replaced (Figure 3). Thus the absence of bearing slap would have made bearing knock more discernible, audible even to the naked ear.

**Figure 3 – Photo (by Author) of Piston Skirt Showing Original Machining Marks**

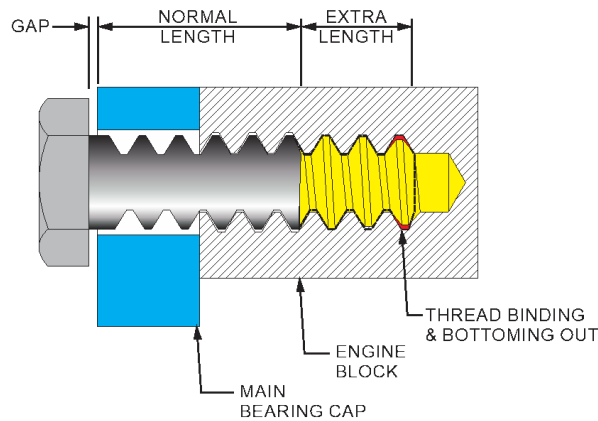
Further, there is risk that the longer bolt bottomed out or engaged with partially formed thread, giving the assembly mechanic the false impression that the torque setting had been achieved where in fact a gap would remain. This hypothesis could explain the noise heard on the video supplied indicating a hammering of the crankshaft against a loose bearing cap. Under such conditions a serious failure would be imminent. The gap under the bolt is idealized in the sketch in Figure 4.

**Figure 4 - Gap Effect of Using a Longer Bolt**

A proper method of repair is the use of threadserts. A threadsert is a high strength piece of metal with threads on the inside as well as the outside. The procedure is to drill and tap the engine block oversize to suit the threadsert outside diameter thread and then insert the threadsert ready for a standard bolt.
