# **Examination of Slip Behavior in Drywall Partition Walls**

**Preliminary Report of Bidirectional Subassembly Tests at Lehigh University: Phase I of Nonstructural Testing**

**Hamed Hasani and Keri L. Ryan**

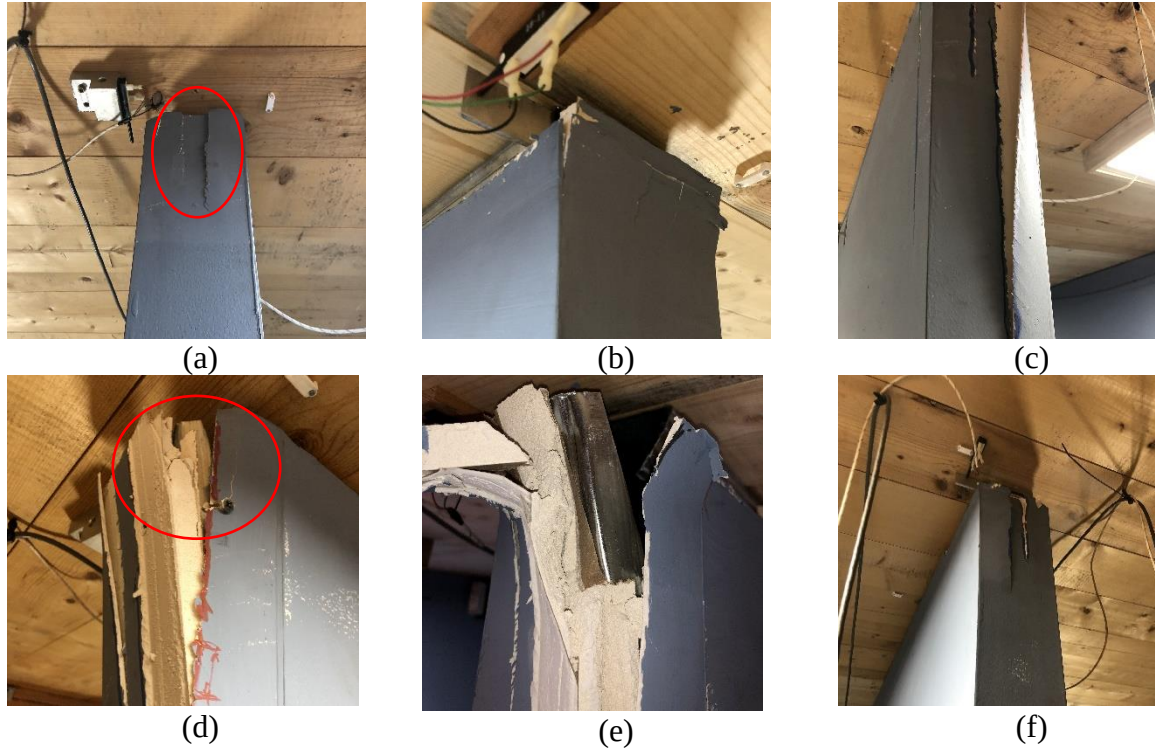
The seismic performance of the drywall partition walls was preliminarily evaluated through observation of the damage mechanisms (Figure 5). After each cycle, the damage to the partition walls was assessed, and a damage description recorded. Corner beads at the end of both walls started to lightly detach at around 0.46% drift (Figure 5(a)). This damage occurs because the entire wall below the top track tends to remain stationary, while the top track tends to move with the top diaphragm (natural behavior of slip-track). Since fire regulations permit only up to half-inch gap at the top of the gypsum (Gypsum Association 2018), while the top track leg length is 2 in. for both types of detailing, the top track hits the gypsum at the top of the wall ends.

The detachment of corner beads increased with increasing drift. Light warping of the gypsum was observed at 0.67% drift (Figure 5(b)), and the corner bead opened significantly at 0.84% in the slip-track connected wall (Figure 5(c)). Coincident with this observation at 1.26 in. displacement, the resisting force increased significantly. Since the stud leg is 1.25 in., the authors believe that the considerable opening in the corner bead is due to the stud not returning to its nested track in the slip-track connected wall. Bending of the end stud was observed at 2.56% drift in the slip-track connected wall (Figure 5(d)). At a drift of 3.2%, the damaged end stud in the slip-track connected wall bent the leg of the track (Figure 5(e)), which was coincident with a considerable increase in the resisting force. While all of this damage progressed in the wall with the slip track connection, the wall with telescoping detailing showed only minor damage at the top end of the wall (Figure 5(f)).

Figure 5: (a) Light detachment of corner bead at wall ends (0.46% drift, slip track); (b) light warping of gypsum (0.67% drift, slip track); (c) significant opening in the corner bead (0.84% drift, slip track); (d) end stud bending (2.56% drift, slip track); (e) track leg bent (3.2% drift, slip track); (f) light detachment of corner bead at wall ends (1.64% drift, telescoping)

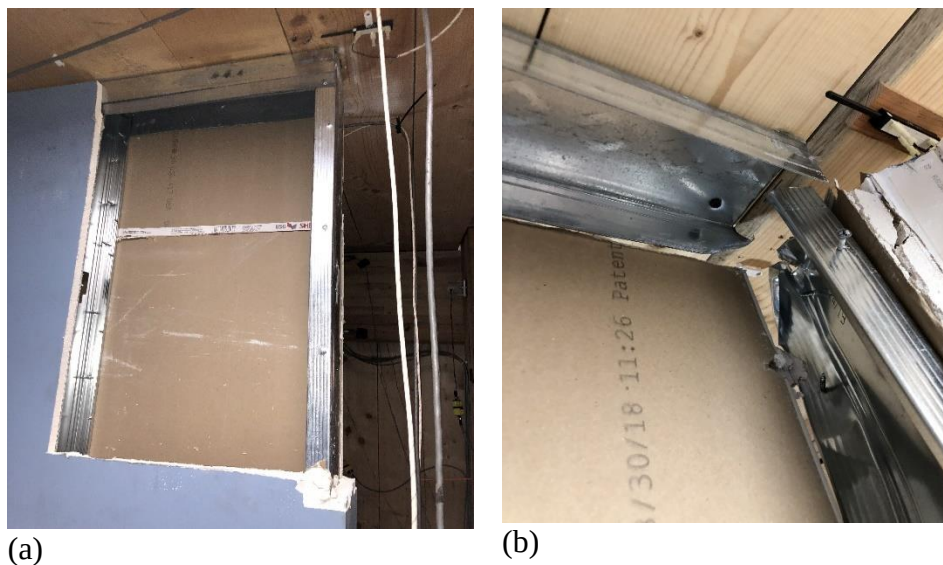
The post-test inspections suggest that the framing of the wall with telescoping detailing remained damage-free during the test (Figure 6(a)). However, the stud and track of slip-track detailing suffered damage due to the detachment of end studs from the track (Figure 6(b)).

Figure 6: Post-test inspection after removal of gypsum board: (a) damage in the wall with telescoping detailing; (b) damage in the wall with a slip track connection
