Real-Time Multi-Directional Testing Facility

# **Examination of Slip Behavior in Drywall Partition Walls**

**Preliminary Report of Bidirectional Subassembly Tests at Lehigh University: Phase I of Nonstructural Testing**

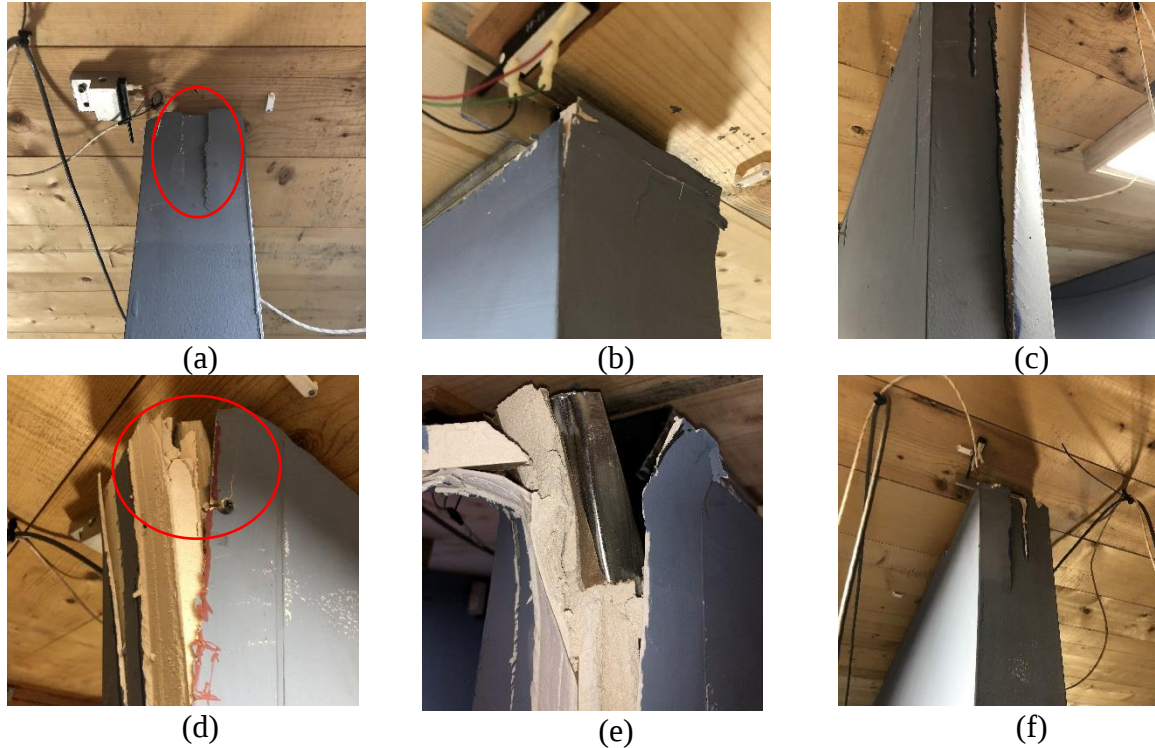
The seismic performance of the drywall partition walls was preliminarily evaluated through observation of the damage mechanisms (Figure 5). After each cycle, the damage to the partition walls was assessed, and a damage description recorded. Corner beads at the end of both walls started to lightly detach at around 0.46% drift (Figure 5(a)). This damage occurs because the entire wall below the top track tends to remain stationary, while the top track tends to move with the top diaphragm (natural behavior of slip-track). Since fire regulations permit only up to half-inch gap at the top of the gypsum (Gypsum Association 2018), while the top track leg length is 2 in. for both types of detailing, the top track hits the gypsum at the top of the wall ends.

The detachment of corner beads increased with increasing drift. Light warping of the gypsum was observed at 0.67% drift (Figure 5(b)), and the corner bead opened significantly at 0.84% in the slip-track connected wall (Figure 5(c)). Coincident with this observation at 1.26 in. displacement, the resisting force increased significantly. Since the stud leg is 1.25 in., the authors believe that the considerable opening in the corner bead is due to the stud not returning to its nested track in the slip-track connected wall. Bending of the end stud was observed at 2.56% drift in the slip-track connected wall (Figure 5(d)). At a drift of 3.2%, the damaged end stud in the slip-track connected wall bent the leg of the track (Figure 5(e)), which was coincident with a considerable increase in the resisting force. While all of this damage progressed in the wall with the slip track connection, the wall with telescoping detailing showed only minor damage at the top end of the wall (Figure 5(f)).

Figure 5: (a) Light detachment of corner bead at wall ends (0.46% drift, slip track); (b) light warping of gypsum (0.67% drift, slip track); (c) significant opening in the corner bead (0.84% drift, slip track); (d) end stud bending (2.56% drift, slip track); (e) track leg bent (3.2% drift, slip track); (f) light detachment of corner bead at wall ends (1.64% drift, telescoping)

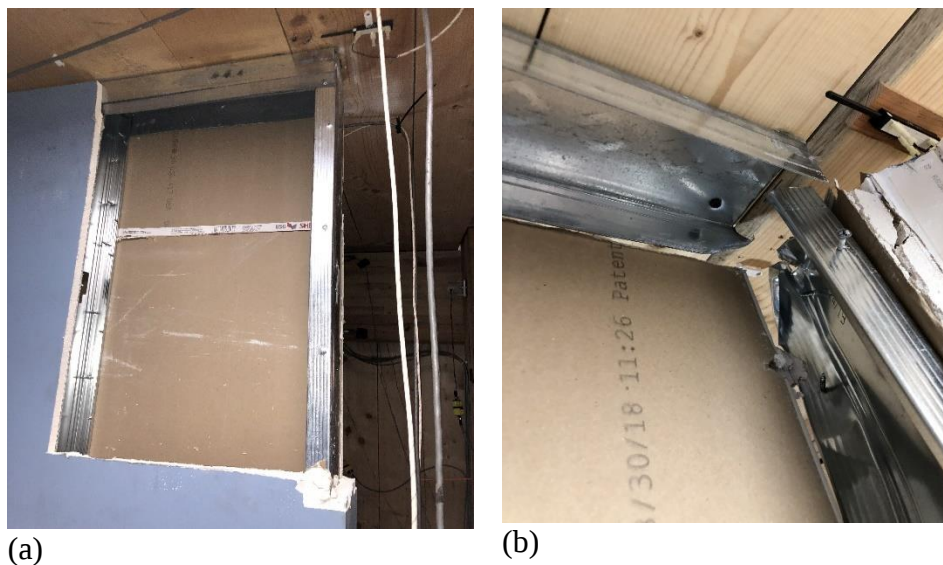
The post-test inspections suggest that the framing of the wall with telescoping detailing remained damage-free during the test (Figure 6(a)). However, the stud and track of slip-track detailing suffered damage due to the detachment of end studs from the track (Figure 6(b)).

Figure 6: Post-test inspection after removal of gypsum board: (a) damage in the wall with telescoping detailing; (b) damage in the wall with a slip track connection
