# Toyota RAV4 Loss of Control and Collision Study

(Dr) Edward Brell BSc MEng PhD

## 1. Introduction

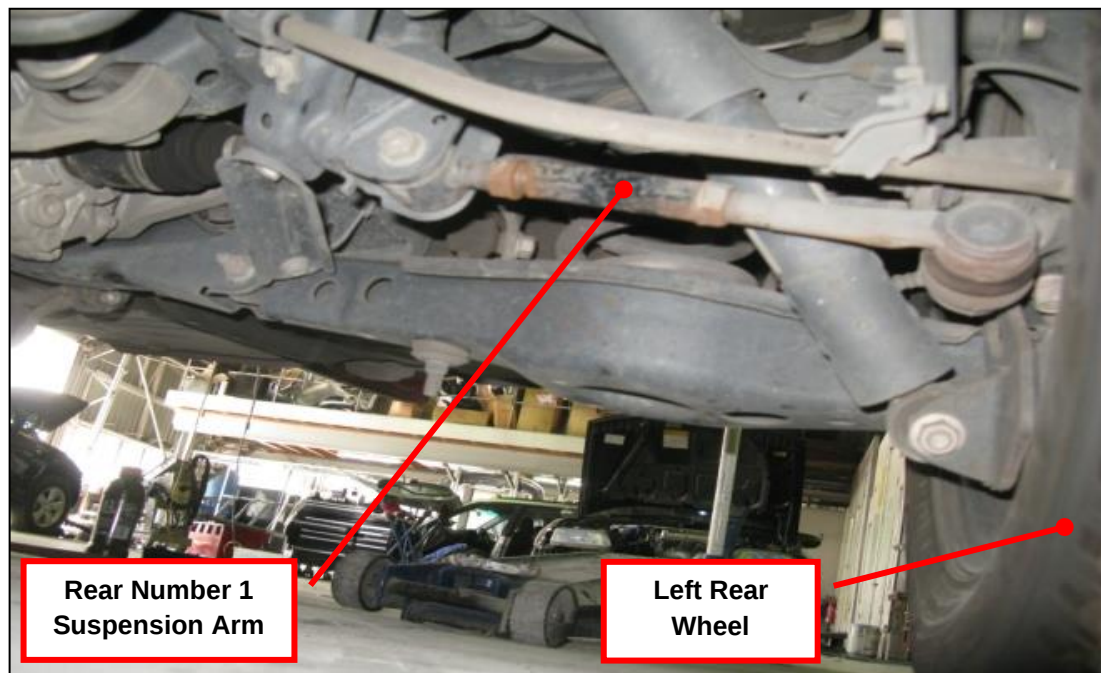
- 15     The incident Rear Number 1 Suspension Arm, as first photographed by the author upon arrival at a Smash Repair Facility is identified in the actual vehicle by Figure 2.

Figure 2 – Photo taken by the author of Rear Number 1 Suspension Arm.

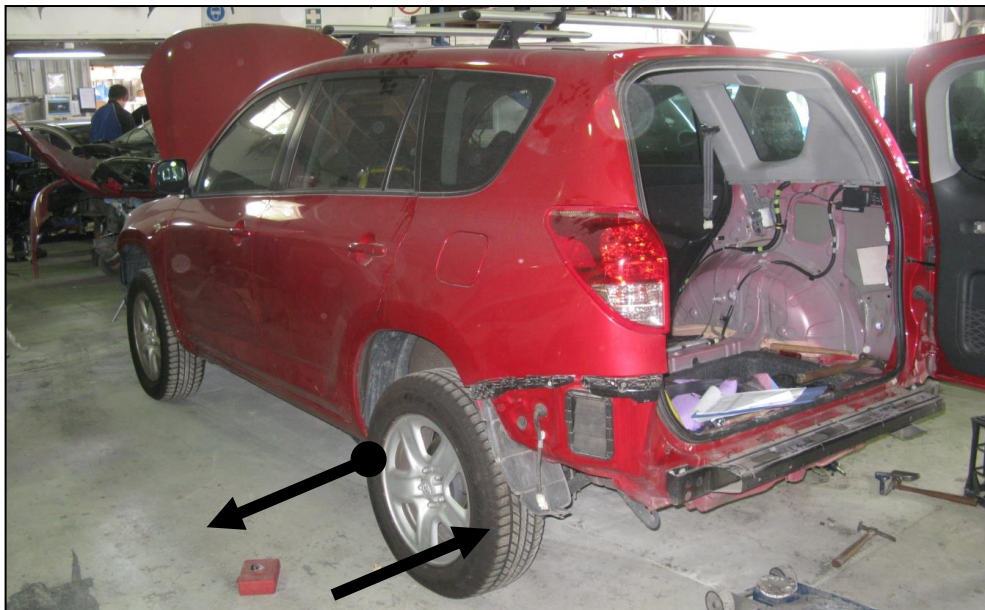
5 The mechanic at the facility noted that the left-hand rear wheel was displaced at an angle to the vehicle. The front of the left-hand rear tyre pointed outwards and needed to be “kicked” in to manoeuvre the vehicle off the delivery truck, alluding to a procedure of impact to one side of the left-hand rear wheel.

10 It was noted that the left-hand rear wheel was angularly displaced so that the front of the tyre was proud of the vehicle wheel arch while the rear of the tyre was well into the wheel arch. This was photographed by the author and shown in Figure 4, the arrows showing the direction in which the wheel was displaced.

Figure 3 – Photo showing angular displacement of rear wheel (arrows show direction).

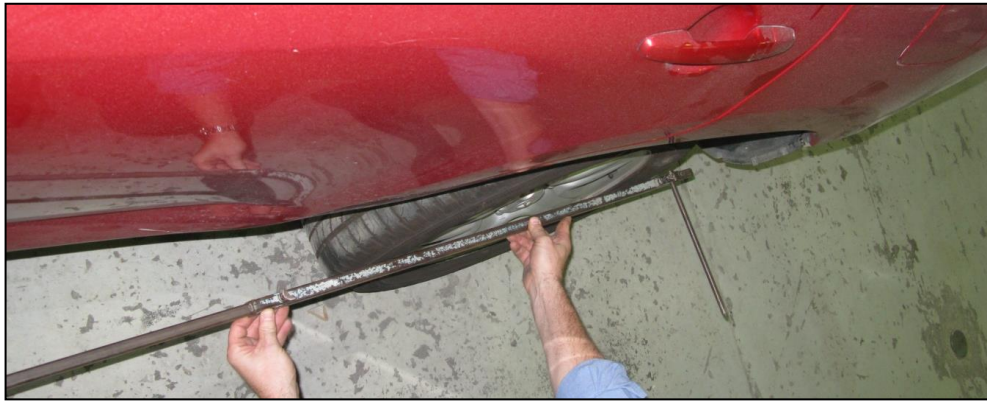
15 A straightedge from the workshop floor was applied to the wheel to illustrate the degree of angular displacement of the left-hand rear wheel in Figure 4.

**Figure 4 – Straight-edge on wheel showing outward displacement.**

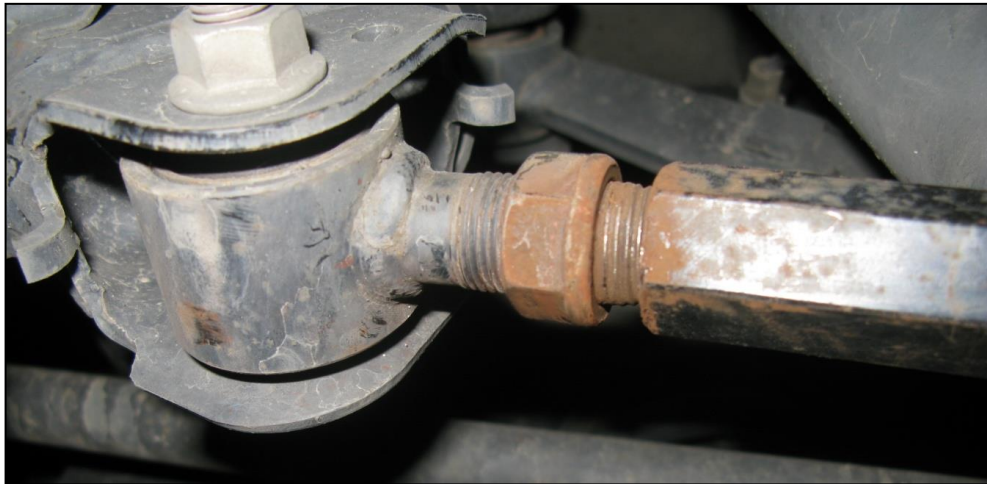
manual methods. Figure 6 and Figure 7 are 'before and after' manipulation photographs taken by the author.

Figure 6 – Body end component as photographed before wheel manipulation.

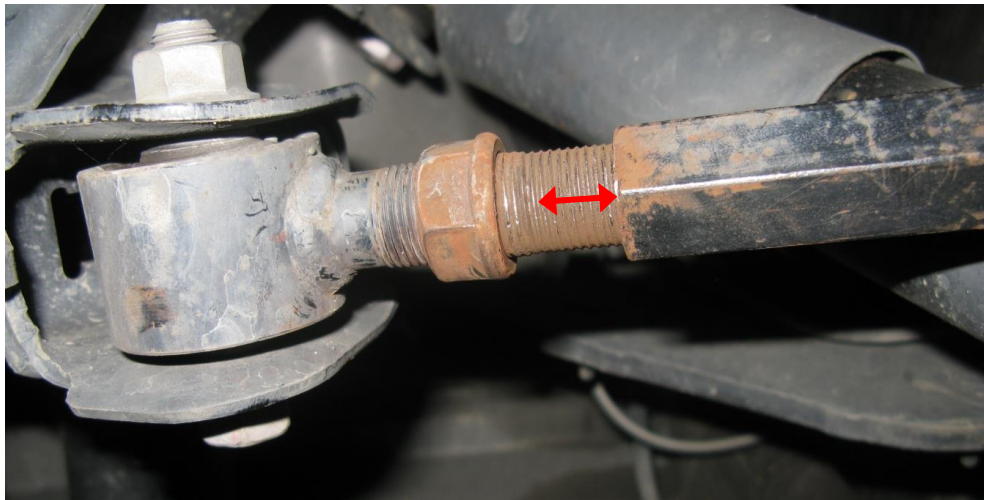
It was observed that the Rear Number 1 Suspension Arm was lengthened as a result of the manipulation by an amount approximately equal to the double ended red arrow shown in Figure 7.

Figure 7 – Body end component as photographed after wheel manipulation.

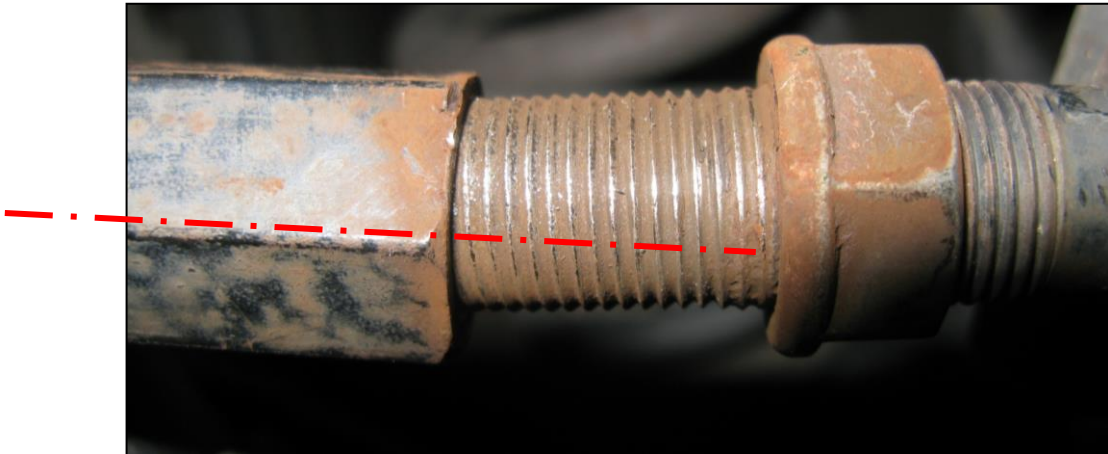
The Rear Number 1 Suspension Arm was then photographed by the author from various angles to visually assess the extent of damage. These photos appear in Figure 8 to Figure 10. Captions under the figures indicate the nature of damage. The photos in Figure 8 to Figure 10 were taken from the underside of the vehicle. The engagement within the arm was quite loose.

Figure 8 – Highlighting misalignment.

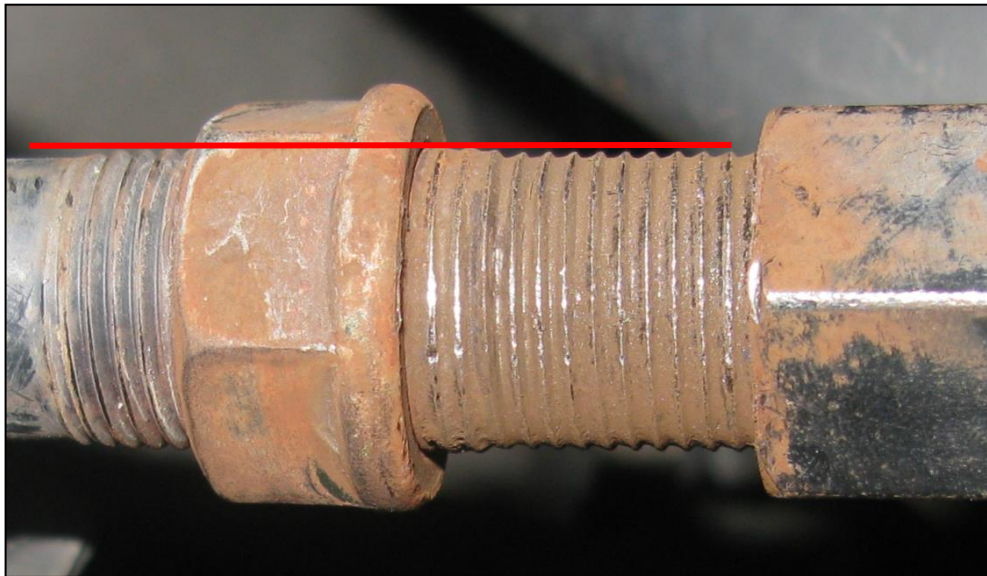
Figure 9 – Highlighting reduction in thread diameter.

The process also reduces the diameter of the male component and increases the diameter of the female component until the male part can be extracted from the female part (being the adjustment nut) without a great effort.

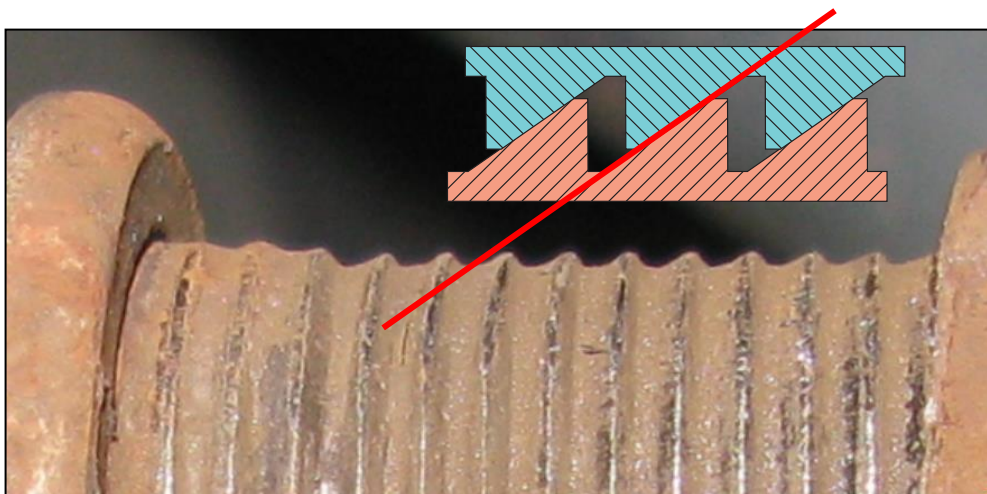
Figure 10 – Highlighting reshaped thread.

10 The rusting on the surface of the affected area is an indication that the reshaping was not an incident artefact but that it had happened over some time. It is not possible to estimate an exact time any more precisely than measuring in months rather than days.

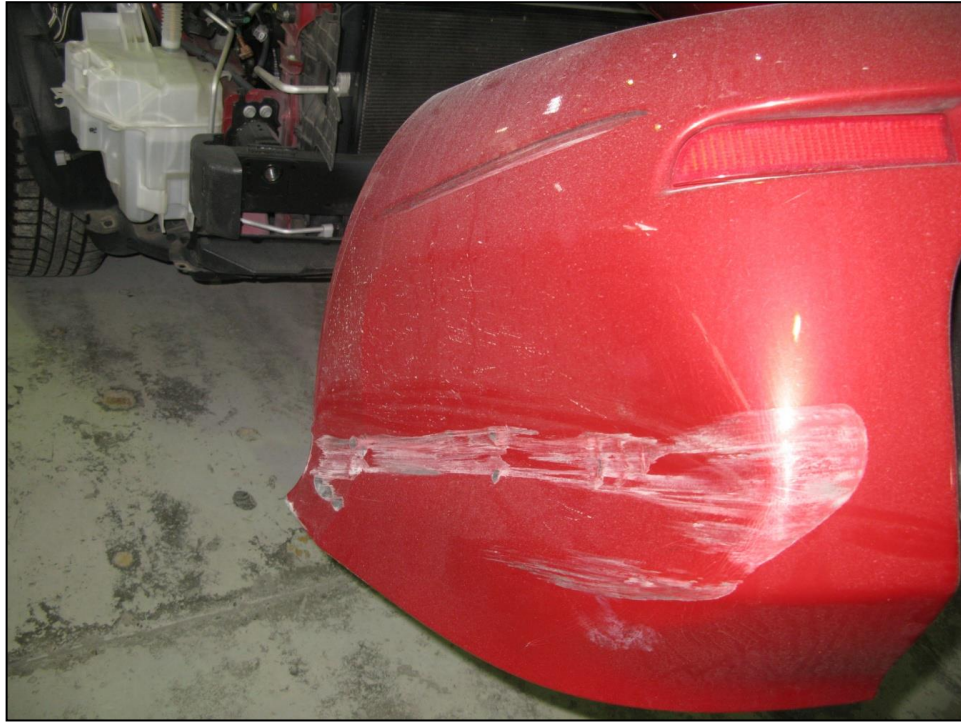
Figure 11 – Photograph of rear bumper showing damage to right-hand side.  
(Bumper was stored upside down)

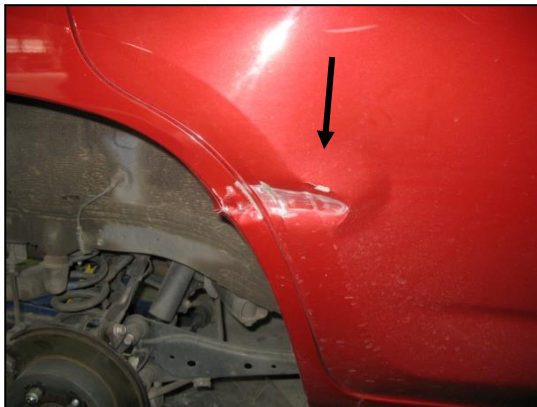
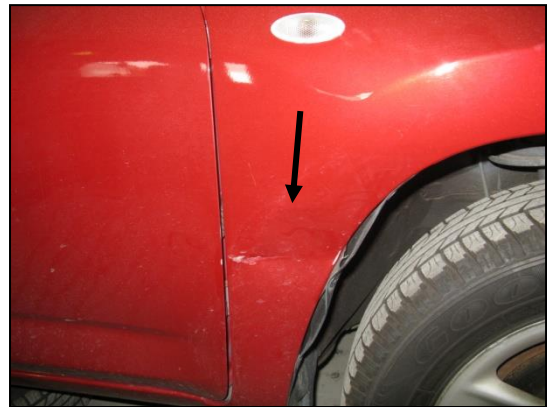
Figure 12 – Photographs of right-hand side damage to rear and front wheel arch.

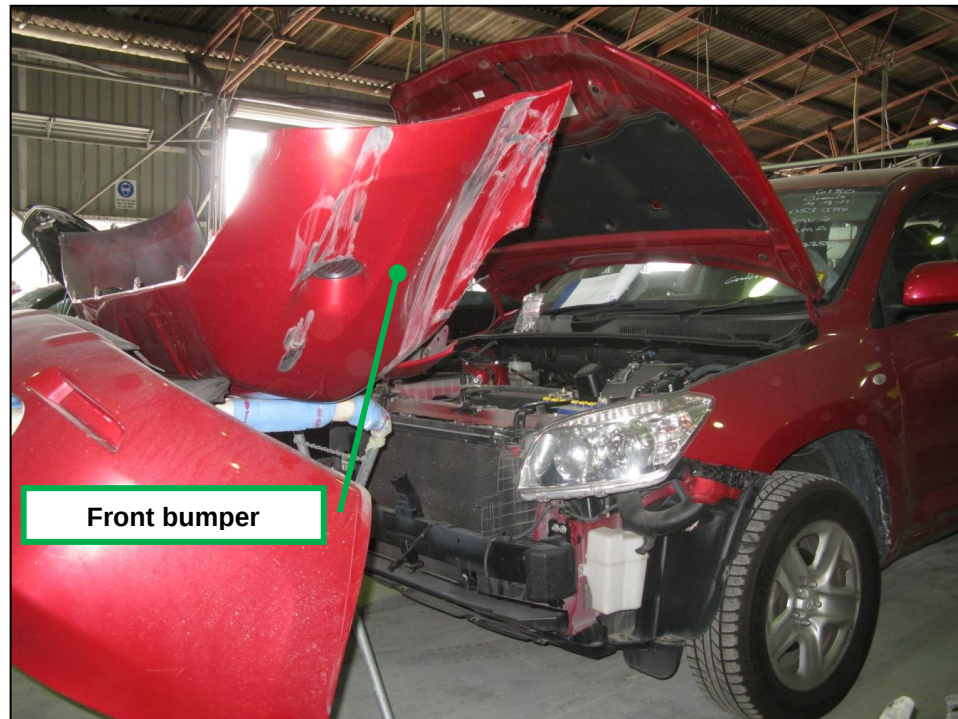
Figure 13 – Photograph of the front bumper showing damage to right-hand side. (Bumper was stored upside down).

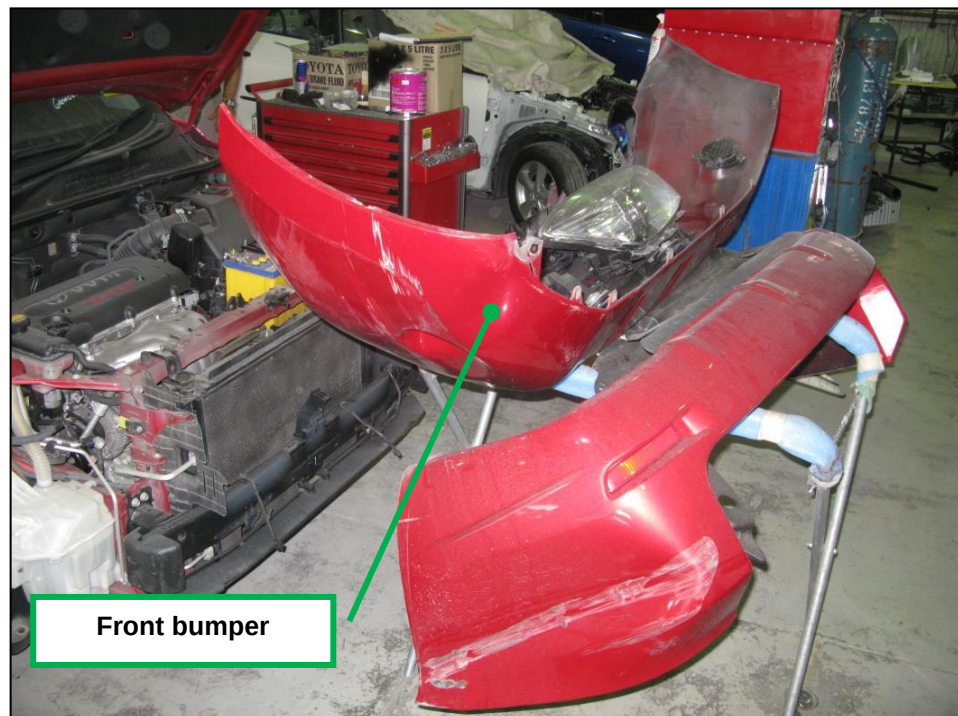
Figure 14 –Photograph of the front bumper showing damage to the left hand side. (Bumper was stored upside down).

Photographs were taken by the author that were inconsistent with other aspects of the incident. These appear in Figure 14 and Figure 15.

Enquiries were made with Mrs Blunt who advised that the accident damage described above was reported to the insurance company some five months prior. This is to help the reader understand that the damage observed and presented in Figure 14 and Figure 15 is not related to this incident.

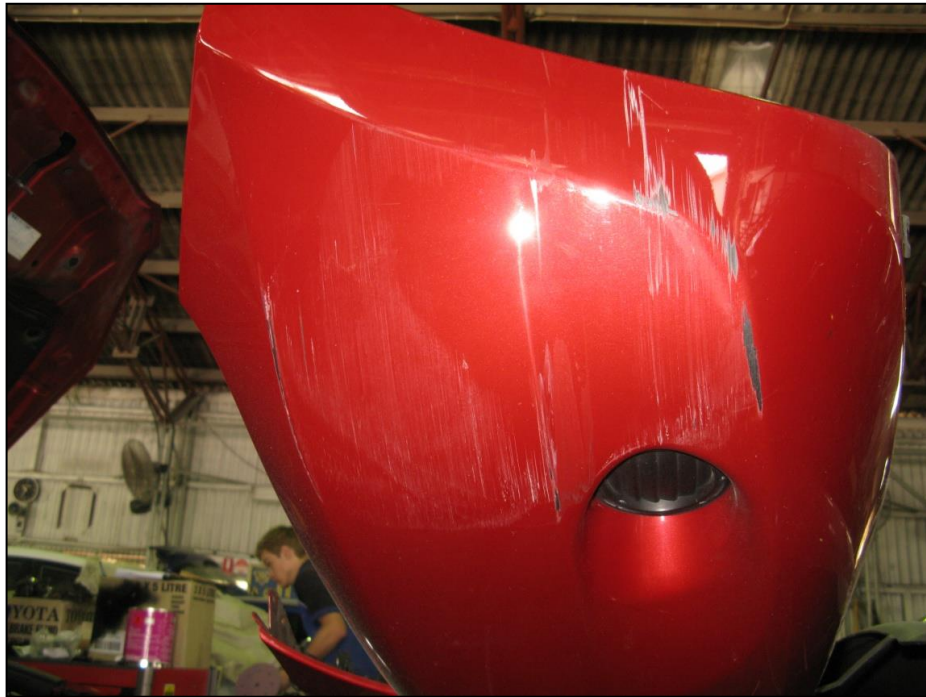
**Figure 15 – Close-up photograph of the front bumper showing damage to the left hand side. (Bumper was stored upside down).**

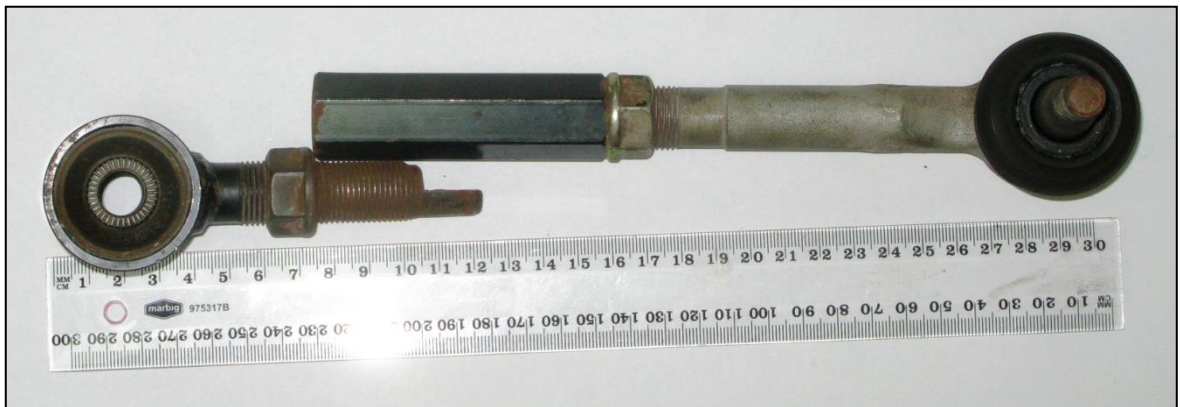
- 5 The Rear Number 1 Suspension Arm was disassembled by the author by simply pulling the components apart manually. There was almost no restraint offered by the thread. The two sub components are shown in Figure 16, comprising body mounted end on the left of the photo and wheel mounted end to the right of the photo.

**Figure 16 – Disassembled Rear Number 1 Suspension Arm into two sub components.**

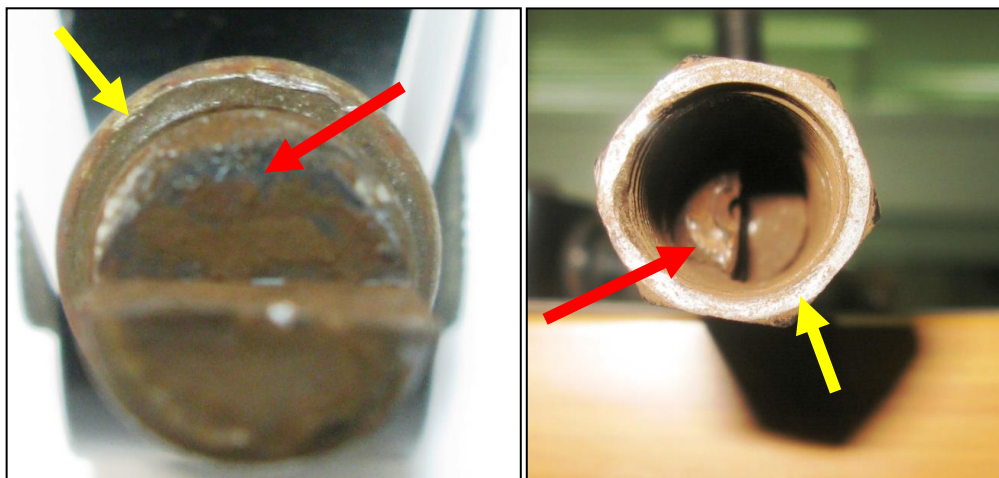
- 10 The subcomponent of the left-hand side of Figure 16 is a welded fabrication whereas the subcomponent on the right-hand side exhibits a forging. An observation made was that while the parts offered little restraint to tensile forces, the Rear Number 1 Suspension Arm in compression did not appear to be impaired. This is highlighted by the observations in Figure 17.
- 15 The ends of the subcomponents were photographed to highlight the burnishing of surfaces indicating the presence of heavy rubbing or impact. This is shown in Figure 17.

**Figure 17 – End view photos of subcomponents showing burnished surfaces (colour of arrows indicates paired surfaces).**

Figure 17 shows surfaces have contacted under impact conditions. It would not normally be a feature of these components to be touching when steering alignment is being performed. This is not to say that they couldn't touch if required by the extent of adjustment needed. The burnished surfaces are an indication of continued impact (flogging) over time.

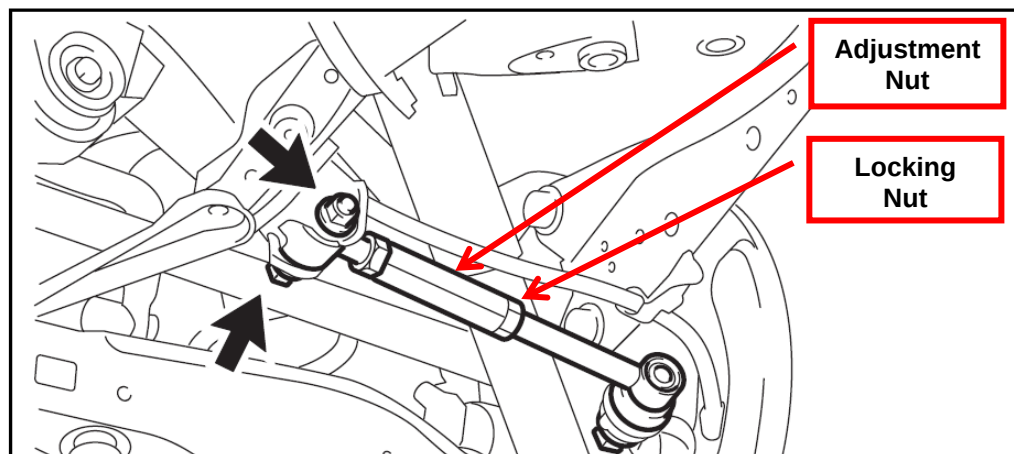
The black arrows correspond with values for tightening torque in the Factory Service Repair Manual<sup>1</sup>. Notable is the apparent absence in the manual of a torque value for locking the adjustment nut.

Figure 18 – Rear Number 1 Suspension Arm highlighting adjustment and locking nuts.

An Officer at the Toyota Facility informed the author that the pre-tension torque for the Rear Number 1 Suspension Arm locking nuts is required to be 56 Nm, from a Toyota document that he was not permitted to share.

This torque value appears inadequate given the published torque values for much smaller bolts attached to the Rear Number 1 Suspension Arm require 90 and 100 Nm. The expectations from the author's experience would be in the order of approximately 200 Nm and even higher depending on the quality of the material used by Toyota for the components of this arm.

15 A simpler method (e.g., “turn-of-the-nut” method) of ensuring the required pre-load in Rear Number 1 Suspension Arm locking nuts is recommended as more suited to a tyre technician’s skills and not requiring specialized tools such as an open-ended torque wrench, not commonly found in a tyre technician’s toolbox.

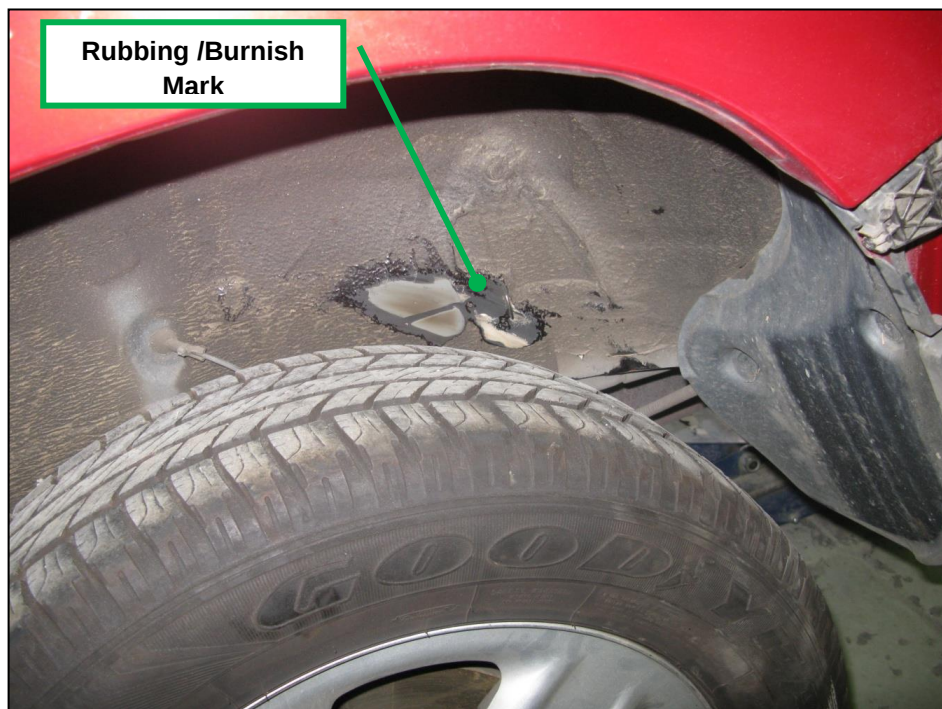
5 An observation was made that the left rear wheel had been rubbing on the inside of left-hand rear wheel arch. This was photographed by the author and is shown in Figure 24. This mark is consistent with the inside of the tyre rubbing against the surface of the wheel arch.

The heavy rubbing mark indicated in Figure 24 is absent on the right-hand side wheel arch. This indicates that the mark was not caused by the normal suspension travel of the rear wheels. It is seen as a direct result of the left rear wheel being out of alignment.

10 The extent of rubbing would suggest that it had been in progress some time prior to the impact with the Armco rail.

The shiny appearance and absence of products of corrosion of the rubbed surface supports that the rubbing was recent to the incident.

Figure 24 –Heavy rubbing mark in left-hand side rear wheel arch.
