1 **David Reid^{1*}, Marcos Arroyo², Mike Jefferies³, Riccardo Fanni⁴, Andy Fourie¹, Antonio**
2 **Gens² & Miguel Mánica⁵**

10 **Matters arising in relation to “*The slip surface mechanism of delayed failure of the***
11 ***Brumadinho tailings dam in 2019*” by Fangyuan Zhu, Wangcheng Zhang & Alexander M.**
12 **Puzrin**

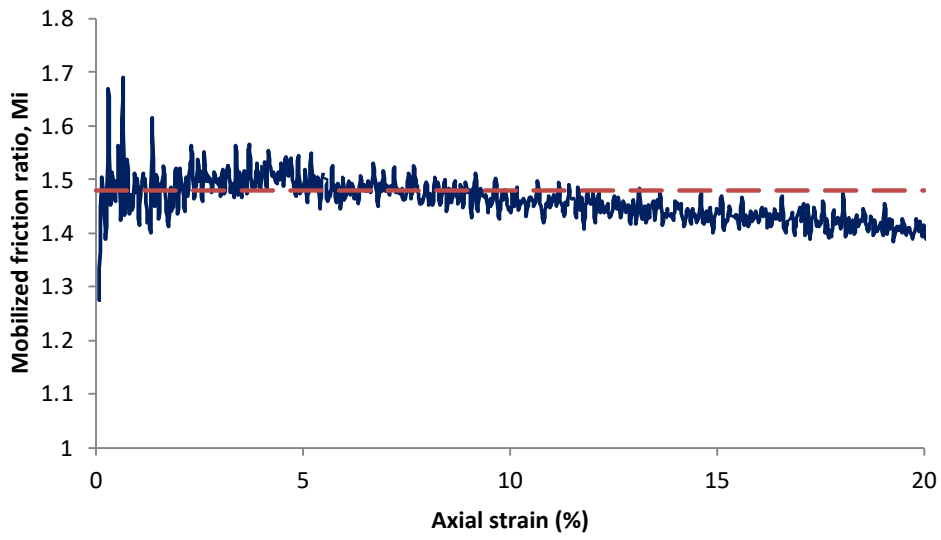
31 Bonding must be demonstrated by mechanical tests. The drained triaxial data in Fig 2b
32 corresponds to TX09 of Robertson et al., an initially dense specimen with shear localization
33 evident in the test report. The boundary-measured response in Fig 2b cannot be identified with a
34 material response. This is not generally the case for the more representative loose specimens,
35 which typically show a near constant critical friction ratio (M) with no rupture of a cohesion-like
36 component (Fig D 1).

129 *Fig D 1 Mobilized friction on a drained triaxial test on loosely compacted ($e_0 = 1.1$) specimen of Brumadinho*

130 *tailings (Arroyo & Gens, 2021; test BRUMA_R_S1_BL_CID_F_2)*

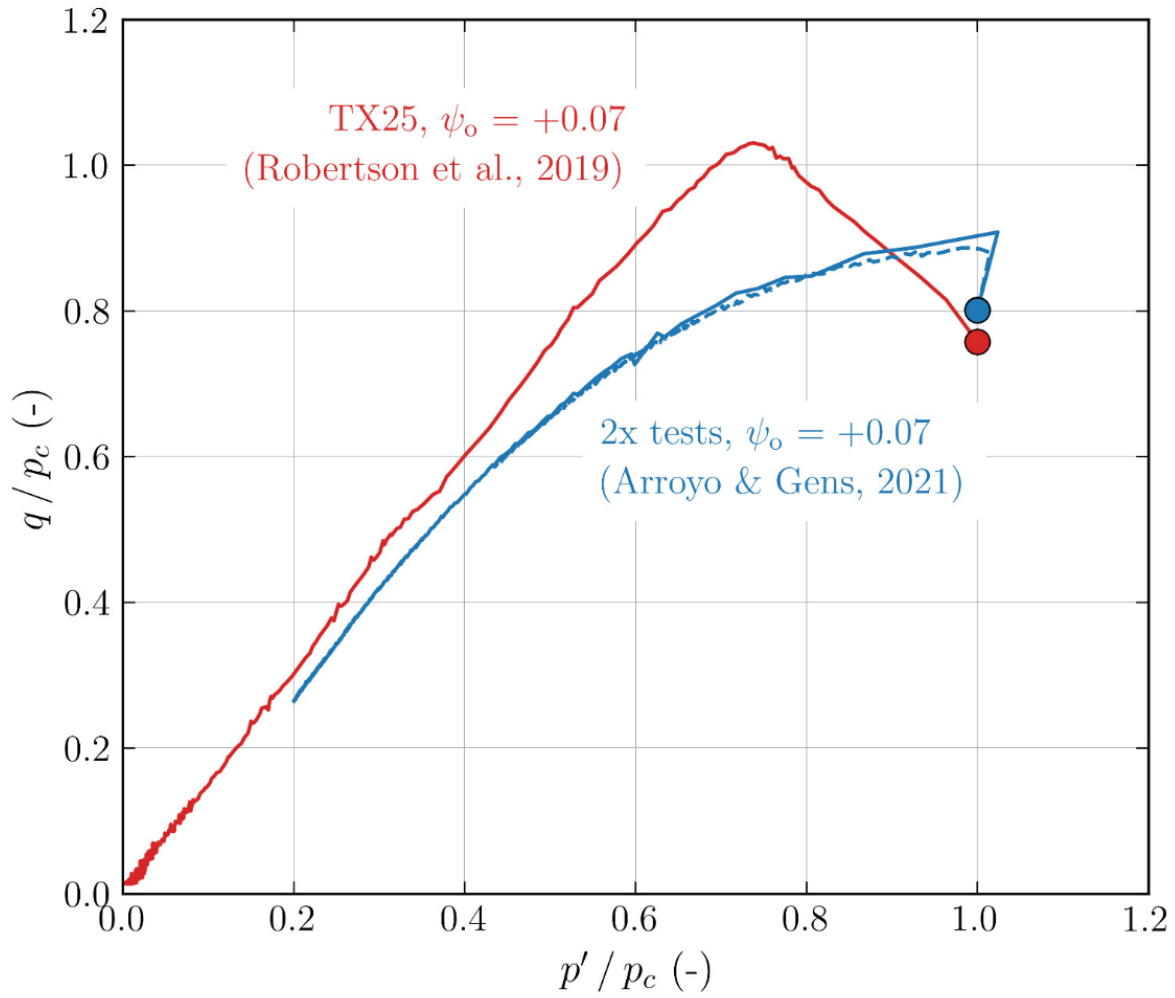
37 The undrained brittleness in Fig 2c is a consequence of void ratio, not bonding, and readily
38 computed by critical state theory. Reid et al.⁴ examined the effect of moist tamping preparation
39 procedures on subsequent undrained triaxial responses and found that much of the anomalously
40 brittle undrained behaviour noted by Robertson et al. was potentially caused by a too-dense
41 tamping process. This is illustrated in Fig D 2 which compares two specimens of B1 tailings
42 sheared undrained from the same initial state parameter. The specimens tested by Robertson et
43 al² – tamped initially into a denser state – show peaks that are not present in the specimens of
44 Viana da Fonseca et al.⁵, which were tamped loose.

133 **Fig D 2 Comparison of anisotropically consolidated undrained triaxial tests by Robertson et al. (2019) and**

Arroyo & Gens (2021) on Brumadinho B1 tailings

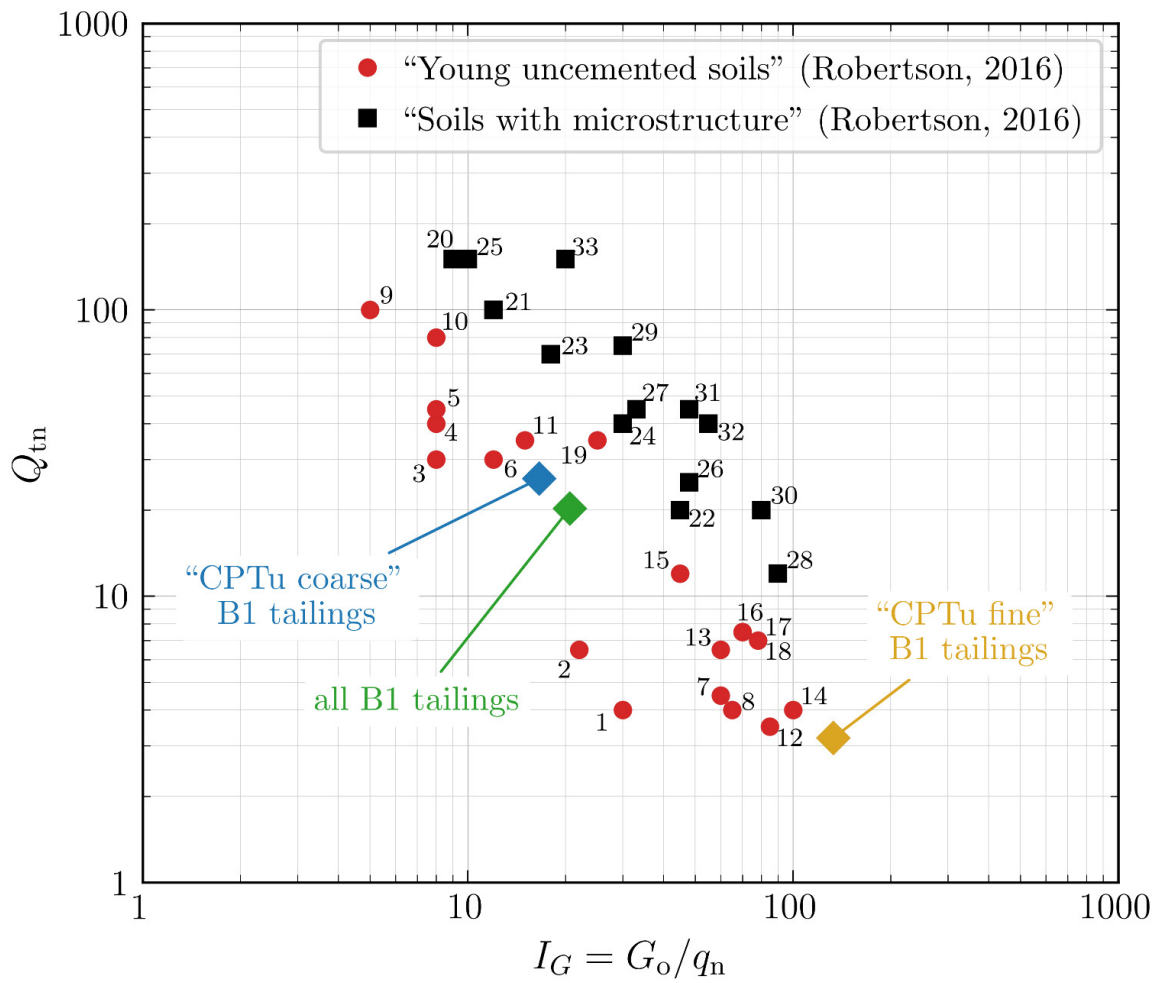
45 Regarding the V_s data, comparison with the database of Cha et al⁶ shows no bonding⁷. Going
46 further, if Robertson's³ approach is applied as originally developed (i.e. using average site values)
47 the Brumadinho tailings cluster with the uncemented dataset (Fig D 3).

138 *Fig D 3 Average field data from Brumadinho dam B1 superposed on $Q_{tn} - I_G$ database from Robertson (2016).*

139 *According to Robertson (2016) the red circles correspond to “young uncemented silica-based soils” and the*

140 *black squares to “soils with microstructure or calcareous”*

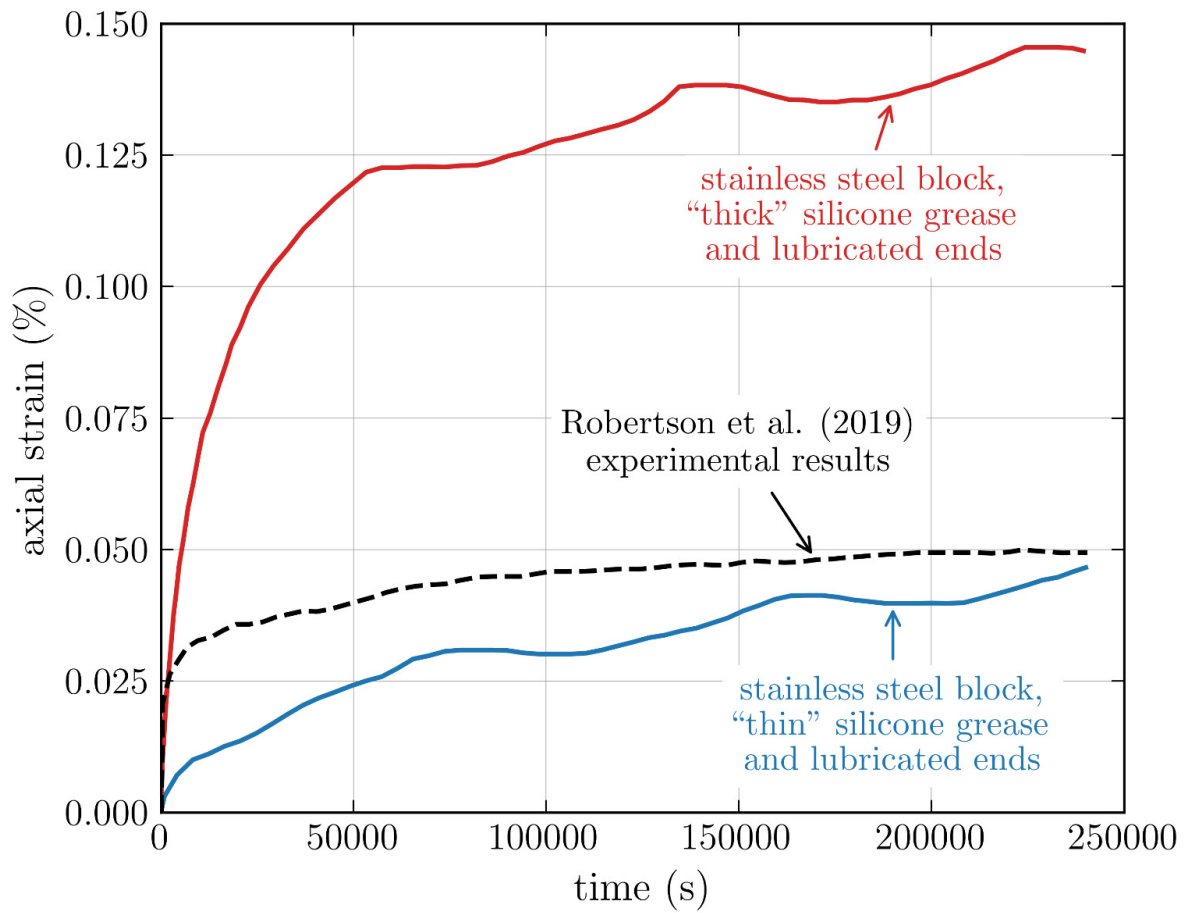
64 Furthermore, the “creep” observed in test TXDW03 is credibly just an artefact of the testing
65 procedure. We performed three triaxial tests on a stainless-steel block mimicking the conditions
66 of test TXDW03:

71 When lubricated platens and latex membranes were not used, the test on the steel block showed
72 no measurable displacements in time. Results for the other cases (Fig D3) suggest that a
73 significant proportion of the creep reported for TXDW03 was viscous deformation/compression of
74 the end lubrication (grease and membranes) rather than actual soil behaviour.

142 *Fig D 4 Externally measured displacements for tests on a stainless steel block tested on a triaxial cell using*
 143 *platens with lubricated ends. The stress condition was the same as in "Test 1" of the authors i.e $K_0 = 0.5$.*
