# Mechanisms and Occurrence of Detonations in Vapor Cloud Explosions –

## Supplementary Material

Geoffrey Chamberlain,<sup>1</sup> Andrzej Pekalski,<sup>2</sup> and Elaine S. Oran<sup>3</sup>

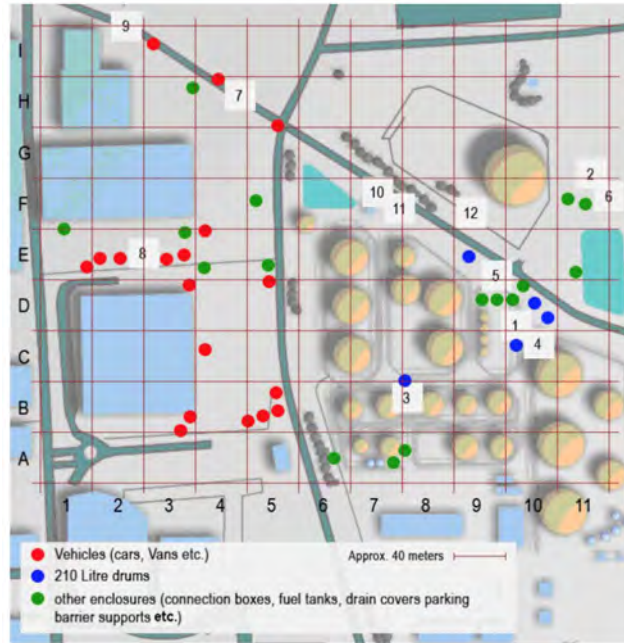
**Figure-S 1.1** Location of vehicles, drums and other enclosures which exhibited damage consistent with overpressures in excess of 200 kPa [2, 3]. For images of selected objects identified by numerical tags, see Figure-S 1.2.

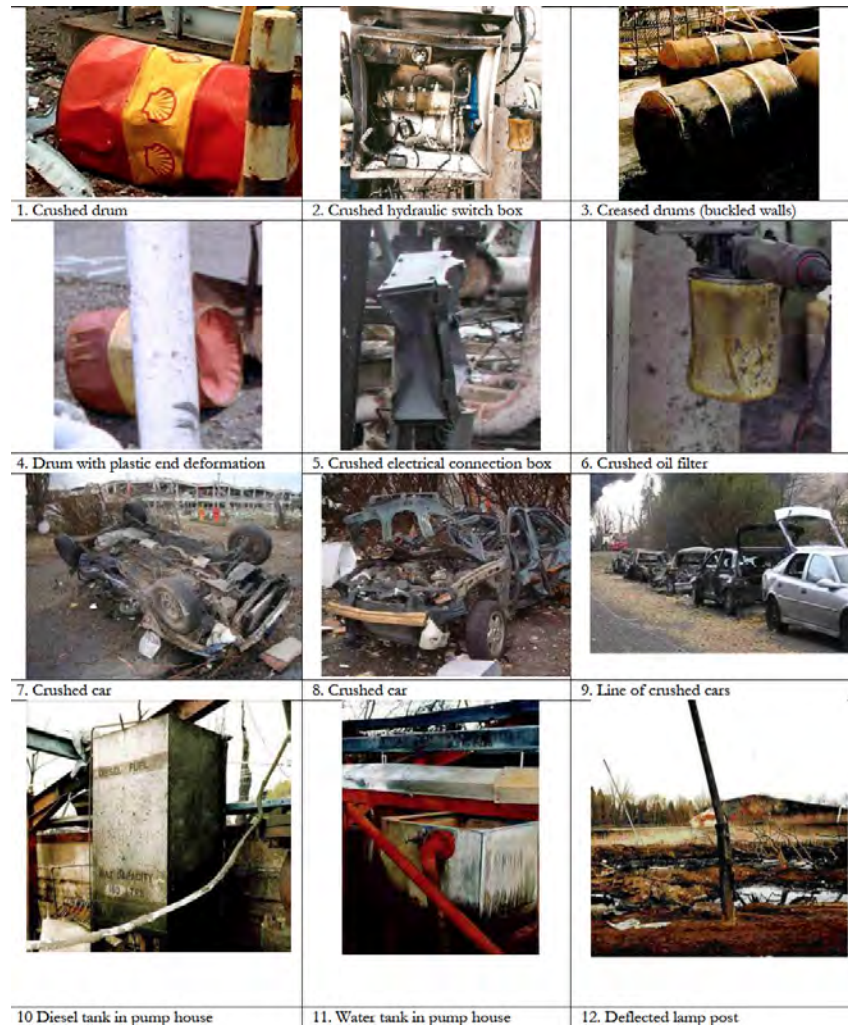
**Figure-S 1.2** Objects identified by numerical tags Figure-S 1.1[2, 3].

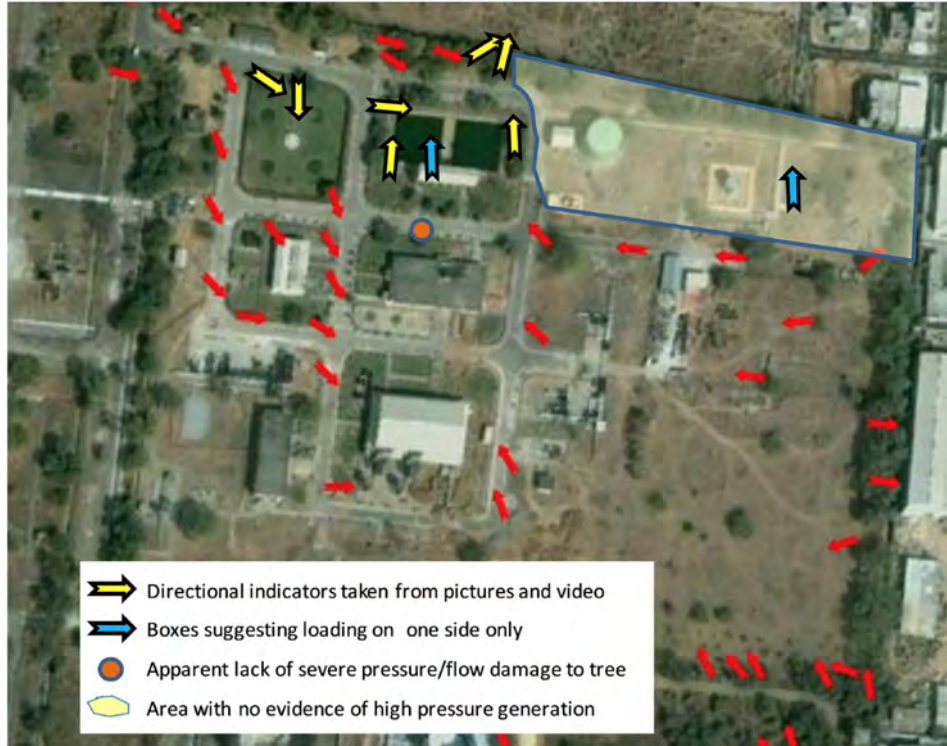
**Figure-S 2.1** Jaipur directional indicators in the Pipeline Division area and area without apparent pressure generation. Figure taken from [4]. The partial transparency through the yellow area shows the green tank, and the wall that is not damaged is the northern edge of the blue area. The main firewater pump house is just south of the firewater ponds.

It is postulated here that a flammable cloud was present in the shaded area at the time of the explosion, as the trees along the section of the north wall to the east of the green firewater tank were all fire damaged. In addition, there was no particular change in the ground level in the vicinity of the green firewater tank that would have prevented the vapor cloud from spreading into this area. Nonetheless, it is possible that the fire damage occurred as a result of fire propagating along the tree line after the explosion. In this scenario, it is possible that the vapor cloud in this area was below the lower flammable limit, which thus explains the absence of pressure damage.

Alternatively, it is possible that the vapor cloud was so thin in this area that it could not sustain a detonation. This hypothesis, however, is inconsistent with the ground level in this area and the persistence of the detonation throughout the rest of the site. The most likely explanation is that the vapor cloud burned out before the main explosion. This also suggests that the ignition point was located in this area.

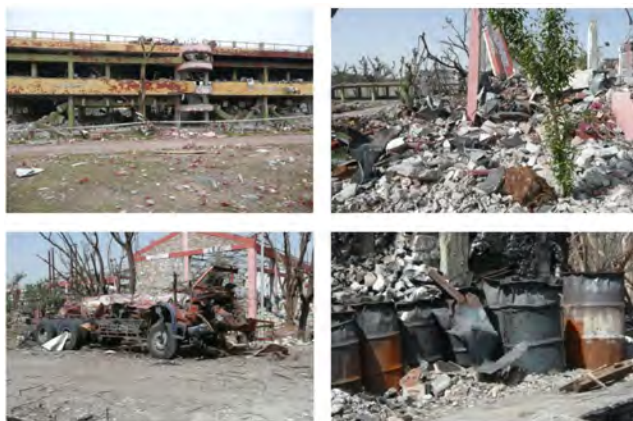
**Figure-S 2.2** Examples of pressure damage on the IOC site [4].

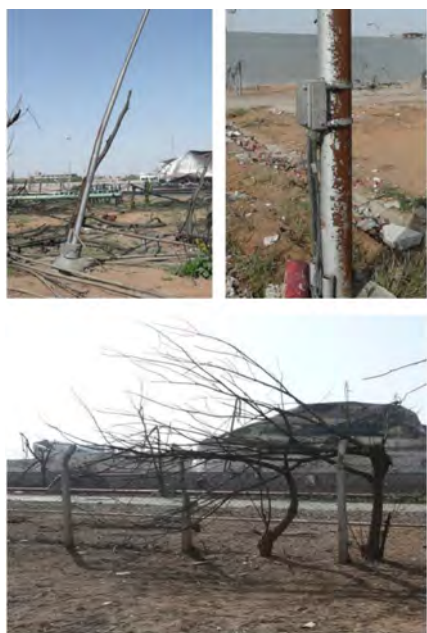
**Figure-S 2.3** Examples of directional indicators: bent trees and scoured poles [4].

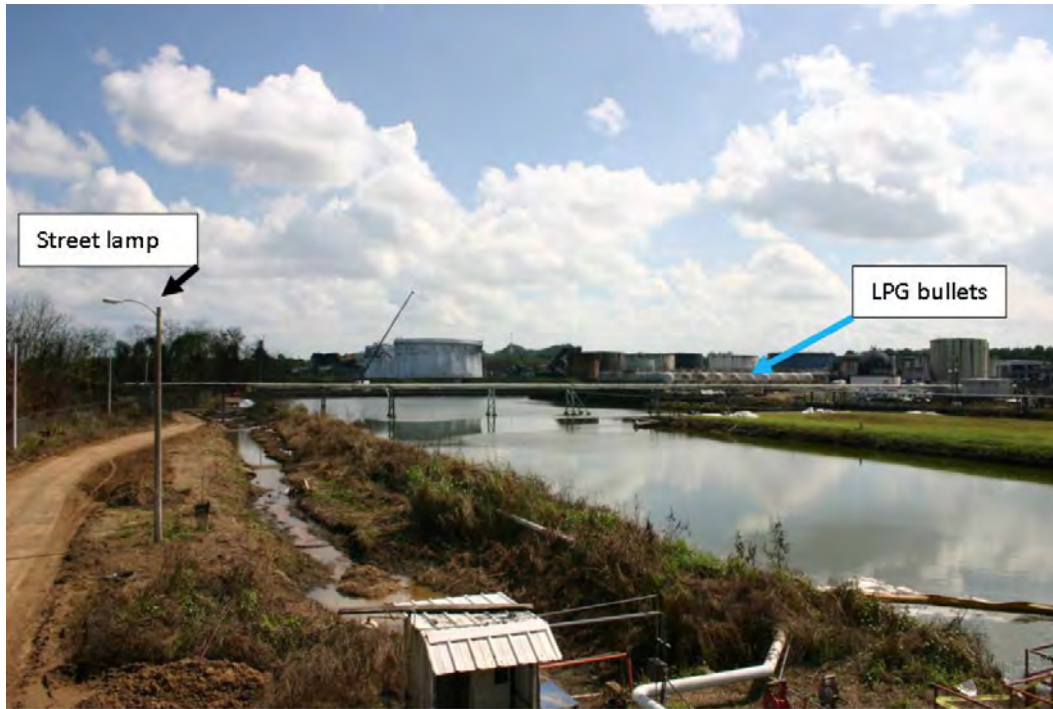
**Figure-S 3.3** View from the waste water treatment CCTV camera (also called the NW camera). Note crushed white tank [6].

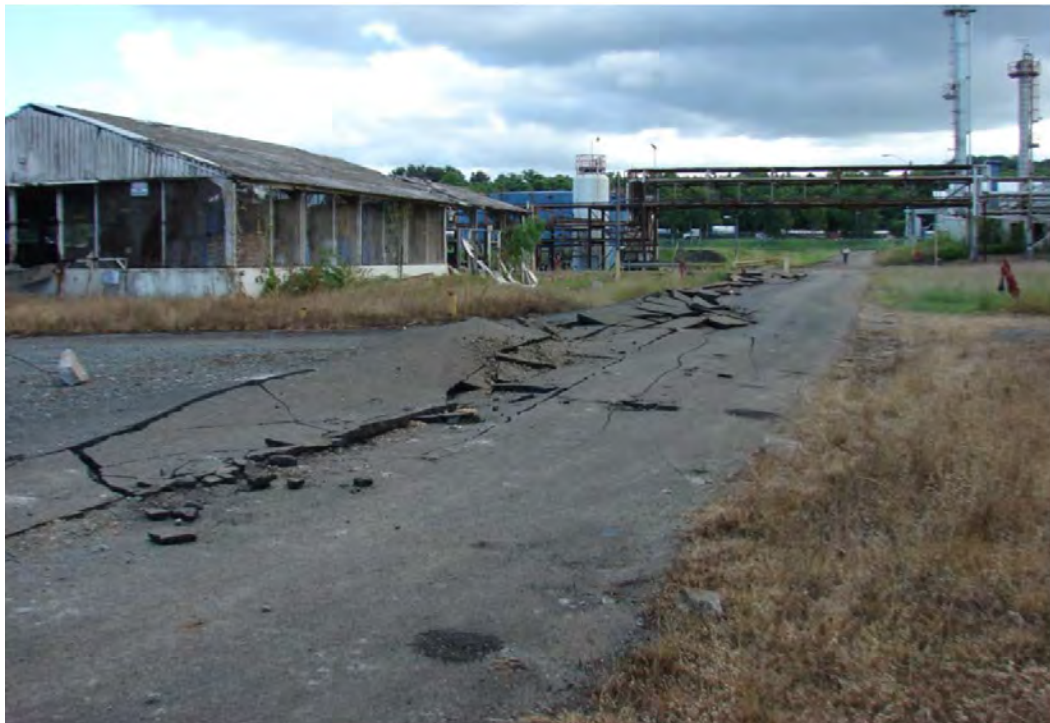
**Figure-S 3.4** Damage to road above water culvert [6].

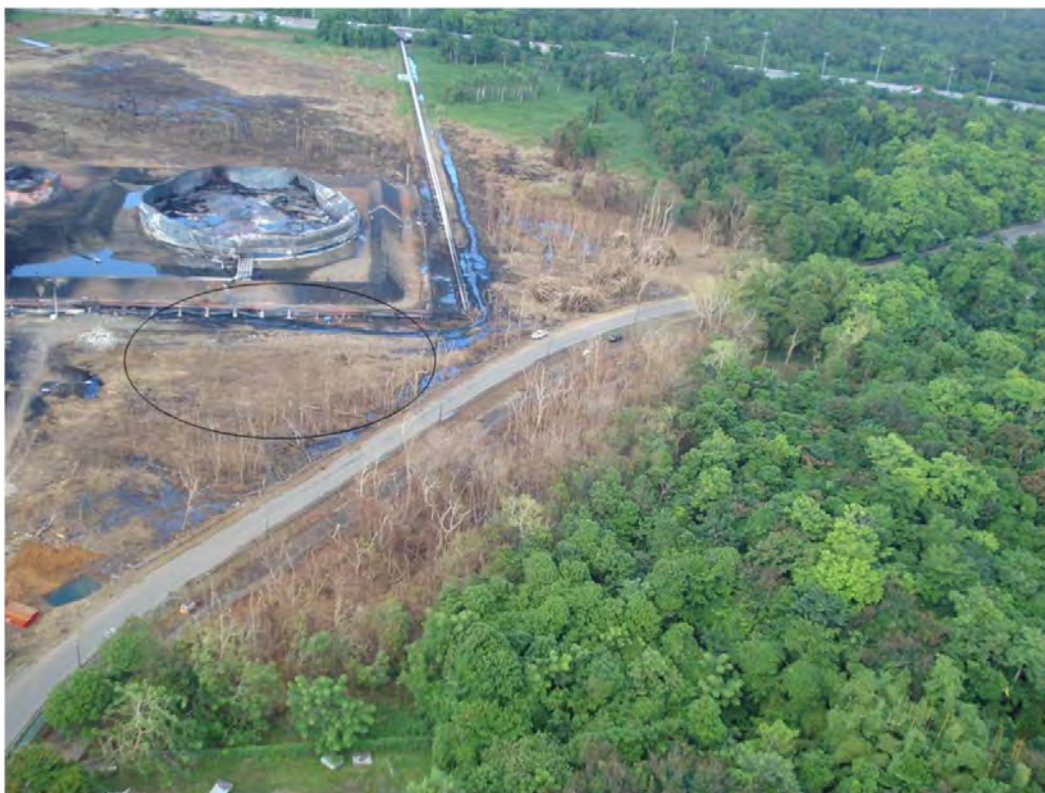
The time between ignition and the main explosion was about  $\sim 7 \text{ s}$ , during which there were several explosions and flash fires. Nearly all of the blast effects can be explained by conventional understanding of flame acceleration. There are examples of flame acceleration through repeated LPG tank obstacles (see Figure-S 3.3), flame acceleration down a 240-m-long buried water duct, an external explosion at the far end (see Figure-S 3.4), and flame acceleration in highly congested regions of dense vegetation (see Figure-S 3.5).

**Figure-S 3.5** The damage to the area that once contained dense vegetation is shown inside the superimposed black oval ring in the middle of the left side of the photograph [6].

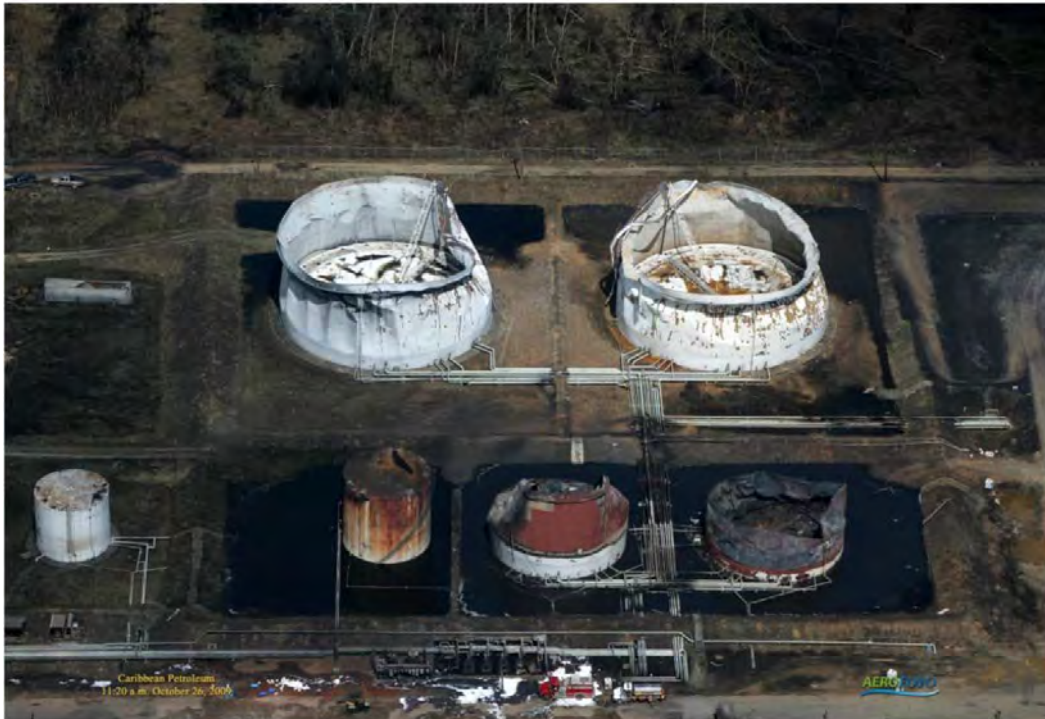
The second anomaly concerns the damage to tanks 406 and 407 (Figure-S 3.6). These tanks did not catch fire, and their damage is typical of a blast impact. Yet they are, respectively, 300 m and 350 m from the location of the explosion in the bamboo area at the east end of the site. Equation (4-2) (from Section 4 of main report) gives 0.08 atm overpressure at tank 407 and 0.07 atm at tank 406. CAM [7] gives approximately the same values, using a highly congested region of 100 m x 40 m. These overpressures are not sufficient to cause the level of damage sustained. The situation is further complicated by the fact that another tank containing fuel oil, number 603, was only about 60 m from the edge of the bamboo explosion, and yet it sustained only superficial damage (Figure-S 3.7).

One possibility here is that tanks 406 and 407 were hit to their southwest position by a blast from fast flames propagating through the line of 11 empty LPG bullets located to their southwest. If the flame speed through this region were  $\sim 180$  m/s, as observed from the northwest video, then an overpressure of around 0.6 atm would be generated. CAM then predicts overpressures of 0.15

**Figure-S 3.6** Blast damage to empty tanks 406 and 407. Figure Figure-S 3.3 was taken from left side of this figure [6].

and 0.09 atm at tanks 406 and 407, respectively. which is insufficient to account for the damage. Additionally, the blast at the gatehouse,  $\sim 450$  m away, is then  $\sim 0.026$  atm, but nothing appears on the gatehouse video at the elapsed time of 23.06 frame 7. The questions, then are: *Why is there no evidence in the video? How do we explain the level of damage?*

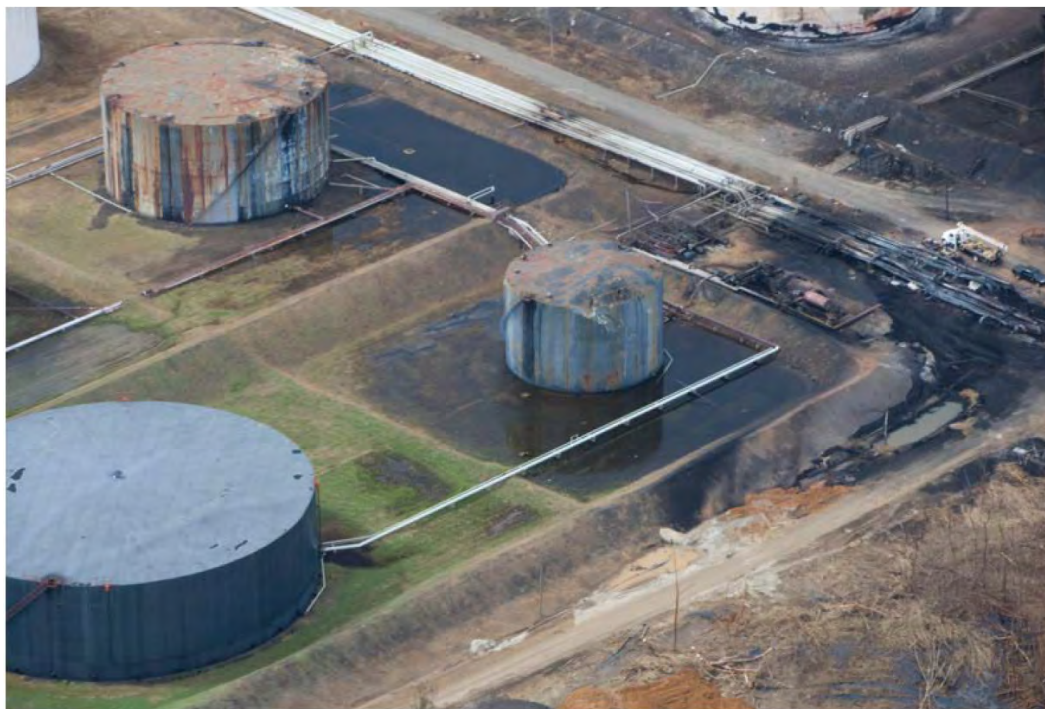
**Figure-S 3.7** Tank 607 is the smaller tank near the center of the picture [6].

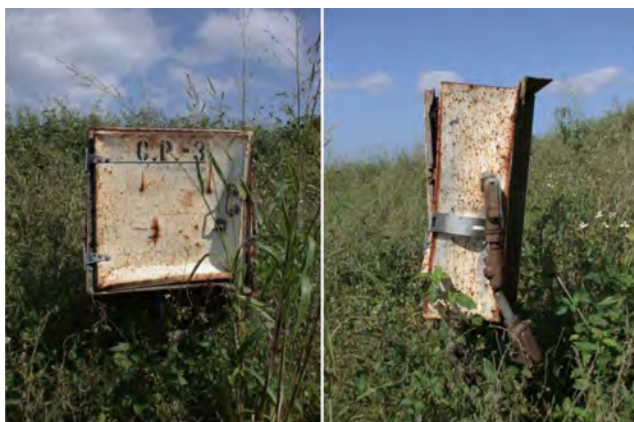
The third anomaly concerns a slightly damaged switch box (Figure-S 3.8) located  $\sim 100$  m from the bamboo area. Tests following the Buncefield explosion have shown that the incident overpressure must be greater than 1 atm to cause distortion of the box. Yet, assuming a detonation in the bamboo area, the overpressure estimated from Equation (4-2) is only  $\sim 0.16$  atm.

**Figure-S 3.8** Damaged switch box, front face (left figure) and side view (right figure) [6].

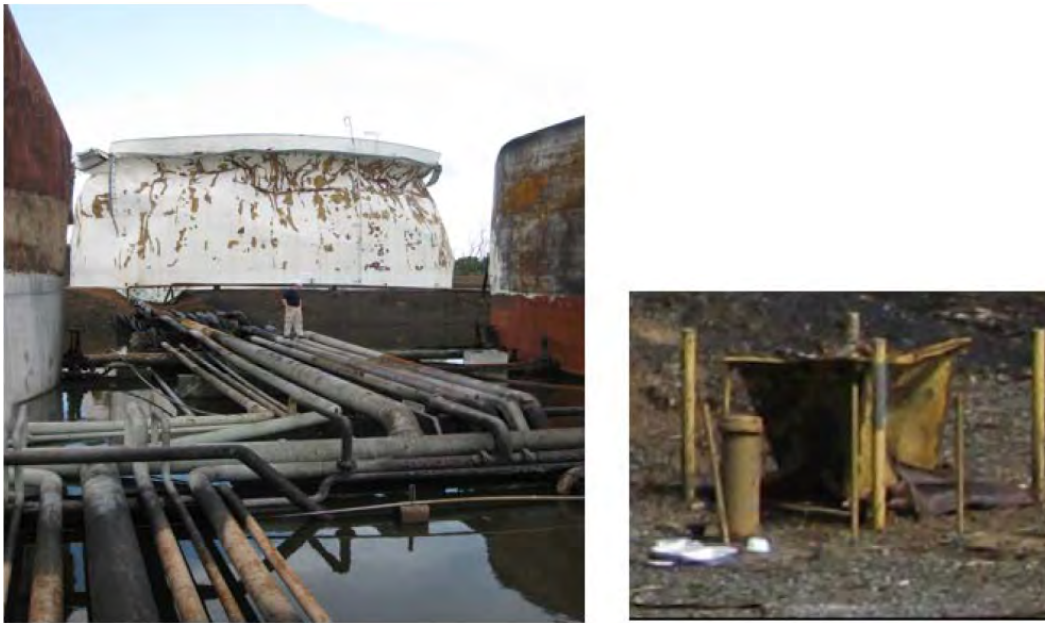
**Figure-S 3.17** Congested pipework in the region between tanks 404 and 405 (triangulated area) (left) and crushed steel box (right) 70 m to the east of the triangulated region [6]. . Note uniformly crashed tank.

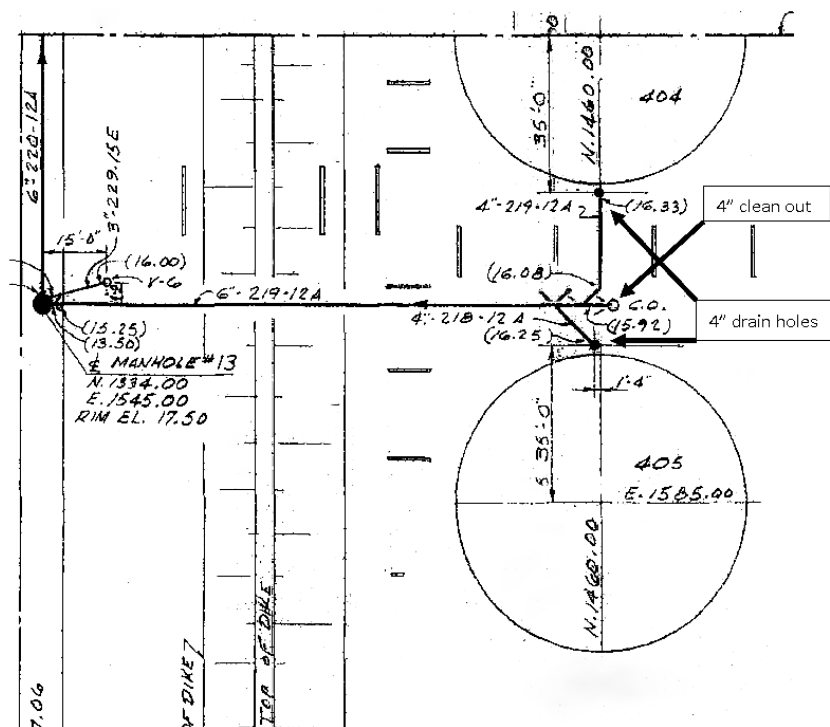
**Figure-S 3.18** Drain system in the region of tanks 405 and 406. Note the two 4-inch drains between the tanks, and the clean out. It would seem that the clean out pipe exits underneath the gasoline pipework [8].

Thus the current hypothesis is that a detonation of the vapor cloud occurred by ignition from a high-velocity jet flame emerging from the drain system between tanks 404 and 405. The vapor cloud in this region was close to the original leaking tank and occupied a large volume, possibly 10-m high. The detonation propagated through the vapors that remained after a partial burnout in the northern part of the site, and it then continued into the bamboo area at the east end.

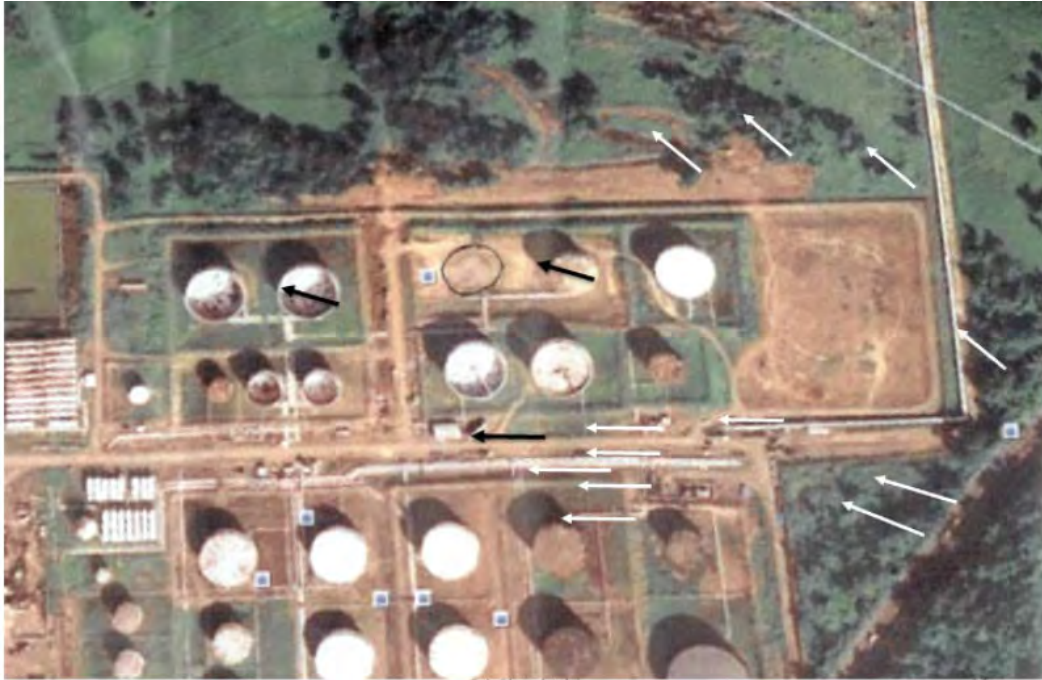
Another possibility is that a detonation propagated all the way to the bamboo area from the tank area, as opposed to a DDT that starts in the bamboo area after the remaining fuel had burnt out. The second case, in which DDT occurred in the bamboo area after the remaining fuel burned out, would have created the positive pulse to cause the directional indicators in Figure-S 3.20.

**Figure-S 3.20** Directional indicators on the eastern side of the site [8, 6].

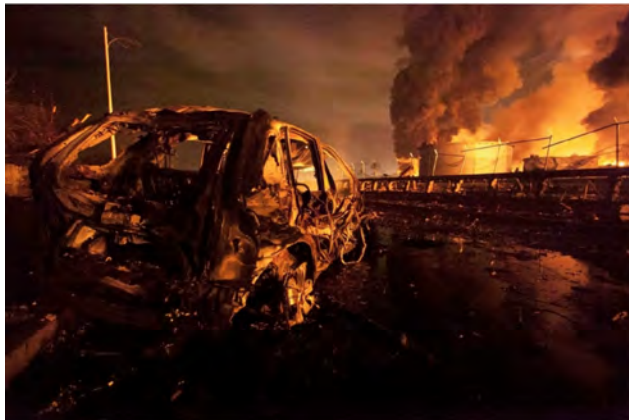
The damage pattern is confusing. The car that is supposed to have ignited the cloud shows damage signs equivalent to at least 5 atm of overpressure (Figure-S 4.2). The fence posts near this car point towards the refinery and away from the car, yet posts further along point in the opposite direction, and the car itself is pushed away from the refinery.

**Figure-S 4.2** Fence poles bent inwards towards refinery. Car close to, or responsible for, point of ignition. (Figure taken from [10].)

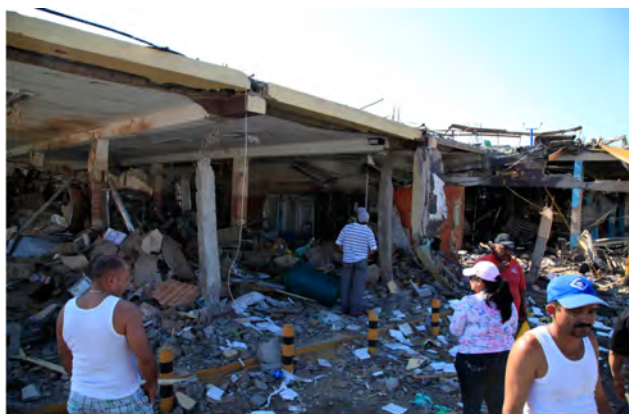
**Figure-S 4.3** Houses adjacent to road running east of the lube oil area. Notice displacements of reinforced concrete poles. (Figure taken from [10].)

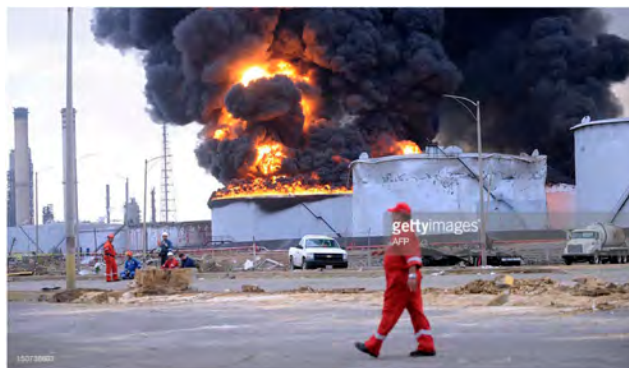
**Figure-S 4.6** Crushed storage tanks. (Appeared on website of *Christian Science Monitor*, 16 September 2013. )

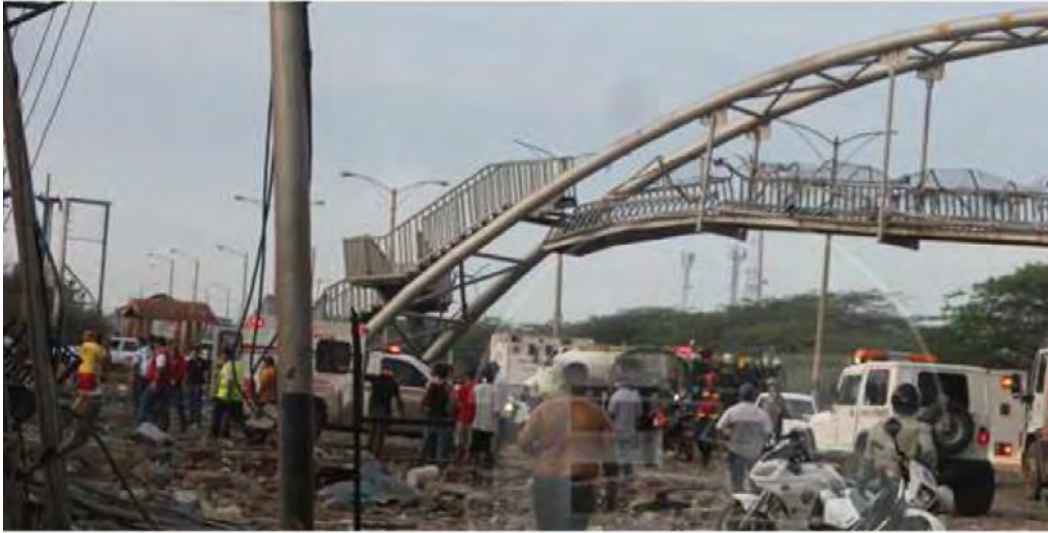
The footbridge (Figure-S 4.7 and Figure-S 4.8) was damaged, and it appears that the supports and railings were drawn towards the lube oil area.

**Figure-S 4.7** Note footbridge drawn inwards towards refinery, suggesting footbridge inside detonation. (Figure taken from [10].)

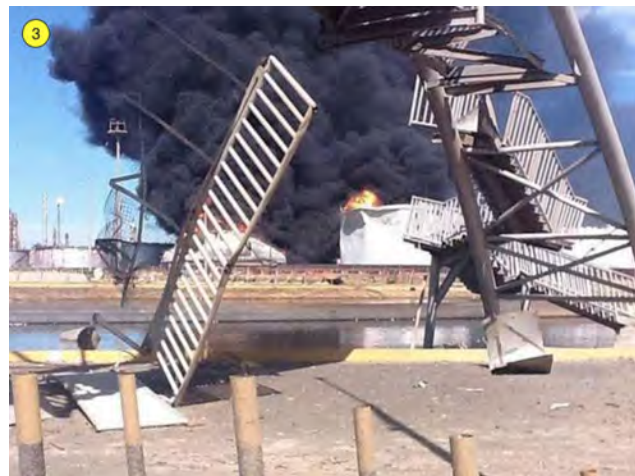
**Figure-S 4.8** Close up of footbridge showing damaged railings and supports drawn towards the refinery. (Figure taken from [10].)

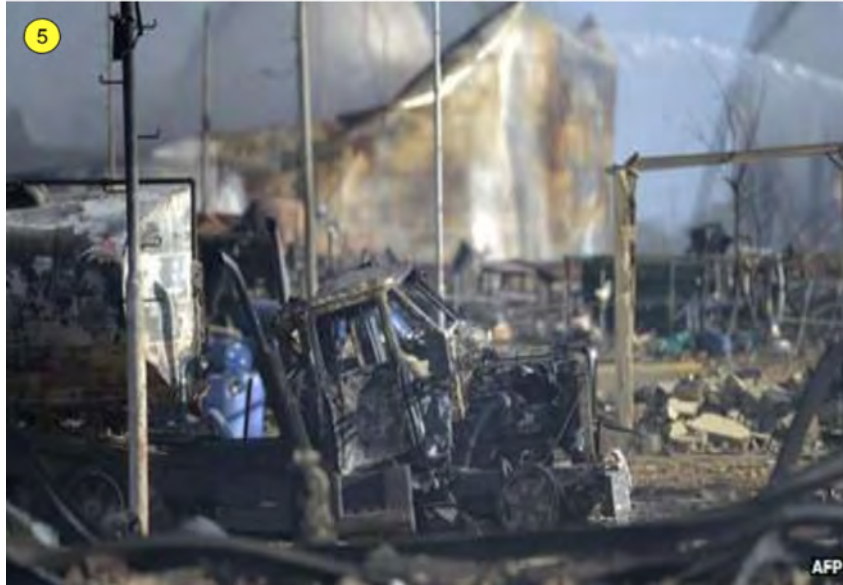
Figure-S 4.9 and Figure-S 4.10 show damage to trucks inside the lube oil area, representative of overpressures greater than 5 atm. Car and tree damage indicate detonation (Figure-S 4.11). The oil drums in Figure-S 4.12 indicate overpressures of at least 3 atm.

**Figure-S 4.9** Damage to truck inside the lube oil plant. Damage suggests detonation.

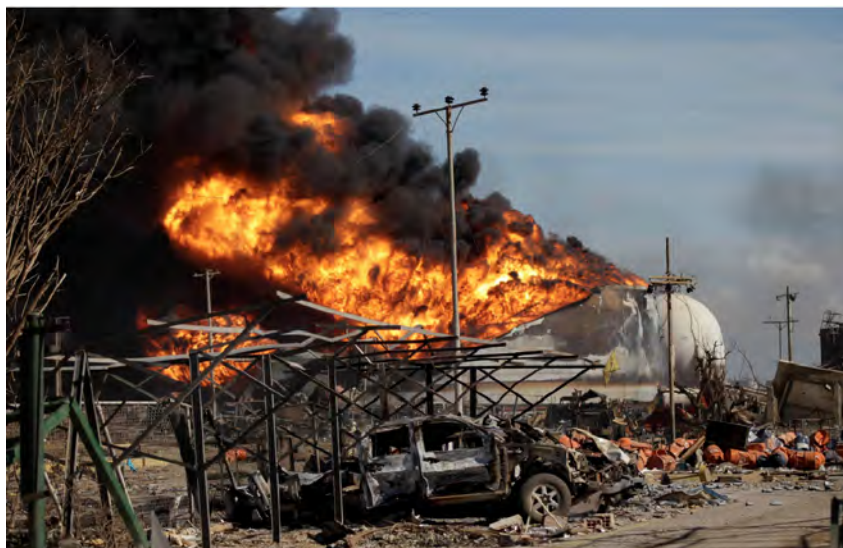
**Figure-S 4.10** Lube oil plant damage to truck and oil drums. Note building destroyed, but poles not bent.

The hypothesis does not explain the bent posts near the ignition point towards the refinery, nor does it explain the lack of bent posts in the lube oil plant itself (Figure-S 4.10). The displacement of the car to the other side of the road and its significant damage also remain an anomaly.

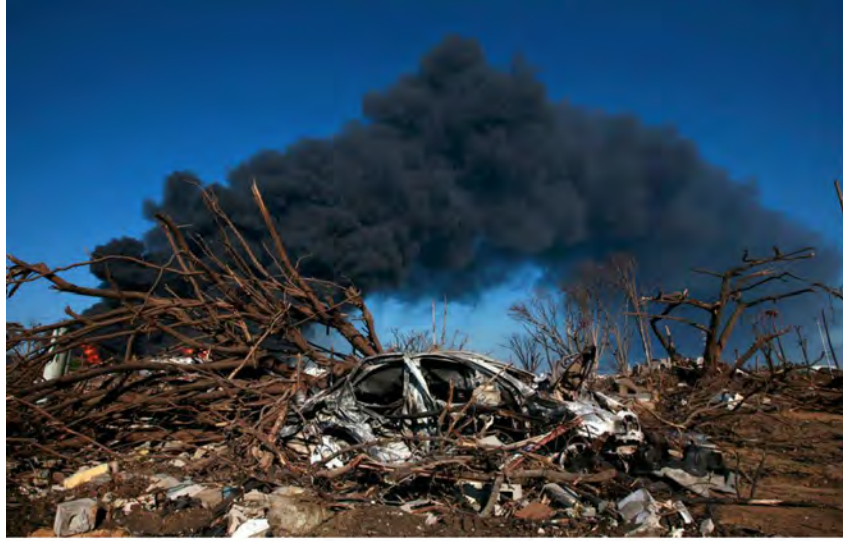
**Figure-S 4.11** Car and tree damage suggest detonation.

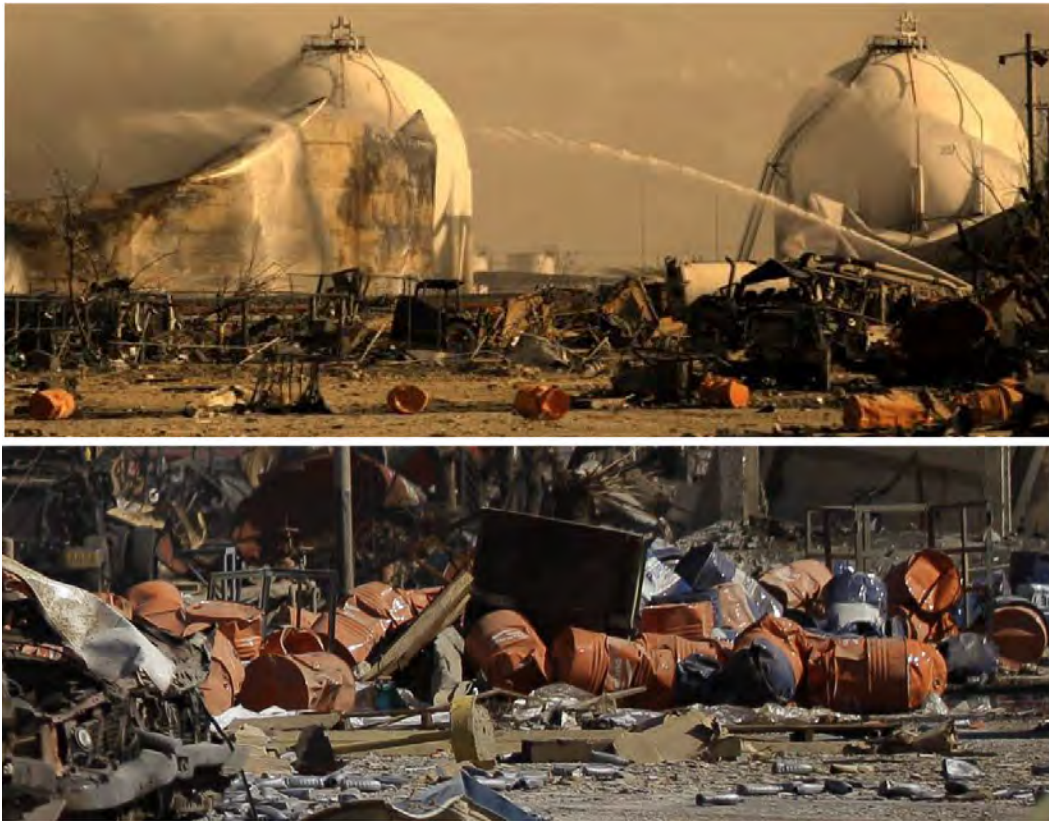
**Figure-S 4.12** Top: Drums and car damage. Bottom: Enlargement of Figure-S 4.10 showing creased drums. (Figure from CTV News, August -September, 2012.)

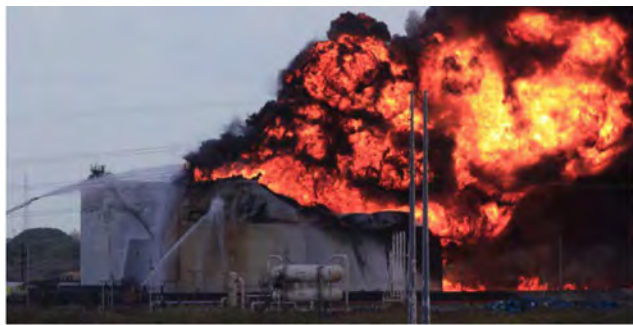
Figure-S 4.13 shows tank damage due to blast impact (suggesting detonation) with a subsequent phenomenon called top tank fire that destroys the impact evidence because it melts walls. The overpressure at the nearest fuel tank ( $\sim 10$  m from the edge of the cloud) would have been around 0.23 atm, sufficient to deform and open up the tank. Additionally, a large storage tank  $\sim 470$  m to the west remained largely undamaged. The overpressure there would have been around  $\sim 0.05$  atm. Other storage tanks inside the cloud show definite uniform crushing (Figure-S 4.14 to Figure-S 4.15), suggesting detonation impact.

**Figure-S 4.13** Crushed storage tank with tank top fire that melts and deforms the tank walls.

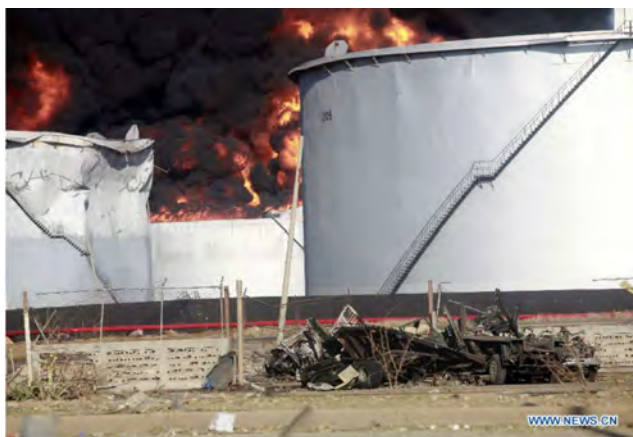
**Figure-S 4.14** Crushed storage tank. Notice damaged cars.

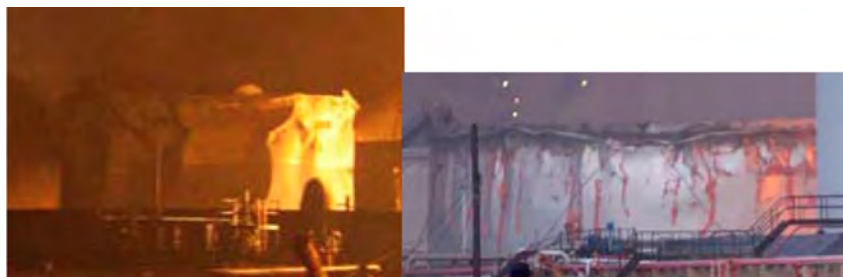
**Figure-S 4.15** Crushed storage tank suggesting detonation impact. (From website Runrun.es, by permission [11].)

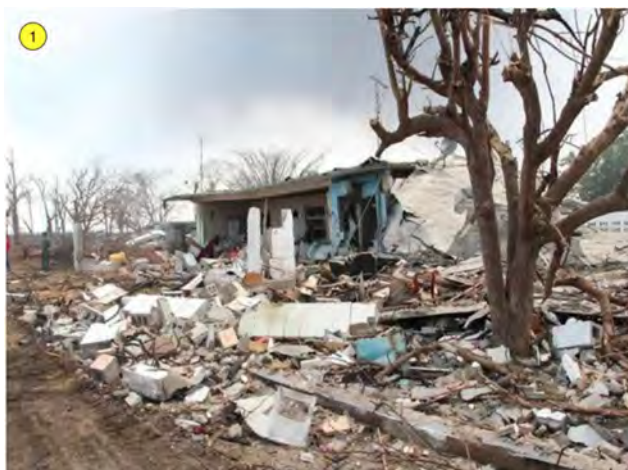
Unless, and here is another hypothesis, there was another fast flame or detonation near this location. Building and tree damage suggest a considerable blast in the vicinity (Figure-S 4.16), which was strong enough to be a detonation.

**Figure-S 4.16** Building damage in the vicinity of the car allegedly responsible for ignition of the cloud [10].

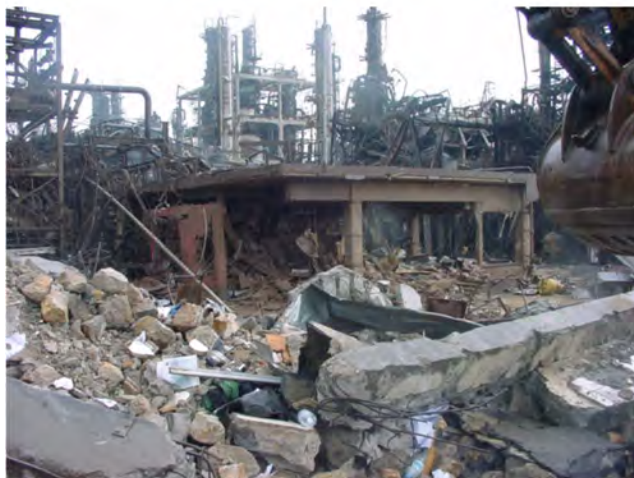
Photographs of the damage reveal several interesting features. The Control Room (Figure-S 5.2) and Maintenance Building (Figure-S 5.3 and Figure-S 5.4) were totally destroyed. Some reinforced concrete supports from the remains of the Maintenance Building were displaced towards Unit 40. Several poles in the open space between the Maintenance Building and Unit 40 (Figure-S 5.5, Figure-S 5.6, and Figure-S 5.7) and a tower support (Figure-S 5.8) are bent inwards towards Unit 40. Figure-S 5.9 shows a considerably crushed heavy duty truck located away from congested space. The damage indicated overpressure significantly higher than 5 atm. This space also contains a few crushed oil drums, indicative of overpressures over 3 atm. The collapsed flash drum and railings in Figure-S 5.10 and Figure-S 5.11, and especially the bent poles in Figure-S 5.5, Figure-S 5.6, and Figure-S 5.7, have been drawn to the SW on Unit 40. When these directional indicators are plotted on a Google Earth snapshot of the site (Figure 5.3 in Main Text) they suggest that a detonation may have occurred. Consistent with this hypothesis is the fact that the vapor cloud was observed to have reached the Maintenance Building.

**Figure-S 5.2** Control Room at Skikda (private communication to GAC, 2004).

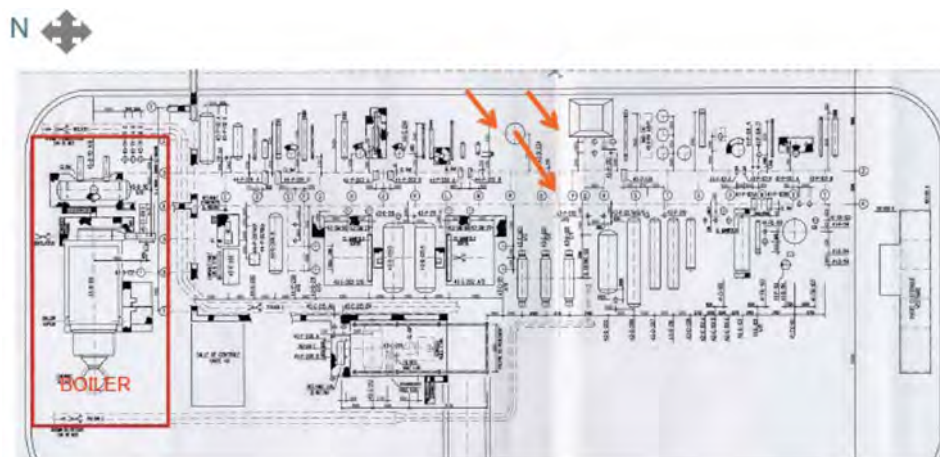
**Figure-S 5.11** Location of a flash drum and railings Unit 40 indicating direction of bend. (Private communication to GAC, 2004, and [12].).

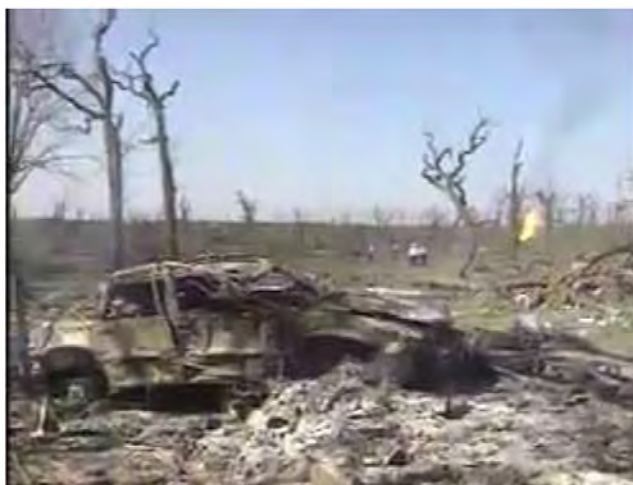
The location of ignition remains unknown, but evidence points towards the car entering the cloud, as shown in Figure-S 6.1. The level of damage resembles that of overpressures  $> 5$  atm, which could only have been generated by a fast deflagration or detonation. Ignition of the cloud would not in itself create large overpressures and the flame would have to have accelerated. The car may have traveled some distance before being damaged to the extent shown in Figure-S 6.1.

**Figure-S 6.1** The video shows a damaged car, shown in the captured image above. The crushing resembles damage caused overpressures  $> 5$  atm [13].

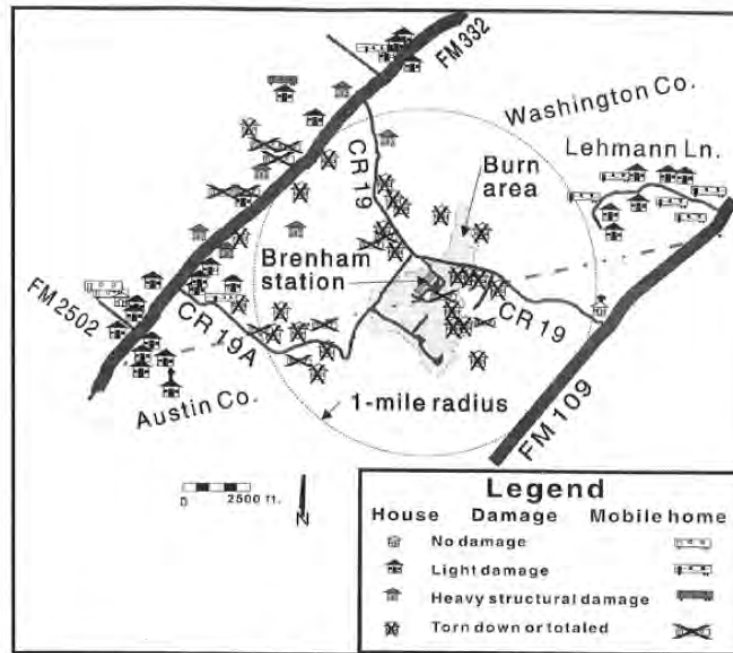
Figure 19: Damage to homes and structures near the accident site from Pipeline Accident Report: Highly Volatile Liquids Release from Underground Storage Cavern and Explosion, MAPCO Natural Gas Liquids, Inc. Brenham, Texas April 7 1992, NTSB-PAR-93-01.

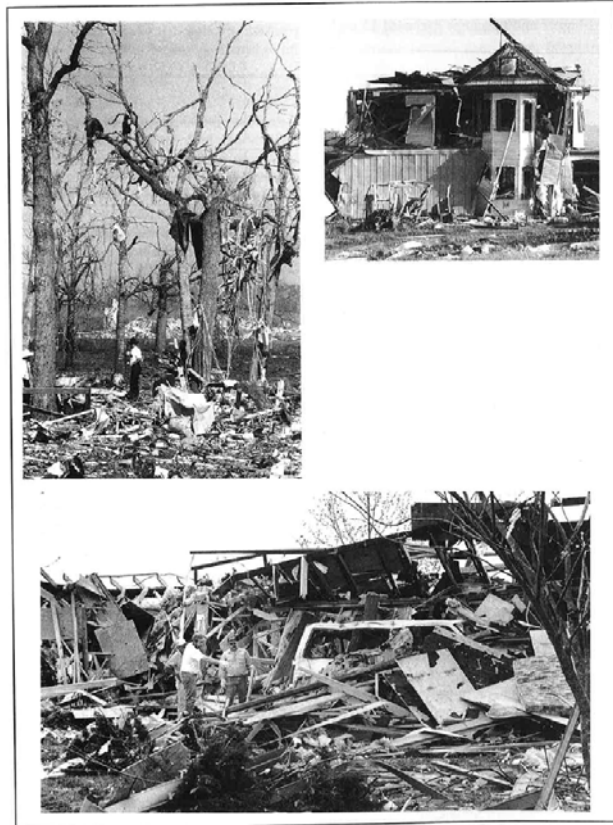
0.05 atm. This would have been sufficient to destroy the mainly wooden houses, as observed in Figure-S 6.2 and Figure-S 6.4.

**Figure-S 6.4** Area residences damaged by blasts. Sketch reproduced from [14]. Top right: a building about  $\sim 800$  m from the release point.

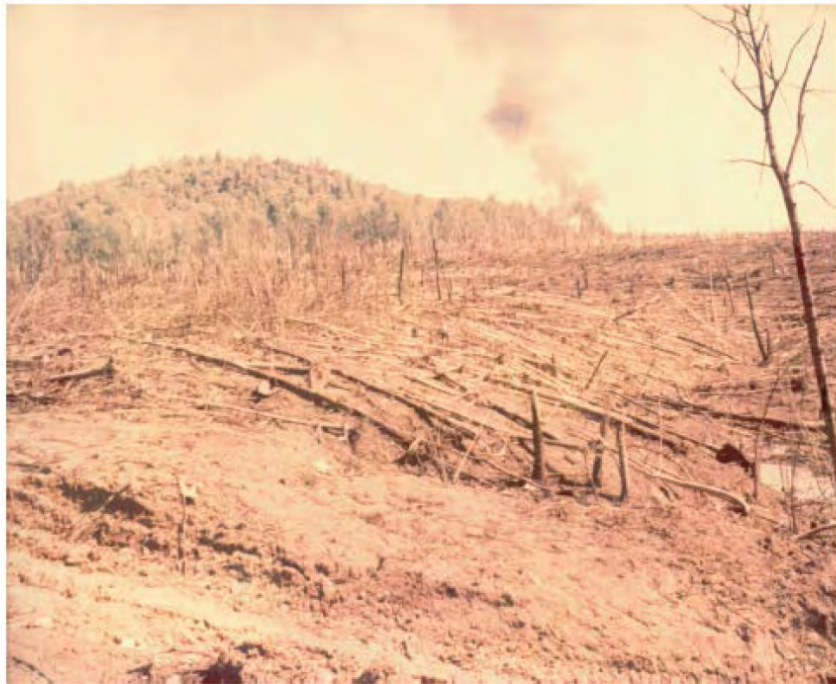
**Figure-S 7.4** Sharp borderline between demolished and original forest, indicating sharp change of overpressure [15].

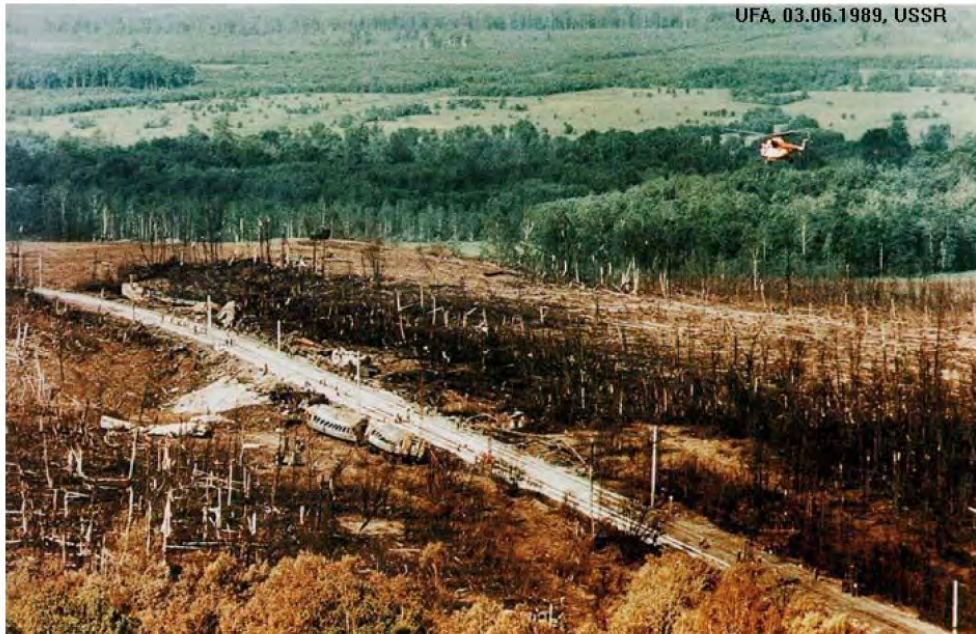
**Figure-S 7.5** View after the accident. Note crushed train on left side (G.M. Makhviladze, private communication).

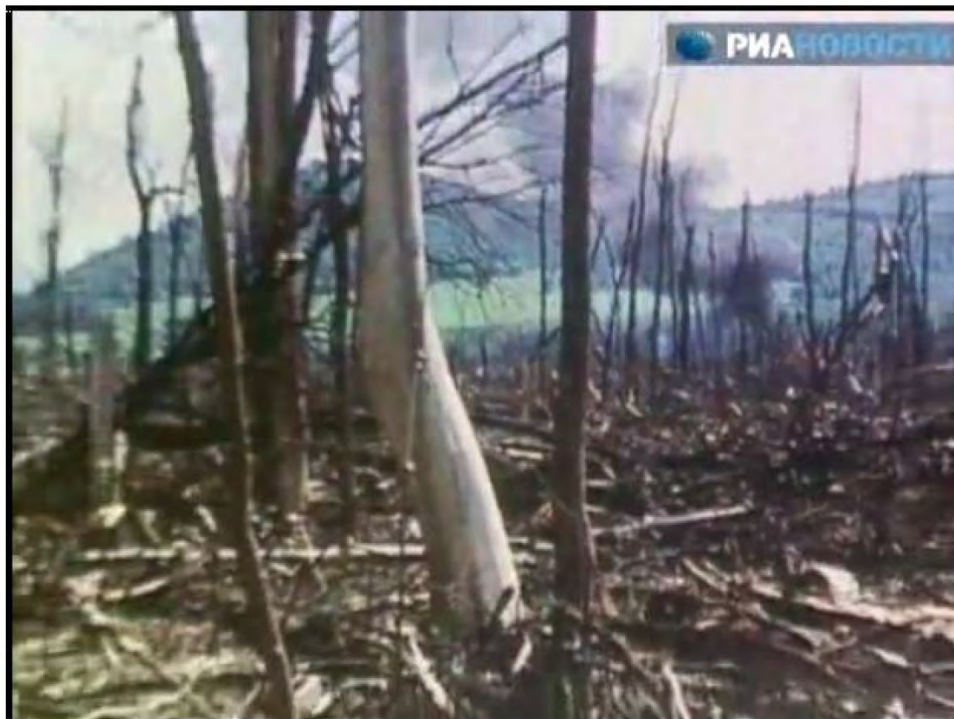
**Figure-S 7.6** Taken from a short video of the incident. Tree breakages near point of release. Note damage to the trees includes breakage of branches and trunks, burnt trunks and uprooting (private communication, G.M. Makhviladze to author AP).

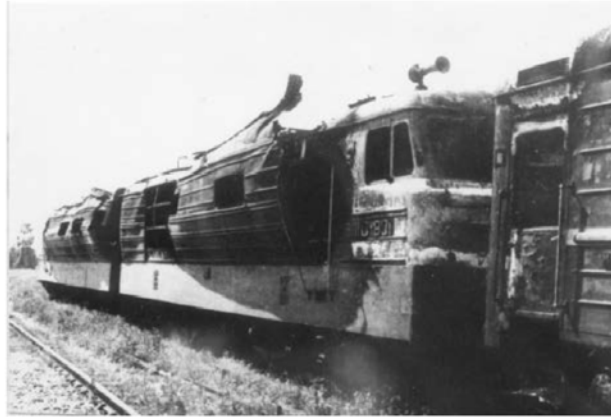
**Figure-S 7.7** Internal explosion(s) evidenced by the barrel like shape of coaches and locomotives [15].

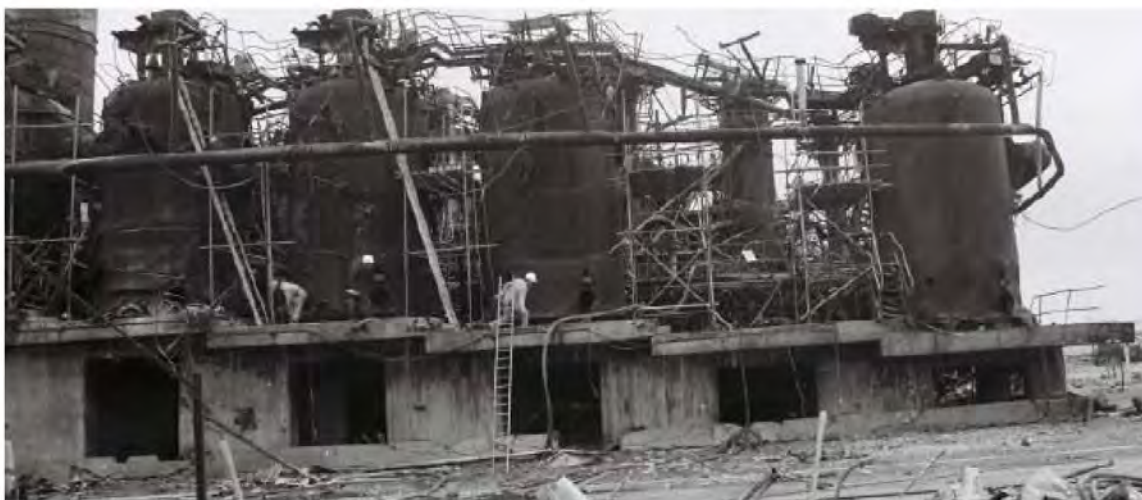
**Figure-S 10.1** Photograph of part of the reactor train after the incident [23, 24]. The dog-leg bypass connecting the gap to the last vessel was lost completely. The scaffolding was been erected after the incident

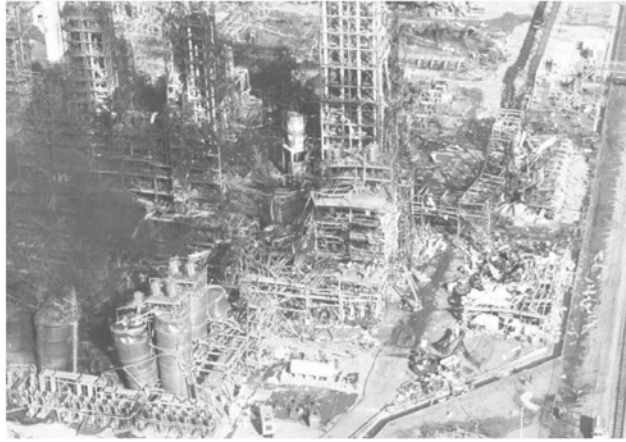
**Figure-S 11.5** View from southwest corner towards north/northeast. Metal fatigue clearly visible in remaining superstructure. Note crushed tanks on bottom left (taken from [25]).

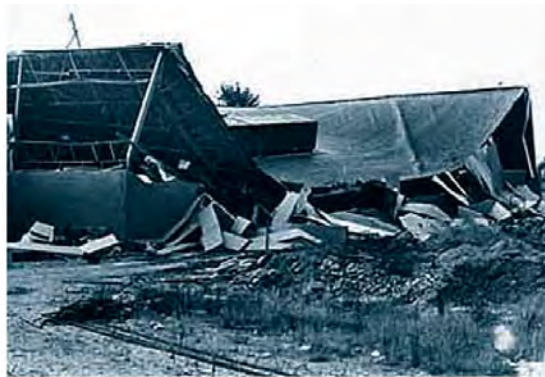
**Figure-S 12.5** The explosion leveled the new school addition to the Lakeview High School building (taken from [26]).

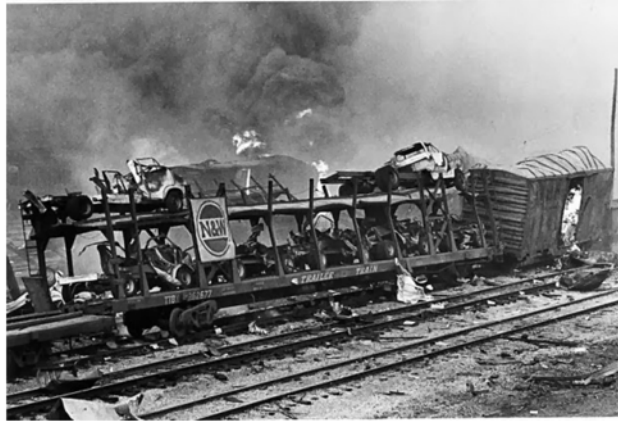
**Figure-S 12.6** View of damaged items. Note the crushed vehicles (taken from [26]).
