# Mechanisms and Occurrence of Detonations in Vapor Cloud Explosions –

## Supplementary Material

Geoffrey Chamberlain,<sup>1</sup> Andrzej Pekalski,<sup>2</sup> and Elaine S. Oran<sup>3</sup>

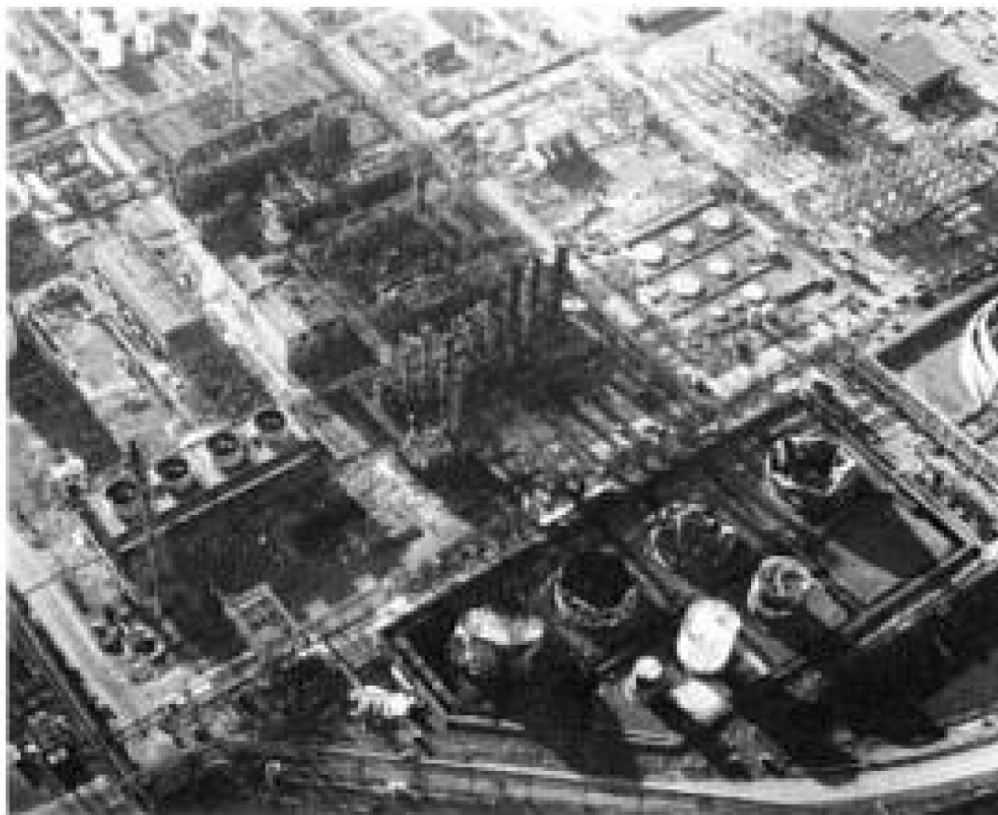
**Figure-S 13.5** Damaged plant. Note the tank damage Reproduced with permission from [30]).
