## **Checking the data of Airbus plane crash in flight 447**

Written by: Danial Karami

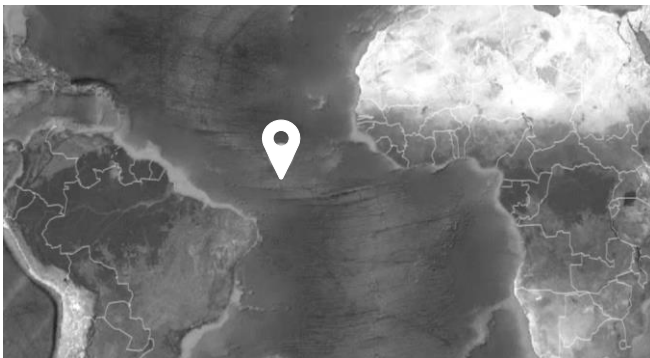
Figure 1. Flight AF447 crash site (N2.98 W30.59)
