Residual Axial and Lateral Load Carrying Capacity of Pile Supported Marine Terminal Exhibiting
Seismically-induced Local Buckling in Inground Plastic Hinges

Department of Structural Engineering
University of California, San Diego

June 2025

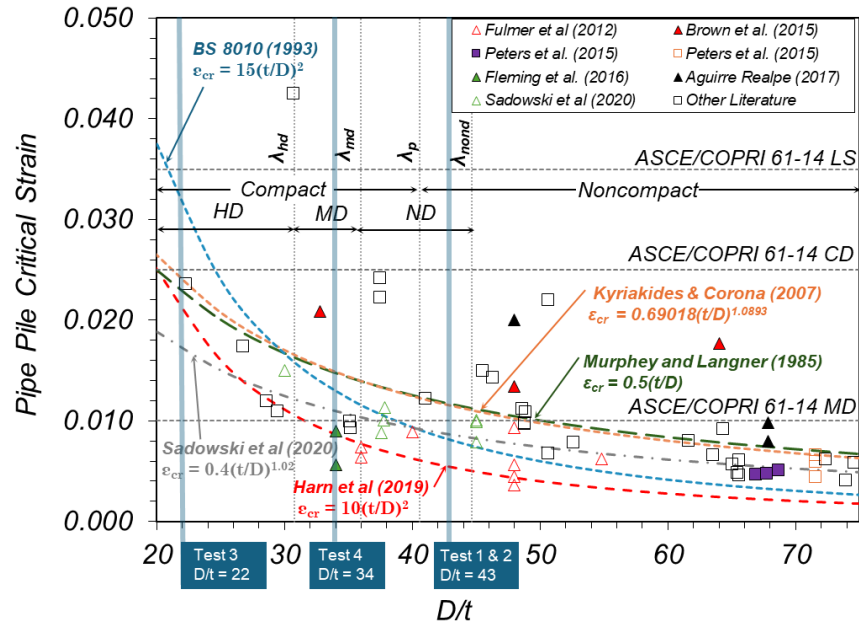
Figure 1: Pipe Pile Critical Strain in terms of D/t Ratio (Harn et al Recreation) [29]

Harn et al. [29] and Sadowski et al. [41] compared critical strains for hollow and filled steel pipe piles in literature against proposed design equations and the ASCE/COPRI 61-14 [8] recommended steel pipe pile in-ground strain limits. Figure 1 recreates the "D/t Effect on Critical (Buckling) Strain" figure from Harn et al. [29], with blue lines illustrating the D/t ratios of the four tests, thereby demonstrating the anticipated performance assuming in-ground plastic hinge behavior aligns with prior findings.

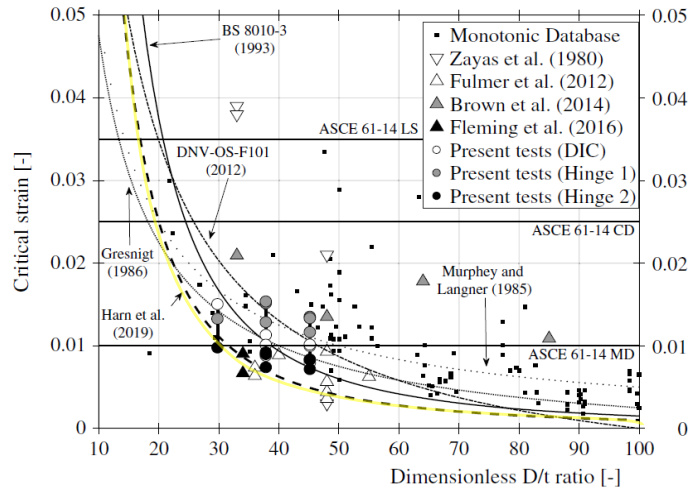
Figure 6: Effect of D/t on Pipe Critical Buckling Strains (Sadowski, 2020) [41]

Harn et al. [29] and Sadowski et al. [41] evaluated the relevant experimental research on the critical strains of hollow and filled steel pipe piles and directly compared the results against recommended ASCE/COPRI 61-14 [8] absolute compressive strain limits. Figure 6 shows the D/t effect on critical (buckling) strain figure presented by Sadowski et al. [41]. The figure presents pipe pile critical strains for piles with D/t ratios ranging from 10 to 100. Results include four in-air tests performed by Fulmer et al. [26], Brown et al. [15], Peters et al. [37] and Sadowski et al. [41], as well as two in-soil tests performed by Fleming et al. [24] and Aguirre et al. [2]. Empty and solid symbols in Figure 1 indicate hollow pipes and filled pipes, respectively, whereas squares and triangles represent monotonic loading and cyclic loading, respectively. Table 2 summarizes the test set-up, pile type, loading protocol, material specification, D/t ratios, average recorded material yield strength and soil conditions, if applicable, for the tests presented in Figure 1. The recommended ASCE/COPRI 61-14 [8] absolute compressive strain limits and the limiting width-to-thickness ratios for compression elements in accordance with AISC 341-16 [3] and AISC 360 [4] considering a material yield strength of 50ksi are presented. Member designations, such as compact and non-compact defined per AISC 360 [4] and highly ductile (HD), moderately ductile (MD) and non-ductile members (ND) defined per AISC 341 [3], are identified for the range of D/t ratios presented. Design equations proposed by researchers are also presented in Figure 6 as a function of D/t, including the Harn et al. [29] proposed simplified equation, $\epsilon_{LS} = 10(t/D)^2$ for defining the LS strain limit. All equations consider only the D/t ratio, ignoring the post-buckling effects of the pile, specifically, the residual axial and lateral load capacities.

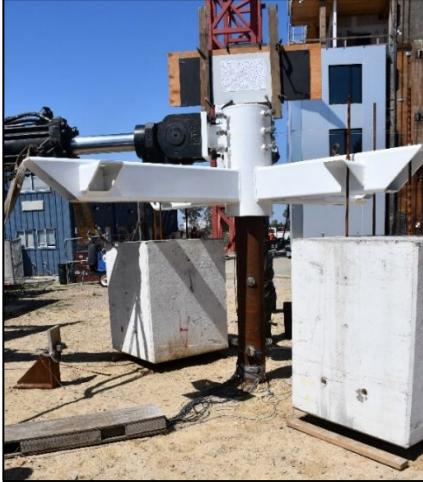
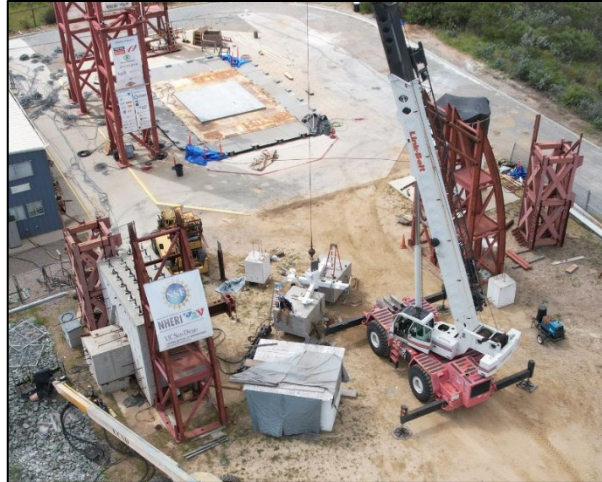
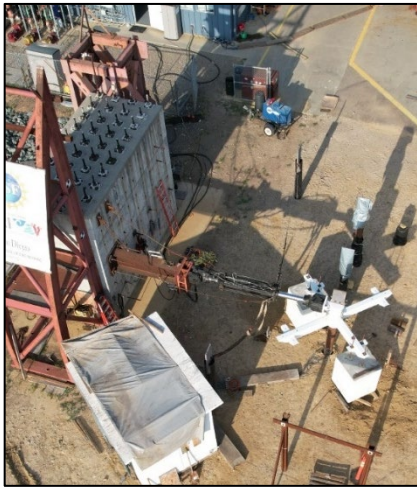
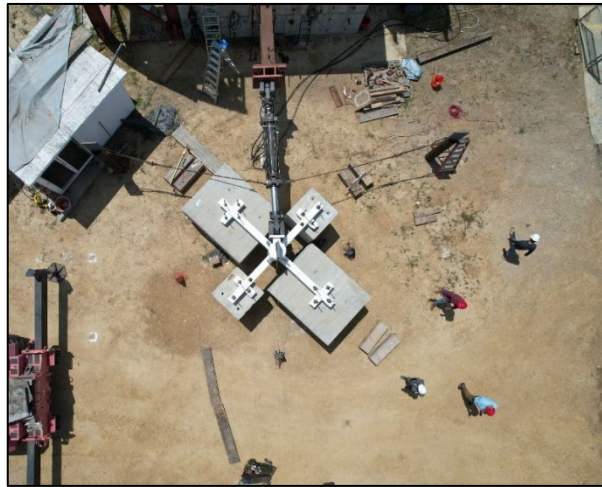
Figure 9: Field Images of Test and Test Set-up

a) *Elevation of Pile Test 01*

b) *Pile Test 03 Set up in April 2024*

c) *Pile Test 01 – Post Test Layout*

d) *Direct overview of Test Pile 04*

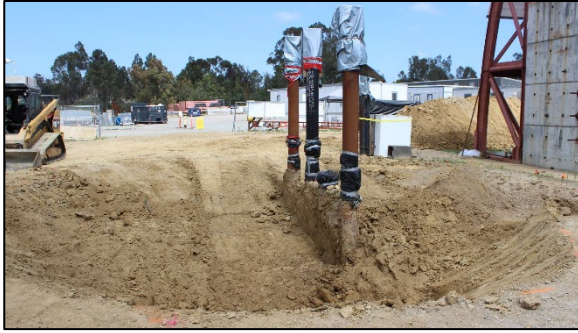
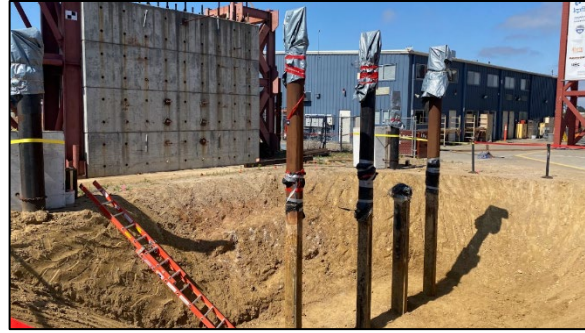
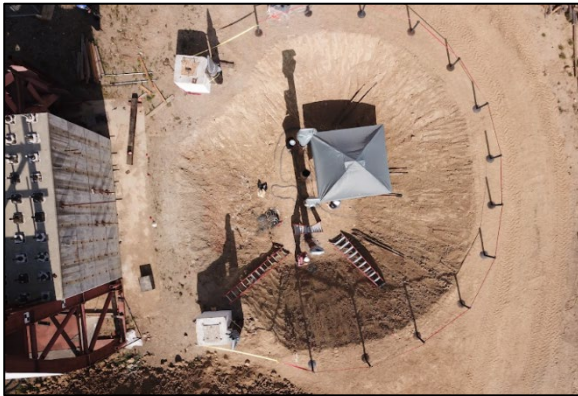
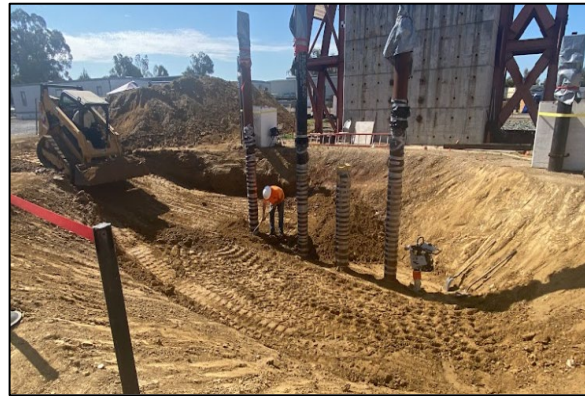
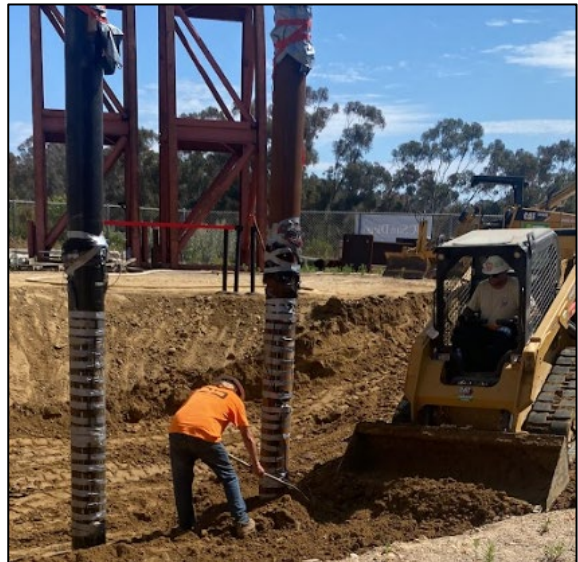
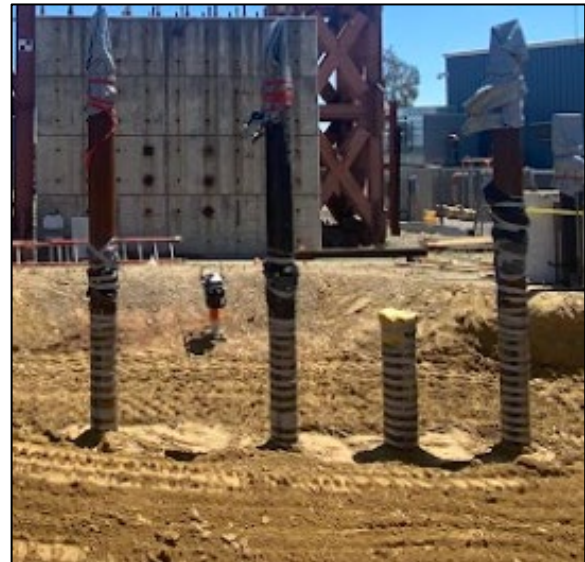
Figure 12: ESEC North Pit Soil Excavation and Backfill Photos

(a) Soil Pit Excavation – Day 1

(b) Final Soil Pit Excavation

(c) Soil Pit Excavation Overview

(d) Backfill Soil Pit – Day 1

(e) Backfill Soil Pit

(f) Backfill Soil Pit

The excavation of the north soil pit was performed over several days in mid-June 2023. Approximately 200 cubic yards of existing in-situ soil was removed and stock-piled and stored southeast of the reaction wall. As recommended by the supporting geotechnical engineer (EMI), a maximum depth of 8-ft and a perimeter wall slope no steeper than 1.5H:1V was implemented. Figure 11 demonstrates the excavation plan of the pit. Soil was removed by hand within a 2-ft radius (clear distance) of the test pile. The two soldier piles remained unexposed with the same driven depth. The backfill of the original soil was performed in mid-July 2023. The Contractor was instructed to backfill the existing material in 8-in lifts compacted to 90% of maximum dry density per ASTM D1557. Hand compaction equipment was used within 2-ft of the test pile. Figure 11 shows field photos of the excavation and backfill.

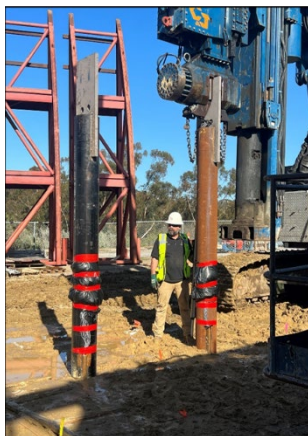
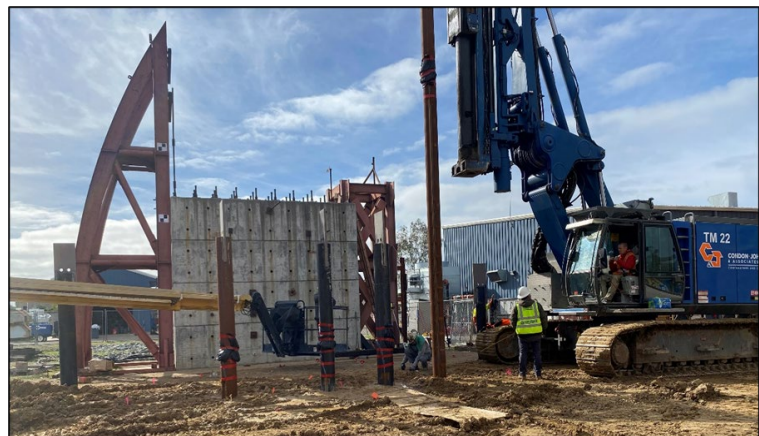
Figure 16: Pile Field Installation

a) Pile Installation D/t 22 & D/t 43 (b) Pile Installation Pile #2 with Vibratory Hammer

The test piles and two supporting soldier piles were installed using an ABI TM22 mobile ram rig with a vibratory hammer on January 6th and January 9th of 2023. Figure 16 shows the piles being installed with the ABI TM22 mobile ram rig.

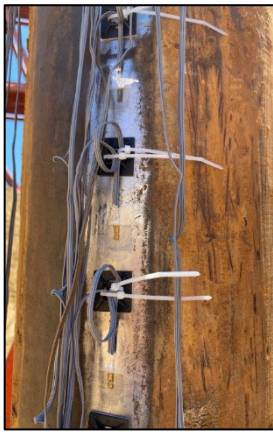
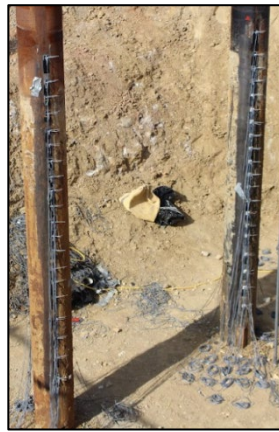
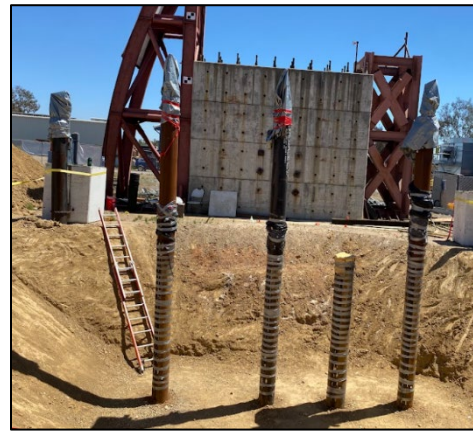
Figure 19: Strain Gauge Instrumentation

(a) 4-in Gauge Spacing

(b) Strain Gauge Profile

(c) Final Strain Gauge Instrumentation

unchanged for the re-instrumentation. Figure 19 shows the in field photos of the re-instrumentation of the pile.

A continuous 20-ft long steel angle, L2x2x1/8, was initially mounted to the exterior face of the pile to protect the strain gauge wires during pile installation. During the instrumentation of the piles, an approximate length of 8-ft 4-in of the angles was removed from the ground surface to the excavation base elevation. These angles were not replaced before backfilling. In lieu of the angle, extensive waterproof adhesive tape was placed on each strain gauge for protection. High strength duct tape was applied circumferentially as reinforcement to reduce tension on the wires during backfill. The duct tape was roughly spaced 4-in vertically.

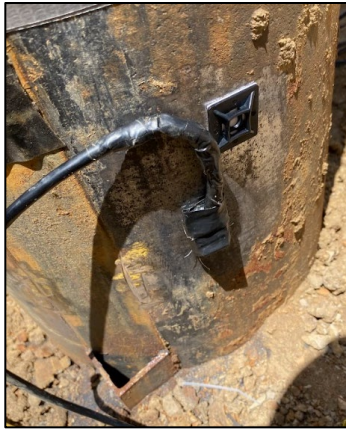
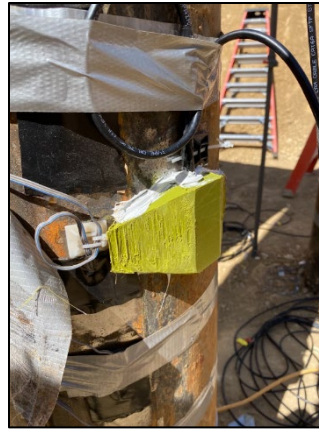
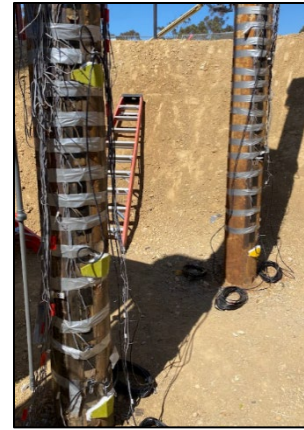
Figure 20: DC Accelerometer Instrumentation

a) Bottom DC Accelerometer Mounted

b) DC Accelerometer with Cover

c) In-ground DC Accelerometers

Five DC accelerometers (AC) were installed along the south external face of the piles, refer to Figure 20. Two were installed above ground with three below ground. The top accelerometer was placed roughly 20-in from the top of pile, just below the knife plate. A second accelerometer was placed within 6-in above the ground elevation. Three accelerometers were strategically placed within the embedded length of the pile, approximately 2.75-ft, 5-ft and 7.5-ft below the ground. The DC accelerometers are capable of tri-directional sensing, measuring static acceleration of gravity in tilt-sensing applications and dynamic acceleration due to vibration or motion. The accelerometers were installed to understand dynamic response during the free vibration tire tests, which was added at the last minute and only performed for Pile Test 1 and Pile Test 3. Covers were designed and created using a 3-dimensional printer. The purpose of the covers was to reduce damage to the accelerometers during soil backfill and during the test.

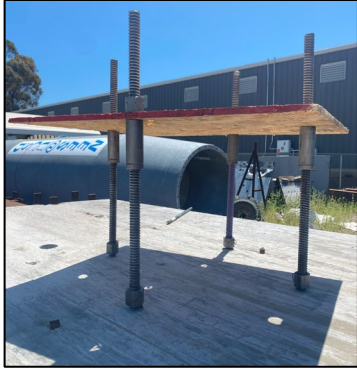
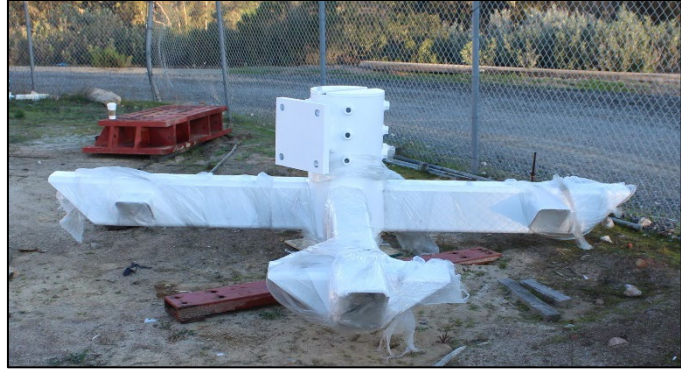
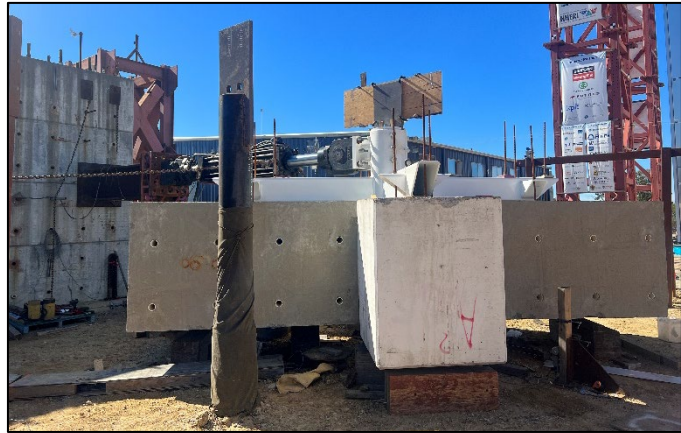
Figure 23: Components of Test Set-up for Application of Axial and Lateral Loading

(a) Concrete Block Anchorage Installation

(b) Steel Loading Apparatus

(d) Complete Test Set-up

The two small concrete blocks were suspended from the loading apparatus with a maximum distance of 6-in above finished ground for Test 1. For the remaining tests, the four concrete blocks were secured in direct contact with the steel crossbeam soffit, providing maximum clearance between the concrete blocks and the ground surface. The concrete blocks were pre-existing from previous projects performed at ESEC. A combination of threaded rods, couplers, hex nuts, plates, and leveling washers were designed to develop a post-installed adhesive anchorage in the block and the top connection with the loading apparatus HSS member. The leveling/spherical washer at the threaded rod-HSS top connection allowed for a maximum angle of correction of 3-deg. The washer was oversized, at least $\frac{1}{4}$ -in diameter larger than the threaded rod, to allow for additional rotation. The connection was designed to accommodate a rotation of no greater than 6-deg.

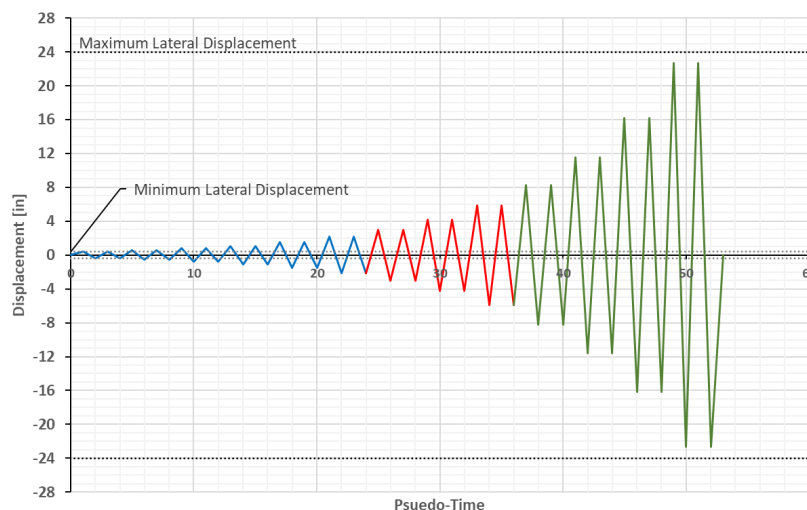
Figure 26: Displacement-Based Loading Protocol Per FEMA 461, 2007 [23]

The lateral loading protocol, as shown in Figure 26, was determined following FEMA 461 [23] unidirectional testing displacement-based loading history for a single specimen test, using an increasing amplitude displacement loading protocol. The targeted smallest and maximum lateral displacements of 0.4-in and 22.68-in are considered and fall within the capacity of the actuator. The lateral displacement amplitude, a , of each cycle was determined as $a_{i+1} = 1.4a_i$, where i is the preceding step. The pile was loaded following this protocol until it exhibited significant ($> 50\%$) degradation of lateral strength, the maximum displacement of the actuator was reached or the clearance of the base of the concrete blocks and the top of ground was within $\frac{1}{2}$ -in.

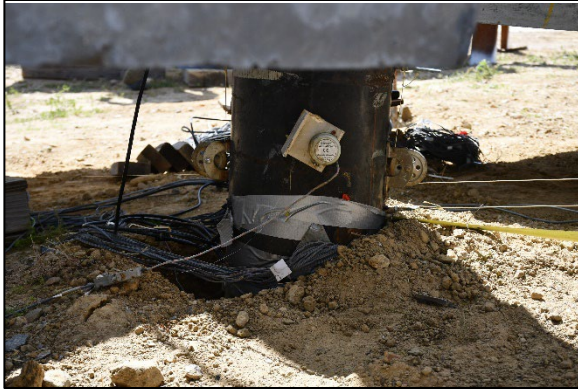
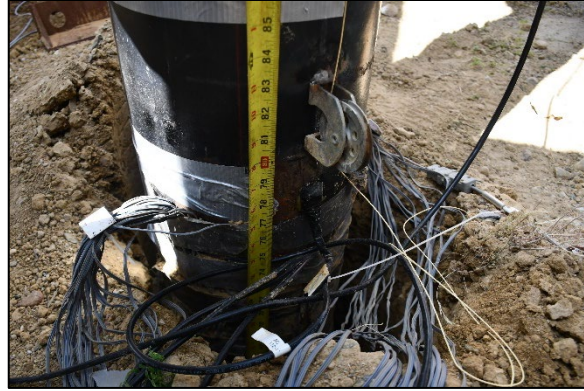
Figure 51: Test 3 Near Ground Field Measurements

(a) Soil Gapping Field Photo at Large Amplitude Displacements

(b) Final Field Soil Gapping Depth Measurement

To evaluate the impacts of the surrounding soil in the pile buckling region, the soil gapping at ground surface was visually evaluated for Test 3 using a near ground go-pro. The go-pro was programmed to take a series of photos within the duration of each cycle, capturing the pile displacement and soil heaving at the top of ground. The longitudinal string potentiometers was installed with insufficient lengths to measure the near-ground lateral and axial displacements at the large displacement cycles which preceded those of Test 1 and Test 2 leading to the Go-pro photos being the only measuring tool. The near-ground measurements were determined using the photos and measuring tool in Bluebeam. The gapping was measured at every cycle peak for the larger amplitude displacement in cycles 7 to 13. Figure 51 shows the near surface soil gapping, heaving and hole depth measurement at the higher amplitude displacements. The measured depth of the developed hole was nearly seven pile diameters deep, indicating that full instrumented depth of the pile was within the gapping boundaries. Figure 52 shows the normalized soil gapping measurements determined from the Go-Pro Photos vs. the calculated chord angle assuming a hinge 3D, where D equals the pile diameters, below the surface. Unfortunately, the inclinometer recordings near ground were determined nonviable. Furthermore, the inner soil plug, as determined in Table 3, is not present for the top 12D. Thus, the increase in soil gapping and the presence of a deep soil plug indicates that at higher lateral displacement amplitudes there is limited soil influence on the pile for up to 7D below the ground surface.

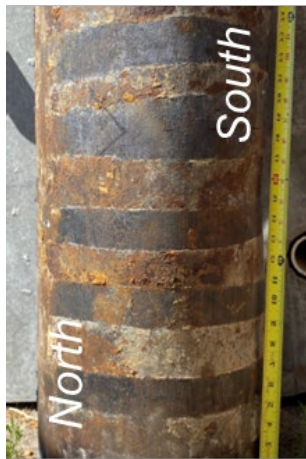
Figure 57: Observed Location of In-Ground Pile Buckling of Test 4

a) *Field Cleaned Elevation*

to Figure 57(a). The piles were painted light grey and 360-degree photos were taken to produce a 3D point cloud model of the pile using AutoCAD ReCap Photo, refer to Figure 57(b).

The visual buckle was observed on the south face approximately 2.35 pile diameters, 30.5-in, below the ground. This depth location was considered processing of the results. No other buckling was visually observed on the pile.

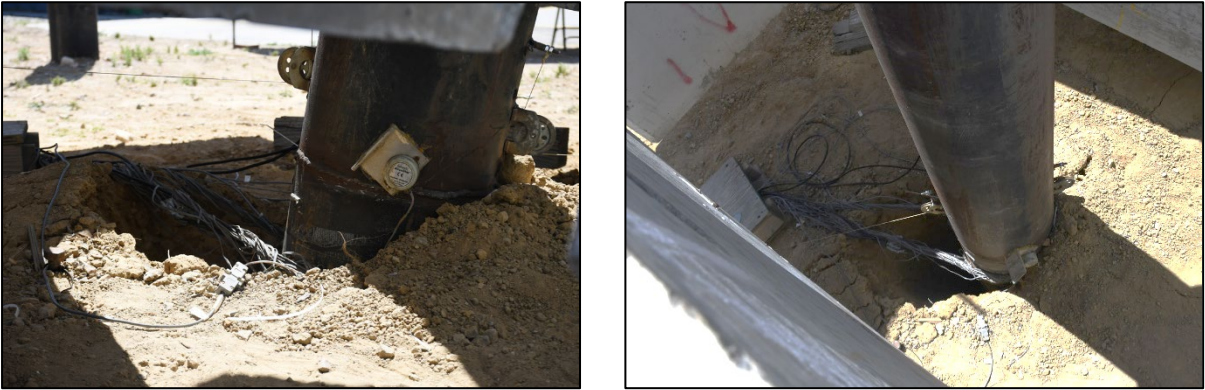
Figure 59: Test 4 Field Photos of Soil Gapping at First Peak of Cycle 13

(a) Near Ground Go-Pro Photo Looking West (b) Looking from above the Concrete Blocks

To evaluate the impacts of the surrounding soil in the pile buckling region, the soil gapping at ground surface was visually evaluated for Test 4 using a near ground go-pro. The go-pro was programmed to take a series of photos within the duration of each cycle, capturing the pile displacement and soil heaving at the top of ground. However, in test 4 the Go-Pro only captured the near soil gapping up to seven displacement amplitude cycle. Therefore, no measurements are summarized. However, similar near surface soil gapping and heaving were observed as seen in the previous tests. Figure 59 shows field photos of the soil gapping at the first cycle peak amplitude of cycle 13. Figure 60 shows the near ground rotation measurements recorded by the above-ground inclinometer.

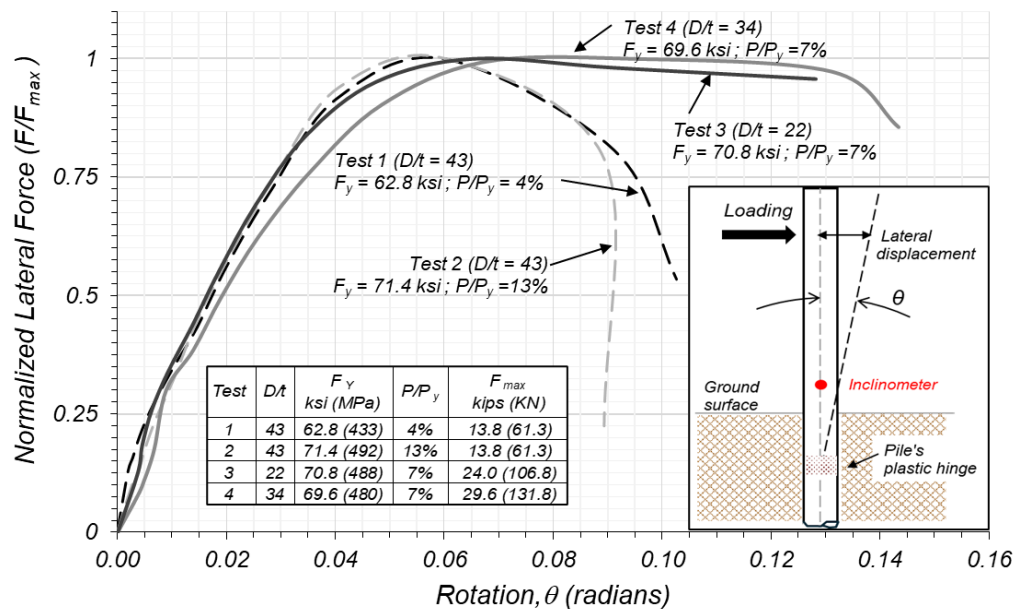
Figure 61: Normalized Lateral Force-Rotation Response Envelopes

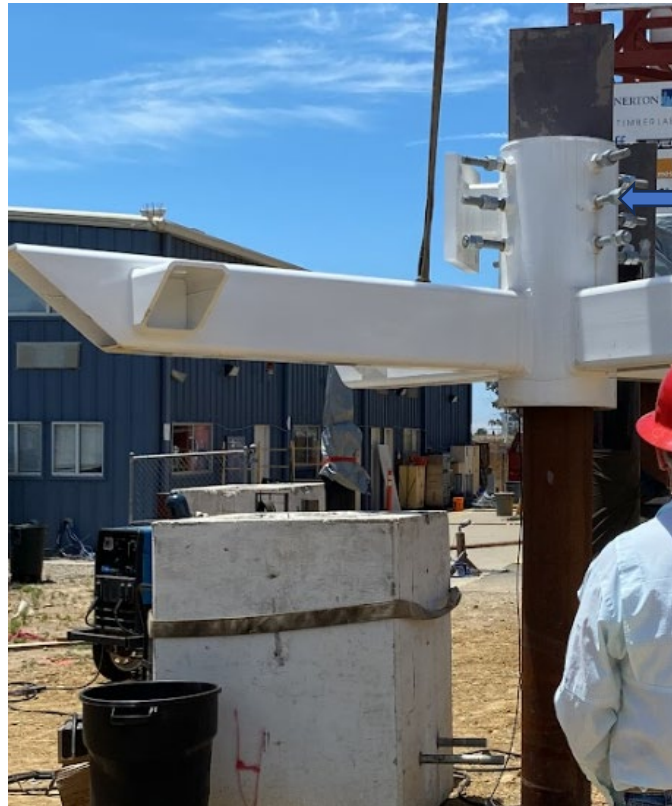
String Pot Eyebolt Installation Position

String Pot Eyebolt (x2) Installation Position
 Minimum 1" apart no more than 3" apart.
 (Closer the better)

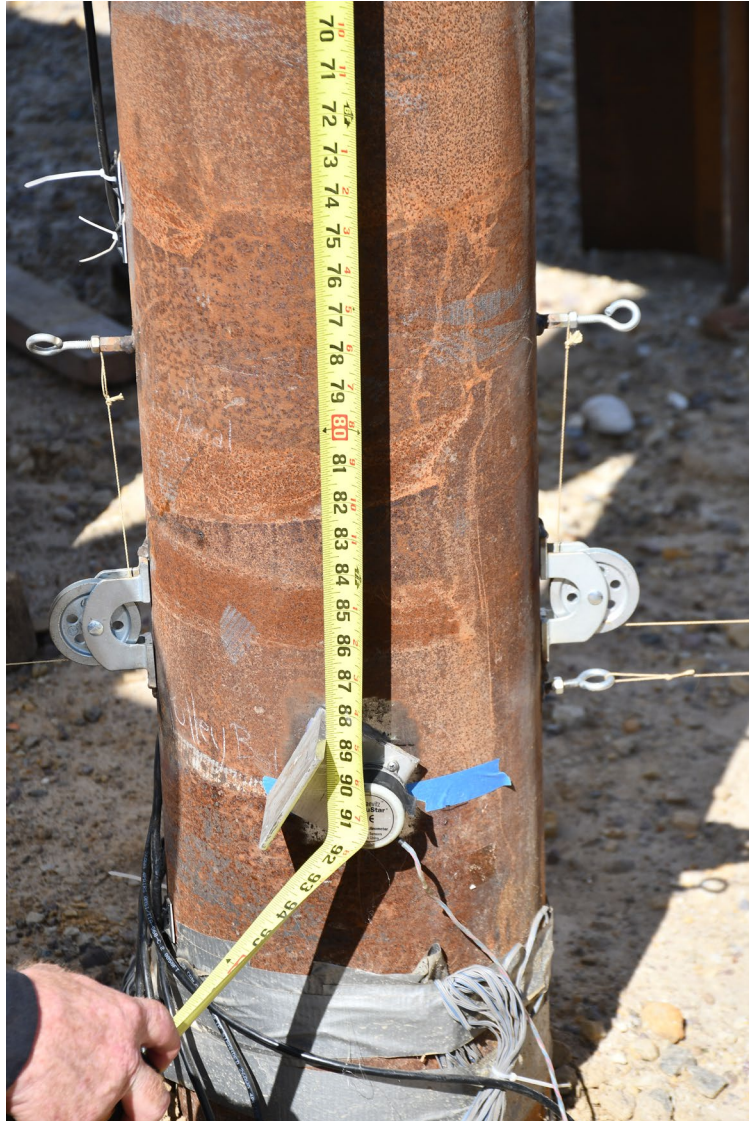
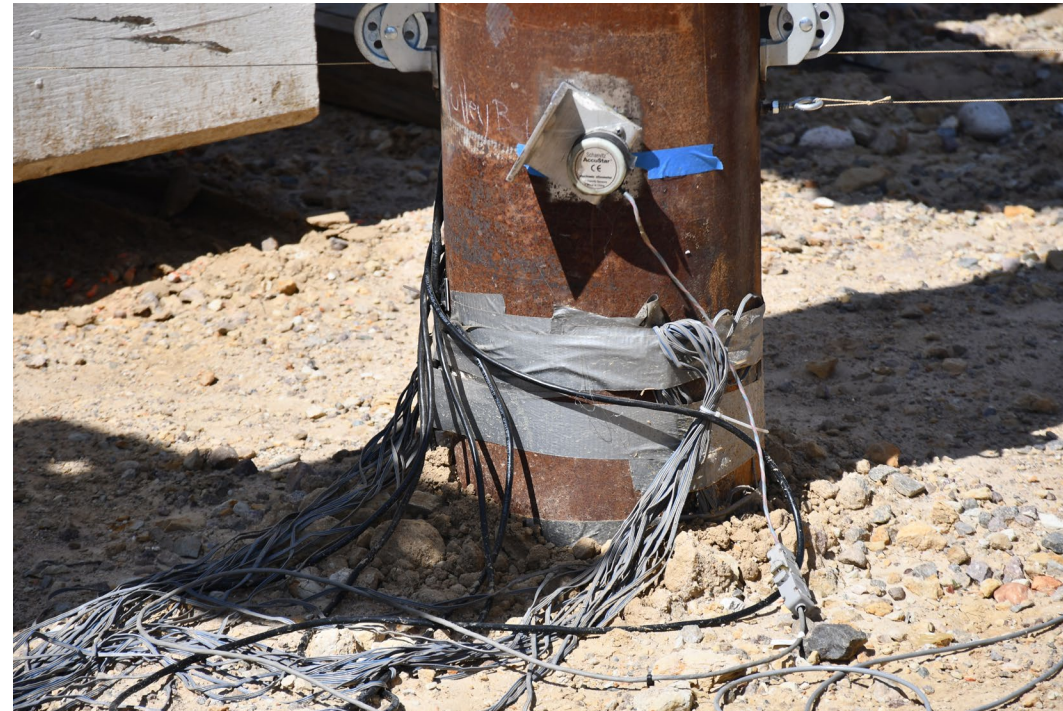
Instrumentation - Incliner

Inclinometer	
DAQID	Location
INCG-106	Above FG approx. 90.75" from top of pile (East-Side)

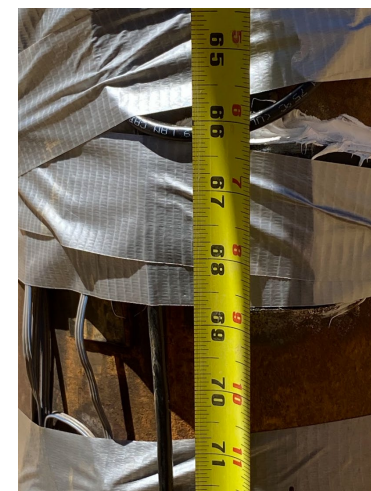
Mid-3

- Top - 0 (20" from Top of the pile)
- Top - 1 (8'-5.5" from Top of Pile)
- Mid - 2 (11'-2.5" from Top of Pile)
- Mid - 3 (13'-5.5" from Top of Pile)
- Bot - 4 (16'-0" from Top of Pile)

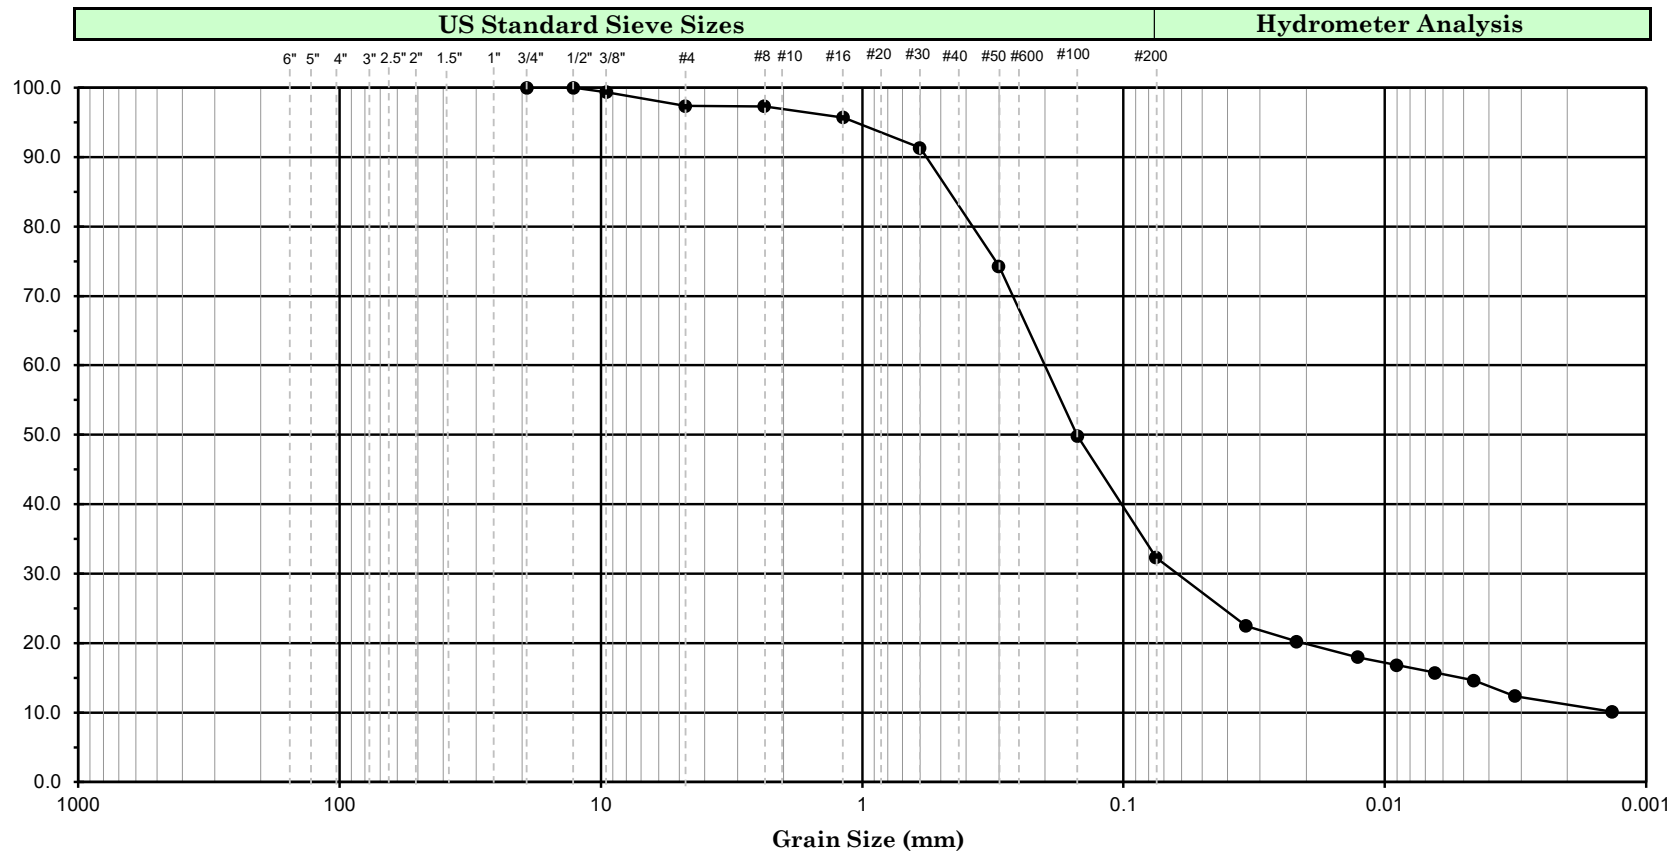
Symbol	Boring Number	Sample Number	Depth		Soil Color	Soil Description	U.S.C.S.
			(ft)	(m)			
●	BH-1	D-3	5.0		yellowish brown	Clayey sand	SC
Remark

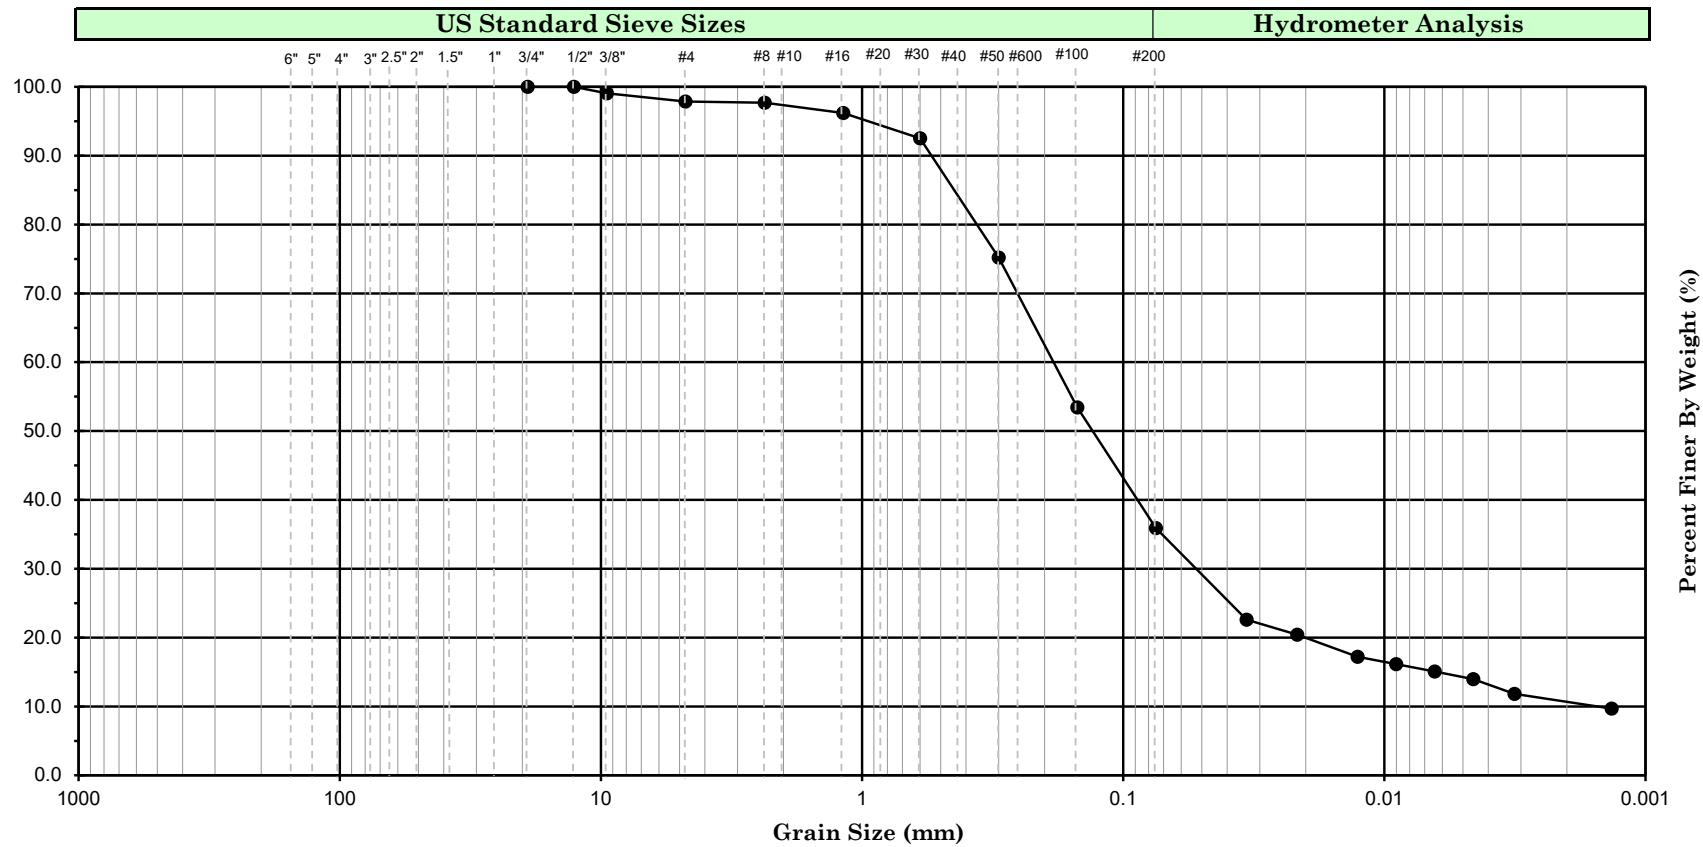
Figure No. :

GRAIN SIZE ANALYSIS
(ASTM D 6913 ASTM D 7928)

Cobbles		Gravel		Sand			Silt or Clay	
		Coarse	Fine	Coarse	Medium	Fine		
Symbol	Boring Number	Sample Number	Depth		Soil Color	Soil Description	U.S.C.S.	
●	BH-1	D-7	15.0		yellowish brown	Silty clayey sand	SC-SM	
Remark

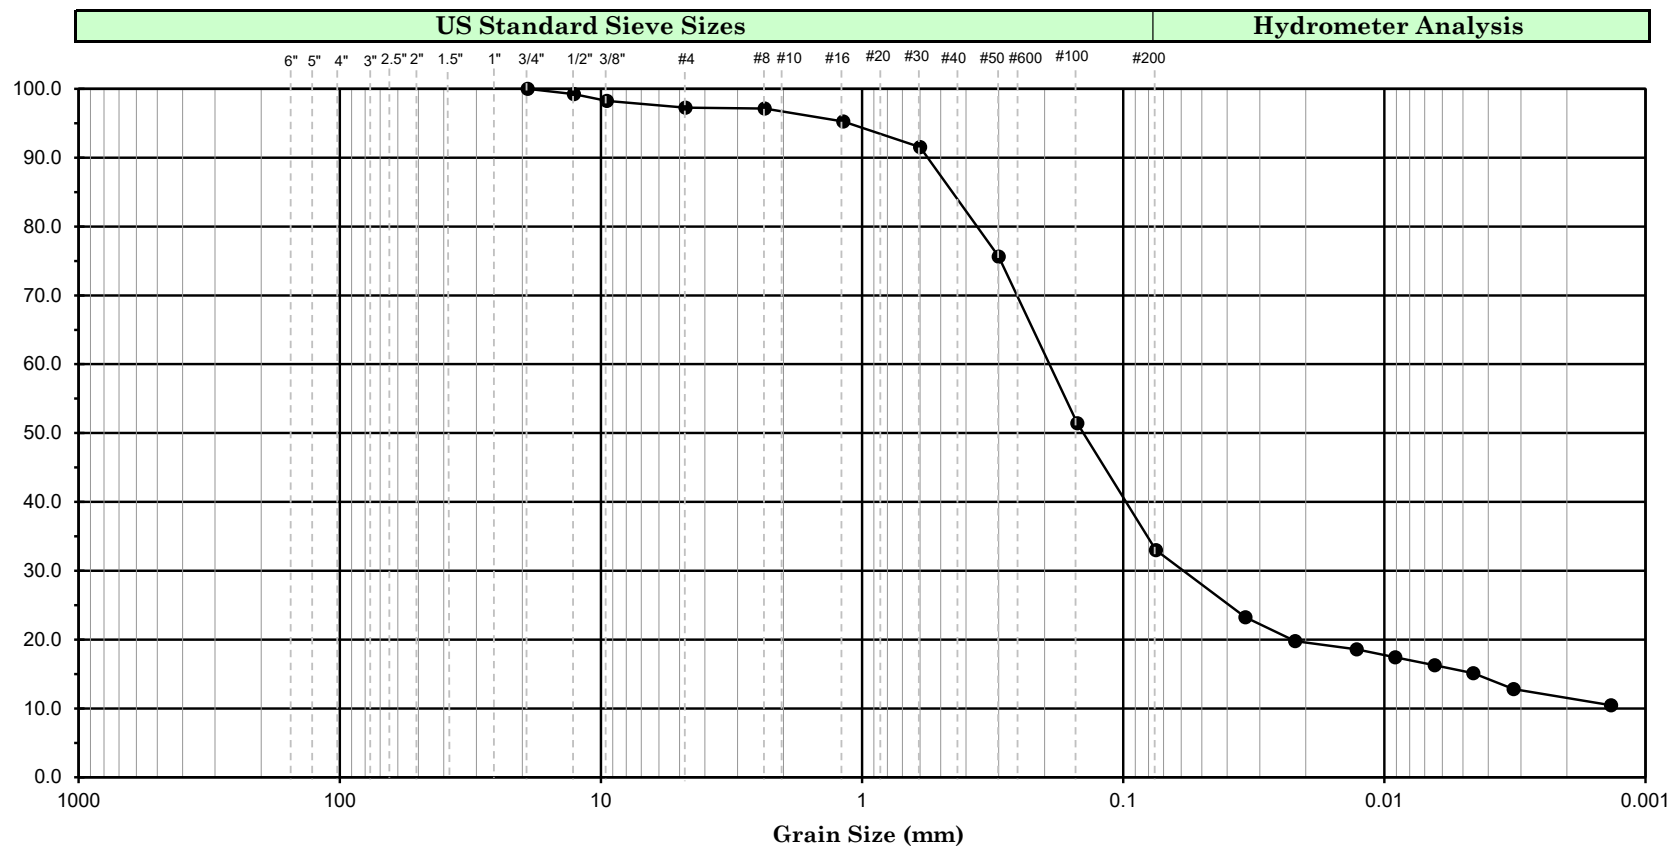
GRAIN SIZE ANALYSIS
(ASTM D 6913 ASTM D 7928)
Figure No. :

Cobbles		Gravel		Sand			Silt or Clay	
		Coarse	Fine	Coarse	Medium	Fine		
Symbol	Boring Number	Sample Number	Depth		Soil Color	Soil Description	U.S.C.S.	
●	BH-2	T-4	(ft)	(m)	yellowish brown	Silty clayey sand	SC-SM	
Remark

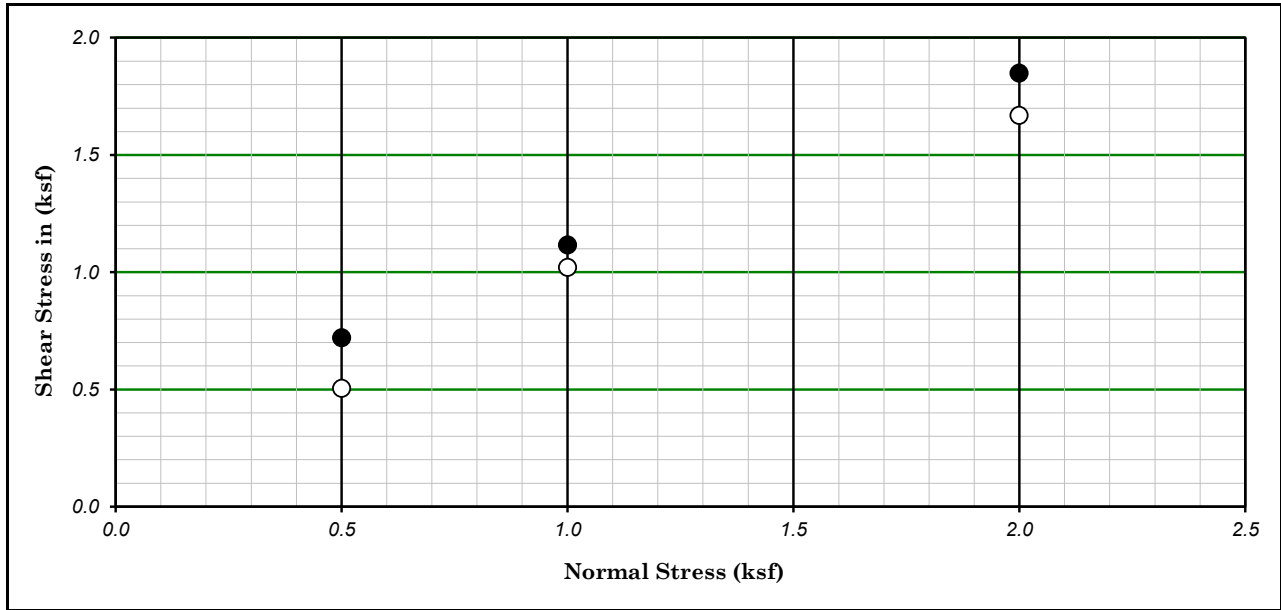
Figure No.

Ultimate : ○ Shear Type : *Field Moisture* *Undisturbed* Peak : ●

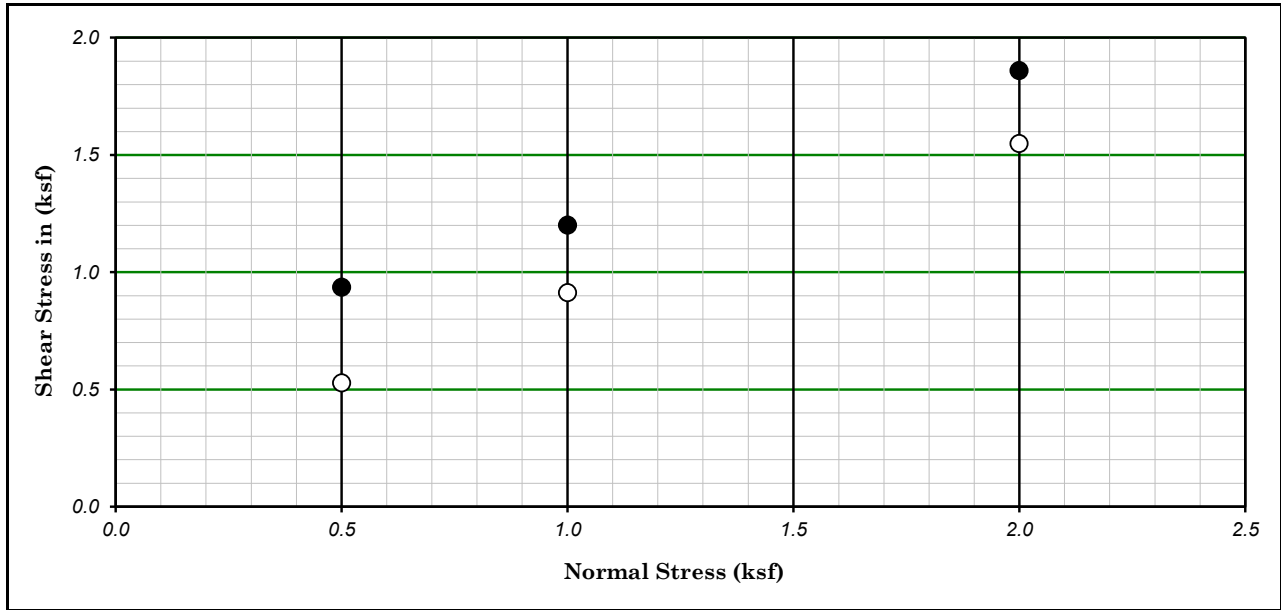
Figure No.

Ultimate : ○ Shear Type : *Field Moisture* *Undisturbed* Peak : ●
