The restoration of severely damaged churches – Implications and opportunities on cultural heritage conservation, thermal comfort and energy efficiency

Tullio de Rubeis ^{a,1}, Iole Nardi ^b, Mirco Muttillio ^a, Domenica Paoletti ^c

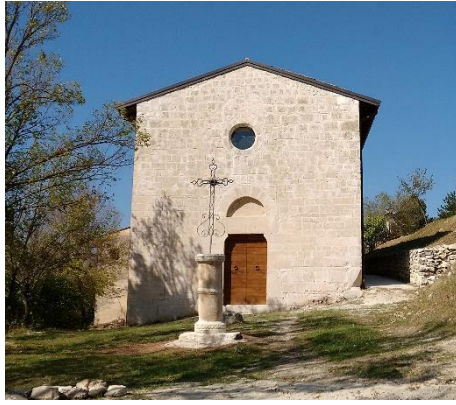
Fig. 2. The South-east main façade of the church of Santa Maria Annunziata of Roio.

The Church of Santa Maria Annunziata of Roio (Fig. 2), located in the outskirts of L’Aquila (lat. 42° 16’, long. 13° 32’) dates back to the 12th century [39]. It is made of resulting materials from the Romanesque age and it has a single-nave plan. The masonry structure consists of limestone blocks and mortar, and the roof is characterized by a wooden structure. The rectory, built with the same materials, is adjacent to the church and it is not object of the present work. Currently, the church has no HVAC system and it has undergone renovation works following the earthquake that struck L’Aquila in 2009.

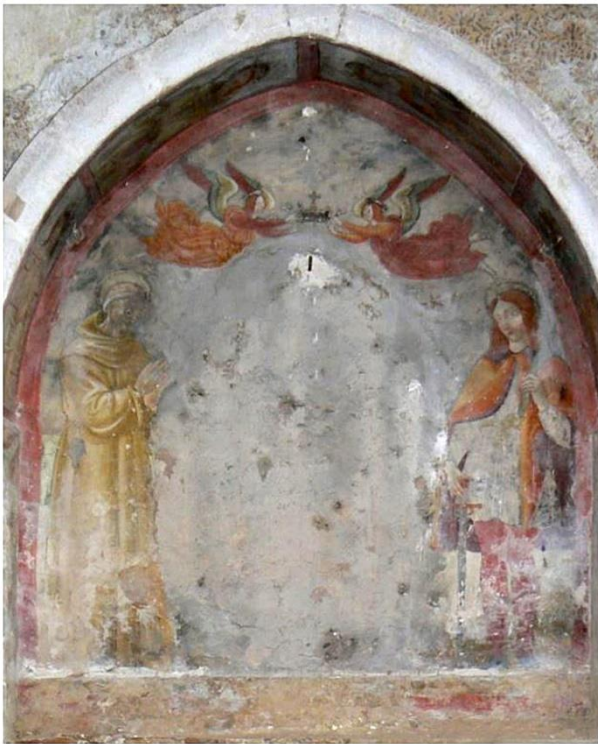
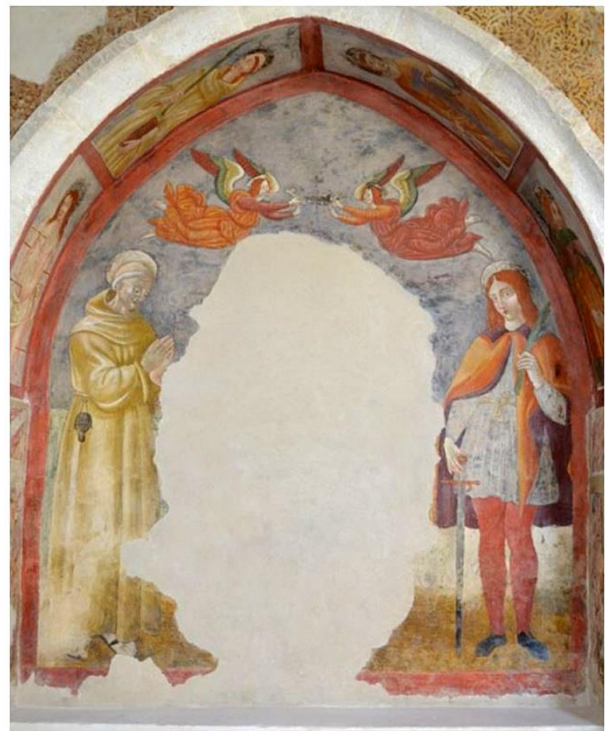
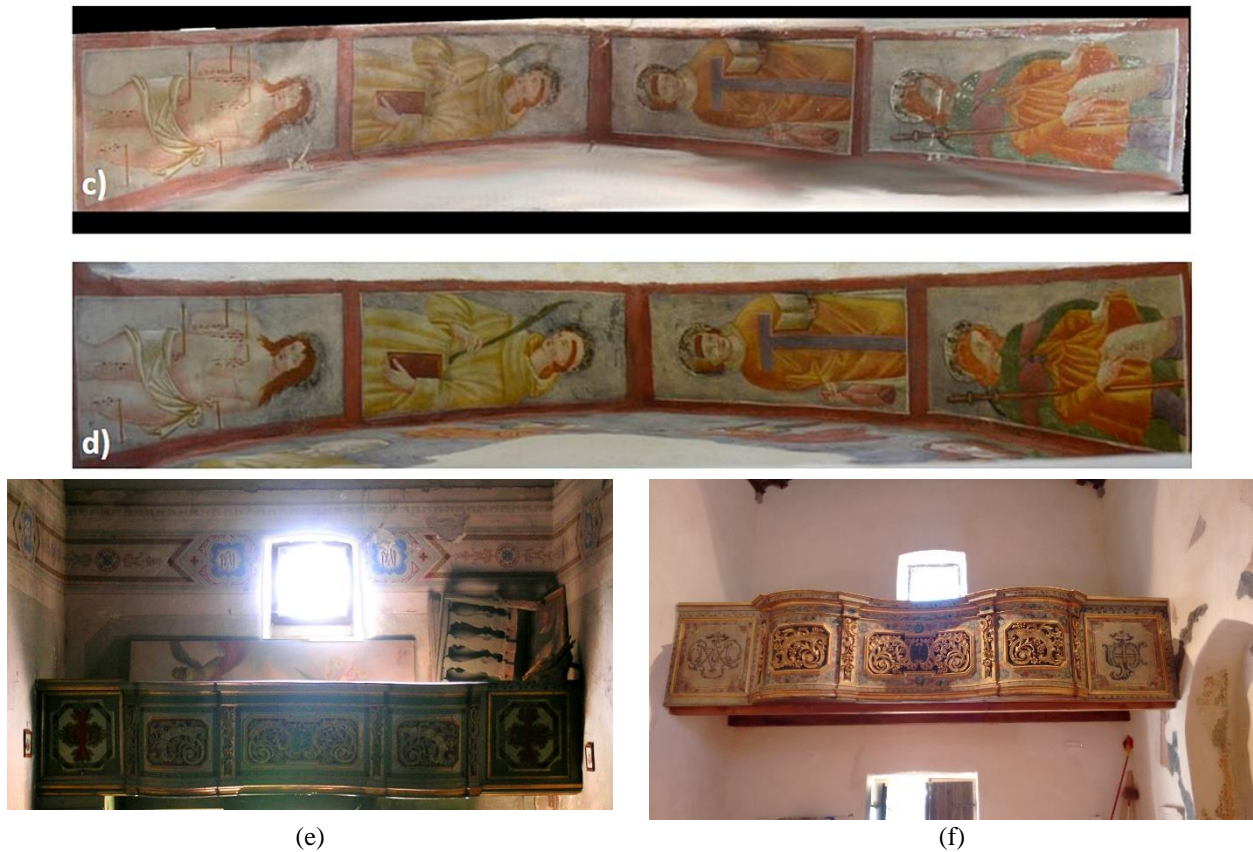
Fig. 3. Restoring interventions. Fresco depicting the "Annunciazione" (a) before and (b) after the restoration. Intrados of the arch (c) before and (d) after the restoration. [Courtesy of Dr. Jenny Rolo and Dr. Noemi Muselli]. Wooden choir (e) before and (f) after the restoration.

Following the earthquake, the bearing structure of the church has been consolidated in order to improve the seismic vulnerability. Before the recent restoration, it could be assumed that the artworks were "*acclimatized*" to the indoor microclimate (without HVAC) and therefore suffered damages (fissures, cracking and other mechanical damages), due to the thermo-hygrometric fluctuations and the ageing. Therefore, from the point of view of the cultural heritage restoration, the artworks preserved in the church were characterized by very different conservation conditions and, therefore, for each of them specific interventions have been carried out. In general, after a historical and archival documentation acquisition of the church, graphic and photographic documentation of the artworks has been acquired. The restoration of the painted surfaces of the church followed the pre-consolidation of the plaster layers, the uncovering of the plaster layers superimposed on the paintings, the consolidation of the plaster layers underneath the paintings, the cleaning of artwork surfaces, the micro-infill and infill of the lacunas in the painted surface, and then the pictorial reintegration. Fig. 3 shows the fresco depicting the "Annunciazione", the intrados of the arch and the wooden choir, before and after the restoration.
