# Forensic Examination of Truck Repair

Dr Edward Brell BSc MEng PhD

This report discusses truck repair work some of which was requested by Mr Gary Waterman of Car-bunc Pty. Ltd. and the repairs carried out on a Mack Truck Model R600 (the truck) currently located at the premises of in Chinchilla Queensland.

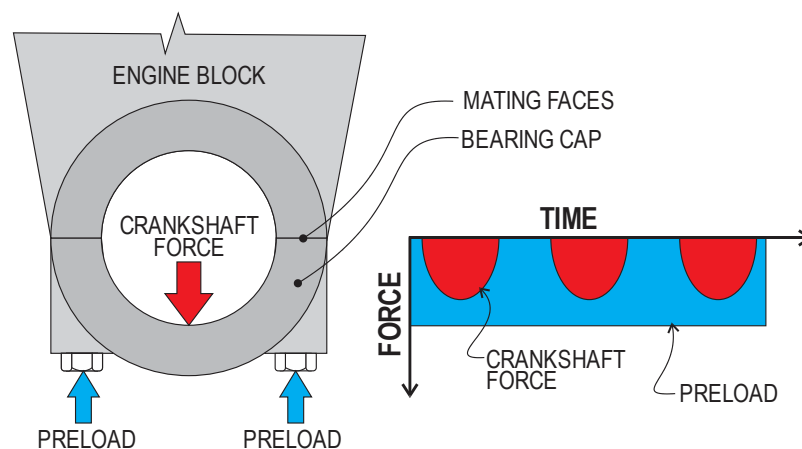
**Figure 14 – Schematic of preloading of bearing cap**  
(To prevent separation at the mating faces.)

The largest force on a main bearing cap is exerted by the explosion of fuel in the upper cylinder volume. This is a force tending to prise the bolted surfaces apart. The explanation that accompanies Figure 4 alludes to a compression failure. Only bolt force applies compression forces to the mating faces. The surface area of the mating faces is far greater than the root bolt area. Therefore bolting load cannot damage the mating faces.

The recommended torque on the bearing cap bolts is designed to apply a preload on the cap that preload force is always greater than the applied crankshaft force. This ensures there is no separation of the mating faces. The idea is embodied in the force-time graph in Figure 4.

In such an event there is risk of damaging the mating faces indicated in Figure 14 and Figure 4.

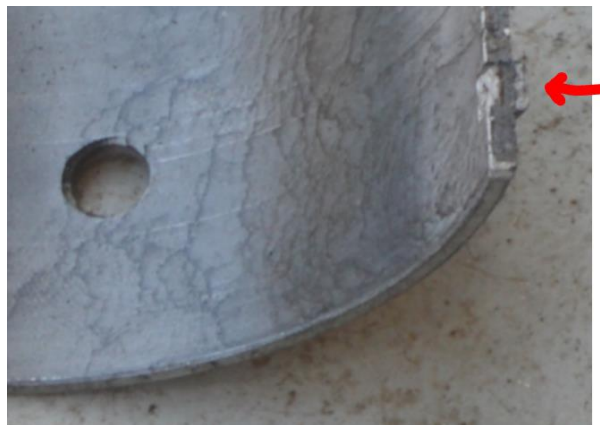
**Figure 15 – Locating lug (red arrow)**

(To mate with corresponding notch in engine block.)

To achieve the replacement of main-bearings the crankshaft must be loosened by a small amount. This is achieved by loosening all main-bearing caps. The top half of each main-bearing half must be slid into place on top of the crankshaft journal. The main-bearing cap must then be fitted and bolted up. At this point there is no certainty that the locating lug highlighted in Figure 15 is properly mated.

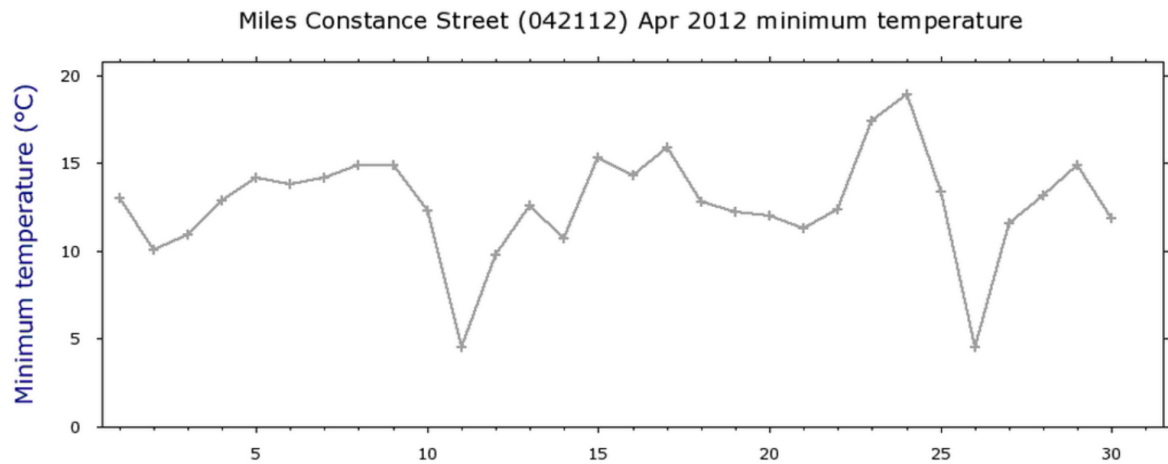
Figure 19 – Graph of minimum temperatures recorded near Chinchilla for April 2012

It was cold on the day of engine breakdown as can be seen on the graph of Figure 19.

The minimum temperatures reported by the Bureau of Meteorology (BOM) indicate that it was cold in the general area for most of April 2012 at the nearest weather station.

10 It is noted that the truck stopped during a test run (“a couple of miles”) just before Easter (5/04/2012) and could not be started but had to be recovered on a float. It is also noted that around Easter 2012 Chinchilla experienced cold days. (Ref Bureau of Meteorology Figure 19). The cause of the engine stopping was not offered by Mr Parker.

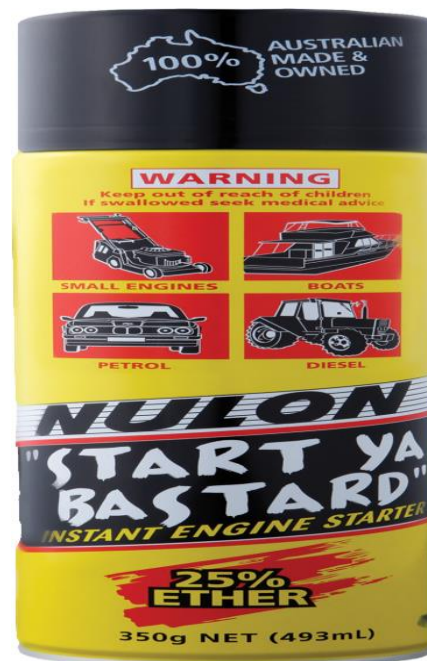
On cold days a Diesel engine may be hard to start. In such situations it is common practice to use a product called “Start Ya Bastard” as depicted in Figure 20.

Figure 20 - Spray Can of “Start Ya Bastard”.

- *As far as the term goes, I believe if too much is used too many times it washes out all of the carbon build up on valves and on the cylinder walls so more blow by is created. (See Figure 6 for photograph of blow-by)*
- *The Ether is dry (no lubrication) and very hot burning. Gas and Diesel engines do not handle Ether well so limit its use to a minimum.*
- *The detonation from Ether breaks rings and burns valves. It ignites too early and it is easy to use too much.*
- *Carbon build up is incomplete combustion from oil and or fuel. When the engine has worn to the point it needs to be rebuilt the carbon can plug the gaps or slop in the worn parts.*
- *If you use Ether to start an engine in warm weather you have other problems you need to deal with, the Ether is causing more harm than help.*

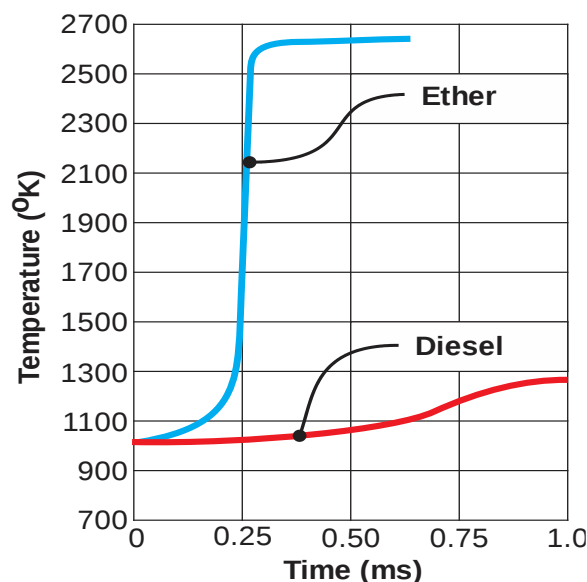
**Figure 21 - Comparison of Ether vs Diesel**  
(for 1 millisecond to peak temperature)  
(*Lakshminarayanan<sup>3</sup> et al and G. Fast<sup>4</sup> et al*)

Figure 21 teaches that the maximum burn temperature of Ether is much higher than for Diesel. The maximum temperature is achieved much earlier. This indicates that the whole upper cylinder surfaces are exposed to higher temperature for a longer period.

Carbon deposits which are a combination of carbon and unburnt fuel leave merely ash as a result of Ether. Moreover, cylinder walls are stripped of lubricant and rings must rub on an unlubricated raw metal surface. Figure 21 supports the forum opinions listed.

Carbon steel melts at 1425-1540 °C<sup>4</sup>. A quick reflection on Figure 21 will reveal that Ether burn temperature is in excess of 2400 °C. Thus it can be concluded that burning Ether in a Diesel engine has the potential to burn valves.

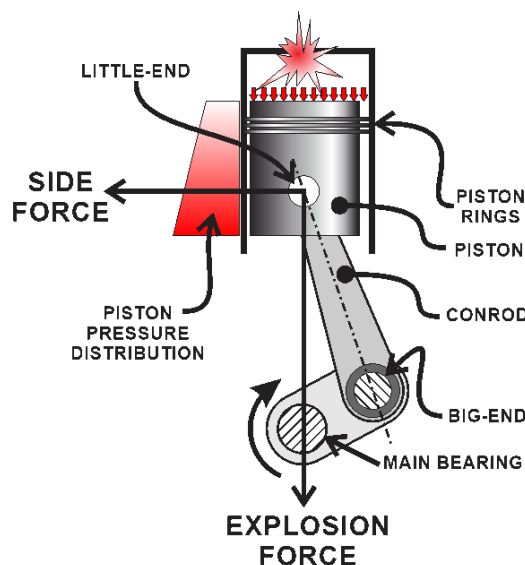
In the theory that wear is proportional to pressure, it is not hard to formulate that the piston skirt wears more on the left-hand side of Figure 1 as compared to the right-hand side.

The clearance caused by this wear allows the piston to perform a rocking motion. The sound and action of the rocking motion is called piston slap.

**Figure 1 - Notional Force Diagram of Piston under Power  
(Piston clearances exaggerated for display clarity)**

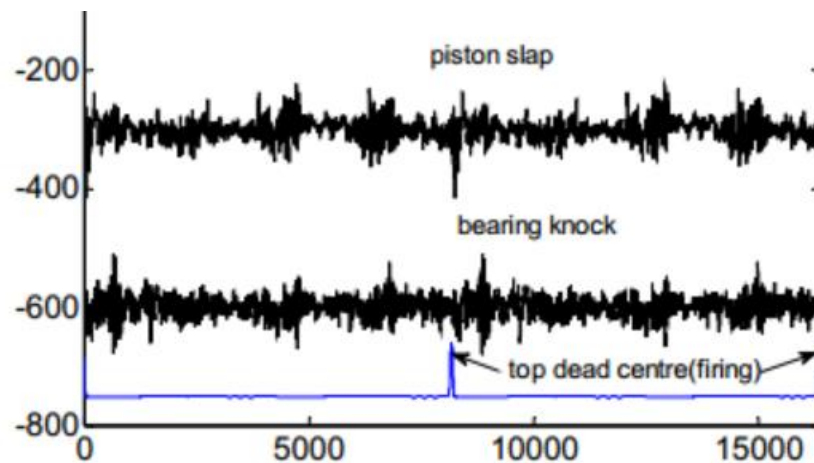
The piston slap signal is distinct and can be compared with bearing knock as shown in Figure 2.

**Figure 2 – Structure-borne sound signals of Piston Slap and Bearing Knock<sup>3</sup>.**

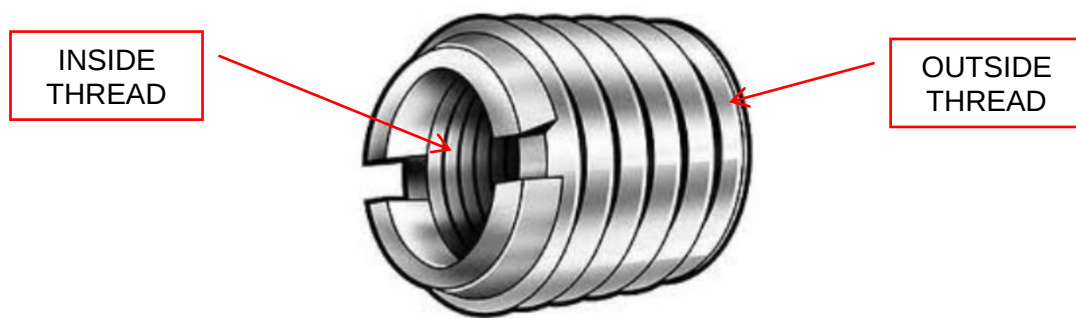
**Figure 5 – Typical Threadsert**

Both reducing the number of threads in engagement and the mere idea of gluing for strength are professionally repugnant.

A proper method of repair is the use of threadserts. A threadsert is a high strength piece of metal with threads on the inside as well as the outside. The procedure is to drill and tap the engine block oversize to suit the threadsert outside diameter thread and then insert the threadsert ready for a standard bolt.
