# Toyota RAV4 Loss of Control and Collision Study

(Dr) Edward Brell BSc MEng PhD

## 1. Introduction

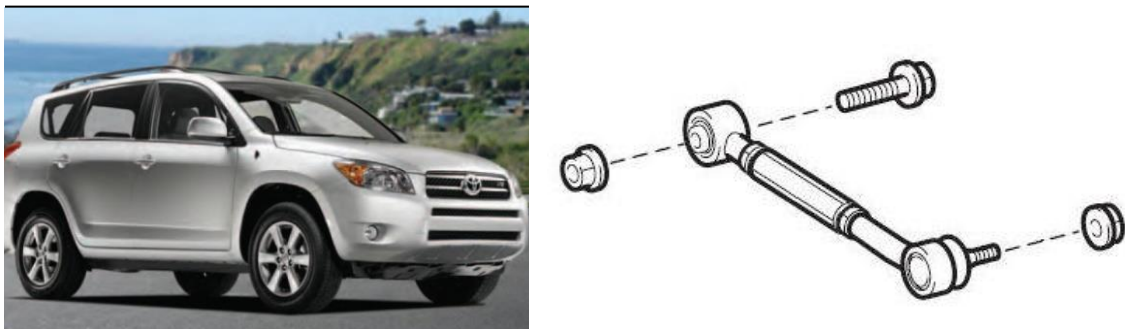
**Figure 1 – Typical Toyota model RAV4 with exploded Rear Number 1 Suspension Arm.**

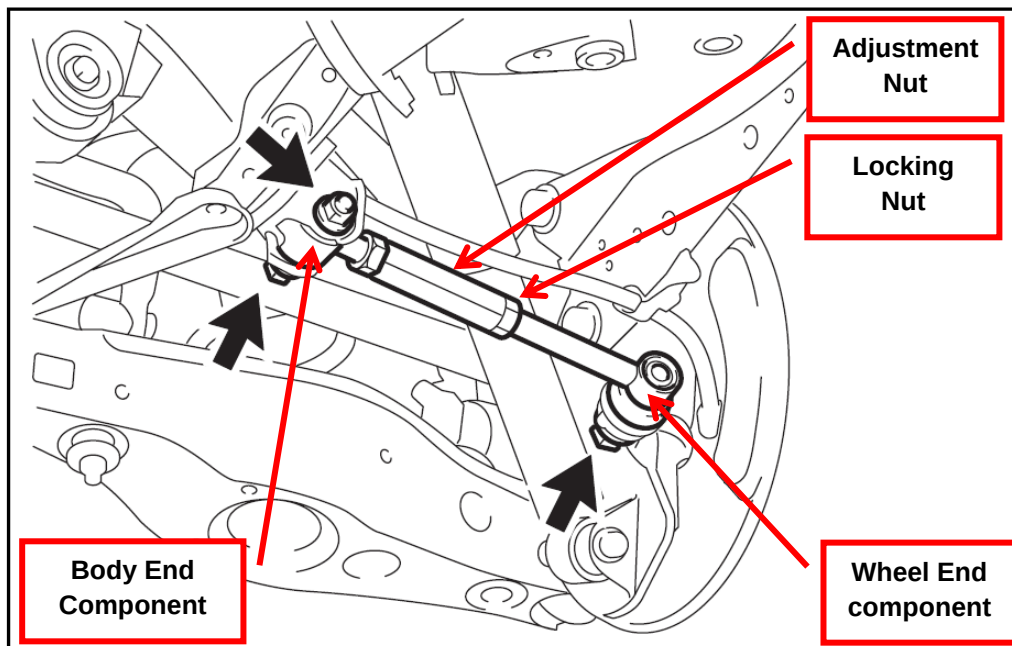
**Figure 5 – Rear Number 1 Suspension Arm components<sup>1</sup>.**

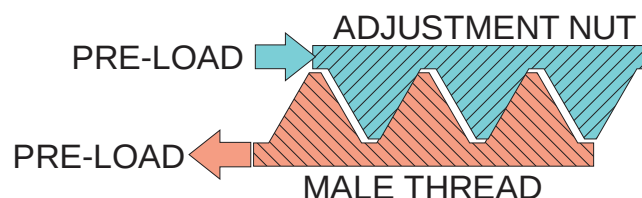
The purpose of the locking nuts is to resist loosening of the thread. One flank of each thread must remain in continuous contact to resist vibration. The idea is embodied in Figure 19 below.

Figure 19 – Visualisation of thread locking.

The intimate contact created by the preload increases friction at the thread flanks, thereby reducing the likelihood of nut loosening.

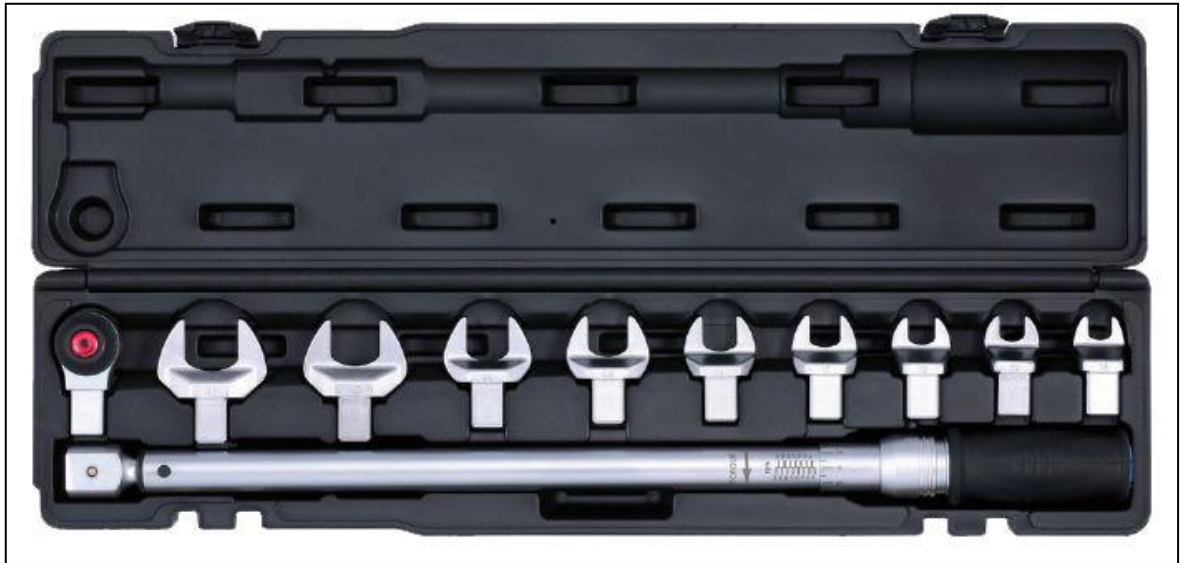
Further, the spanner required for the accurate tensioning has to be an open-ended spanner because of their inability to use a socket that is typically used with a tension wrench. An example of an open-ended tension range can be found in Figure 20 below

Figure 20 – example of a set of open-ended spanners and tension wrench.

5 An open-ended tension wrench is not commonly found in the toolboxes of small service mechanic establishments. Because of this, a turn-of-the-nut method may be more of a convenient torque control of pre-tension in the Rear Number 1 Suspension Arm after rear steering adjustments, provided that a suitable conversion from Nm to degrees turn-of-the-nut is applied. Such a conversion would require knowledge of material properties from the makers of the components.

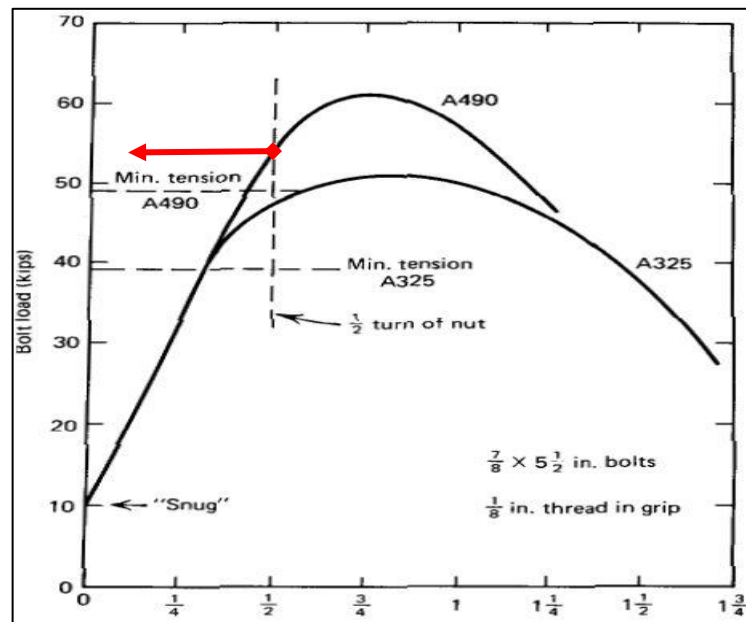
10 Thus it is unlikely that a small service mechanic establishment would have access to this method of a torque control. An indication of the complexity of this method to achieve simplicity at the mechanic level is given by Fisher (2001)<sup>4</sup> in Figure 21 where it can be observed that a  $\frac{1}{2}$  turn of the specified nut on certain length bolt of Grade A490 material will produce ~54,000 lbs force in the bolt.

Figure 21 – Example of turn-of-the-nut method of controlling bolting tension

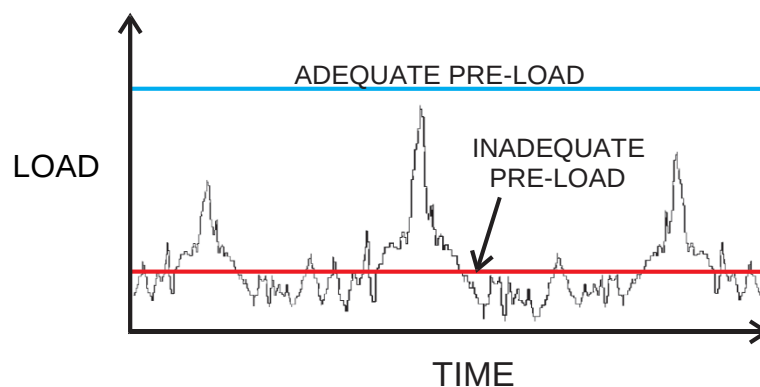
Road surface imperfections and potholes transmit vibrations through the Rear Number 1 Suspension Arm. Material inertial effects occur inside of the Rear Number 1 Suspension Arm as a result of vibration, even though the connection to the body has a vibration mount. These effects manifest in the material as a strain disturbance. Figure 22 is a visualisation of such a strain disturbance to illustrate the importance of adequate preload. The strain disturbance above the inadequate preload line can cause a nut loosening effect. This nut loosening effect manifests as a gap between the surfaces of the underside of the locking nut and the top of the adjustment nut. Once a gap is formed between the two mating surfaces the loosening effect can continue and open the gap further.

Figure 22 – Visualisation of road vibration strain disturbance passing through Rear Number 1 Suspension Arm.

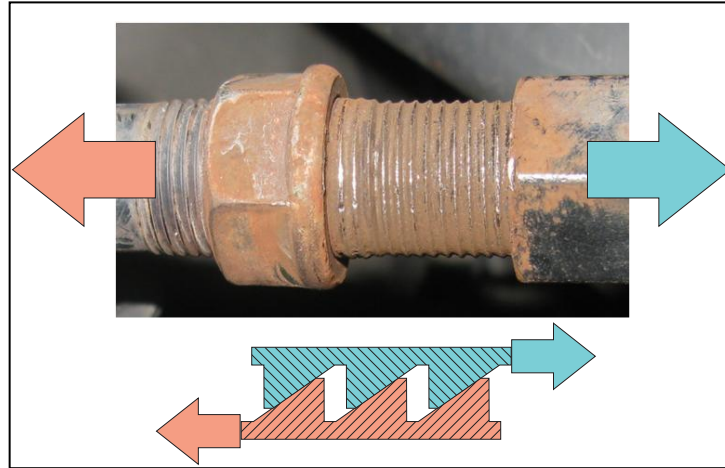
loosens further until the thread faces begin to impact on each other. The result is that the threads are hammered into each other and reshaped as visualised below (Figure 23).

**Figure 23 – Impact force direction and thread form reshaping.**

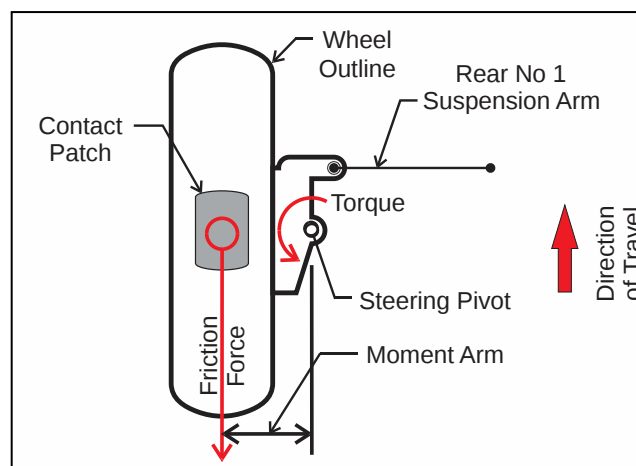
The effect of road/tyre friction at the contact patch creates a moment about the rear wheel steering pivot creating a propensity to rotate about the pivot. This propensity is illustrated in Figure 25 as a torque about the steering pivot. The normal running condition of the Rear Number 1 Suspension Arm is tension.

**Figure 25 – Graphic for tyre friction creating a torque about the Steering Pivot.**

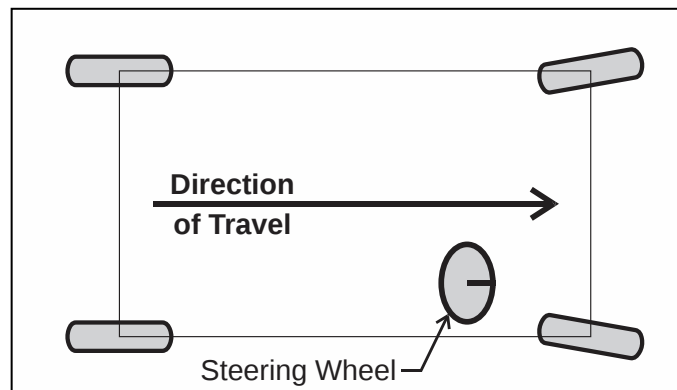
It is of value here to consider in isolation the behaviour of a wheel out of alignment with the direction of travel, often called “scrubbing”, commonly experienced as a result of poor wheel alignment, referred to as “toe in” or “toe out”. In this incident scrubbing occurs analogous to an exaggerated “toe out” condition. This “toe out” condition is demonstrated in the graphic in Figure 26.

Figure 26 –Exaggerated “toe out” condition in the front wheels.

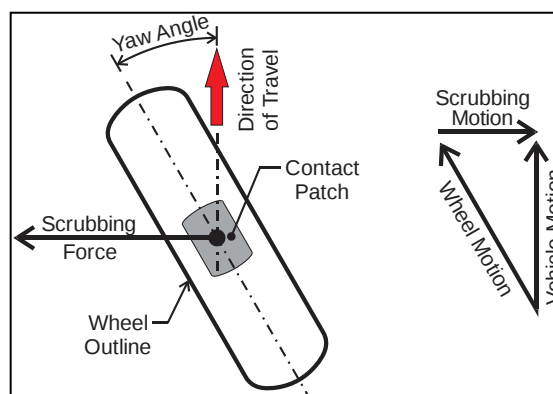
The angle of wheel misalignment is called the Yaw angle represented in the following graphic (Figure 27). Tyre scrubbing gives rise to a lateral force indicated as a scrubbing force in Figure 27.

Figure 27 – Tyre scrubbing as a result of wheel yaw angle.

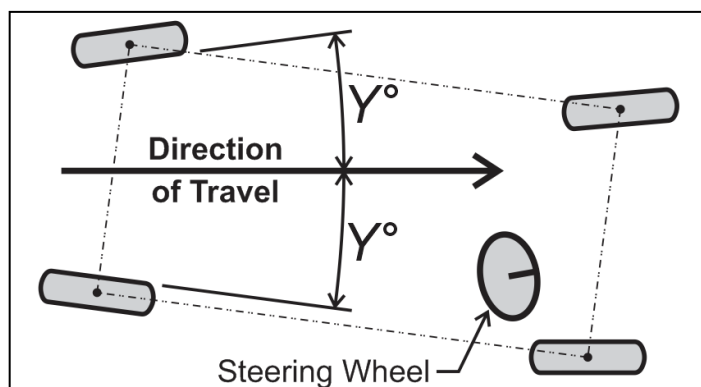
Newton's third Law requires that for every force there is an opposite and equal force. In the behaviour of the vehicle the opposing force is derived from the right-hand side wheel which must be pulled into an angle such that the two yaw angles are equal ( $Y^o = Y^o$ ) (Figure 28).

Figure 28 – Equalisation of yaw angles.

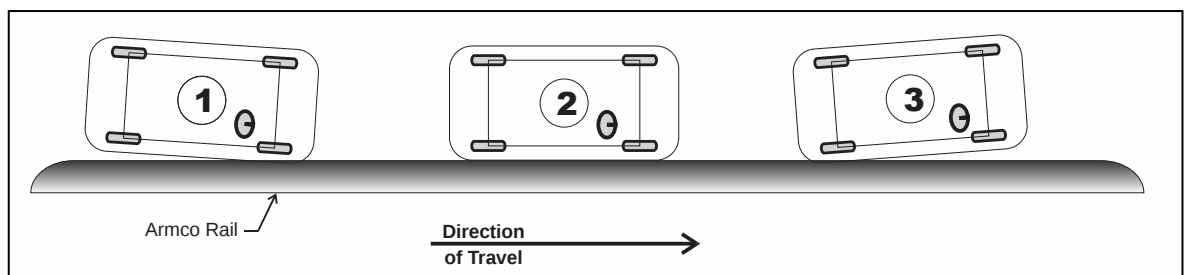
- 5 The depth of penetration at the front and rear bumpers would suggest there was lateral momentum (sideways motion into the Armco rail) bringing the front bumper into contact with the Armco rail first, followed by minor engagement of the middle of the vehicle, followed by a simultaneous disengagement of the front bumper and engagement of the rear bumper. This is visualised in the time sequence; 1, 2, 3 in Figure 29.

Figure 29 – Visualization of vehicle engagement sequence with Armco rail.

The response of the vehicle to the left rear wheel angular misalignment from the Rear Number 1 Suspension Arm lengthening, leaves no scope for the rear of the vehicle to impact first.
