# Mechanisms and Occurrence of Detonations in Vapor Cloud Explosions –

## Supplementary Material

Geoffrey Chamberlain,<sup>1</sup> Andrzej Pekalski,<sup>2</sup> and Elaine S. Oran<sup>3</sup>

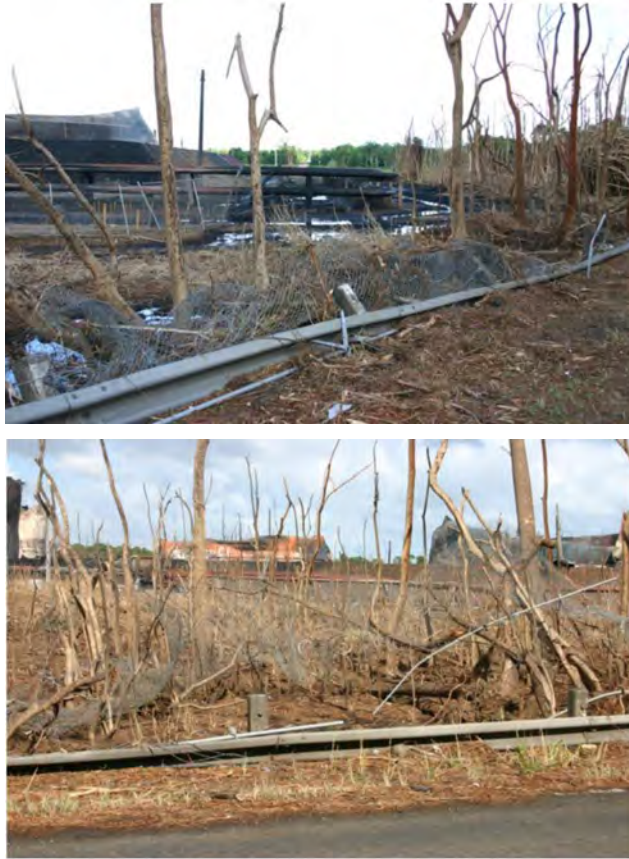
Nonetheless, it is still possible that a DDT occurred in the bamboo area. The region is devastated and some items have been drawn inwards, e.g., tree trunks, railings, wire netting, and roadside barriers (see, e.g., Figure-S 3.8). The overpressure at the gatehouse, some 720 m distant, is estimated to be  $\sim 0.03$  atm, which is sufficient to shatter large windows as observed.

**Figure-S 3.9** Trees, railings and posts drawn inwards towards bamboo area [6].

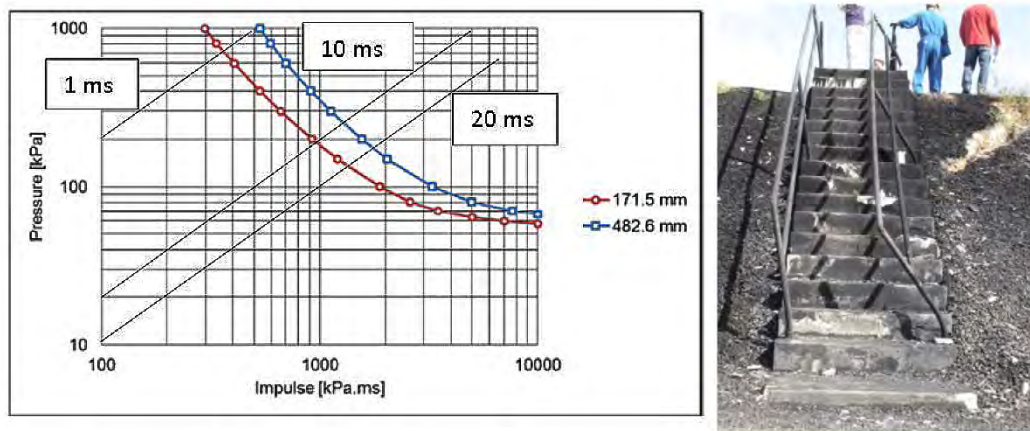
Another feature that supports the hypothesis of DDT is an analysis of bent railings  $\sim 60$  m from the bamboo area (Figure-S 3.10). The minimum overpressure required to produce the measured distortion of 483 mm is about 0.6 atm (static). For a 1-ms pulse, the required overpressure is about 10 atm. The overpressure estimated from Equation (4-2) (Section 4 of main report) is  $\sim 0.4$  atm. The lack of agreement between the two values indicates that the railing was much closer to, or even on the edge of, a detonating cloud.

**Figure-S 3.10** Pressure-impulse diagram for bent railings. Left: Pulse durations are shown assuming a triangular shaped pulse. (The pressure-impulse calculation was performed by B. Burgan of the Steel Construction Institute, private communication, 2016). Right: From [6] showing bent railing.

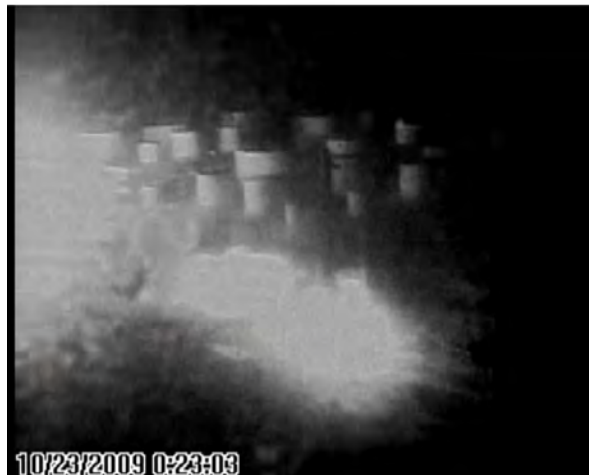
**Figure-S 3.11** Explosion from the south end of the culvert along 4th Street [6, 8].

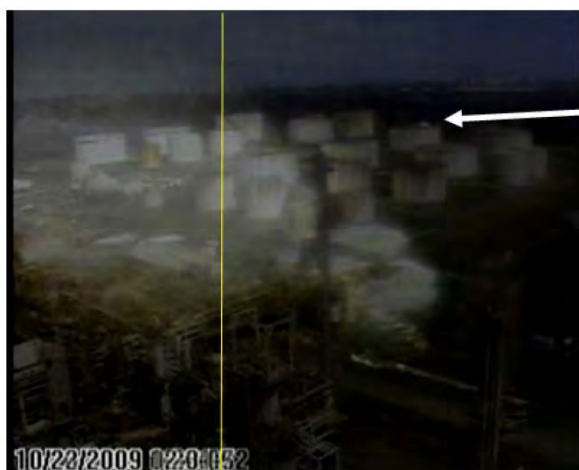
**Figure-S 3.13** First light at east end of site, 23.06 frame 24 [8, 6].

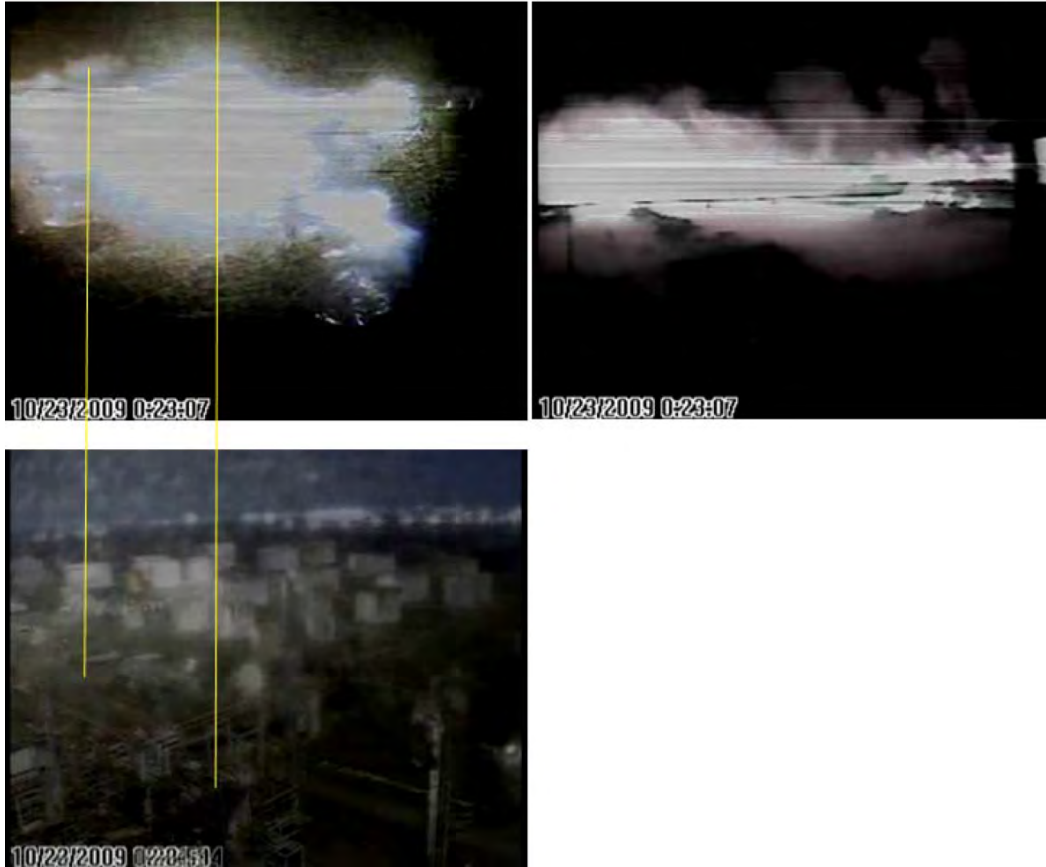
**Figure-S 3.14** First frame of a major explosion at 23.07 frame 21 referenced to site photo (lower). The frames on the left are from FCC camera, and the frames on the right are from the WTT camera [8, 6].

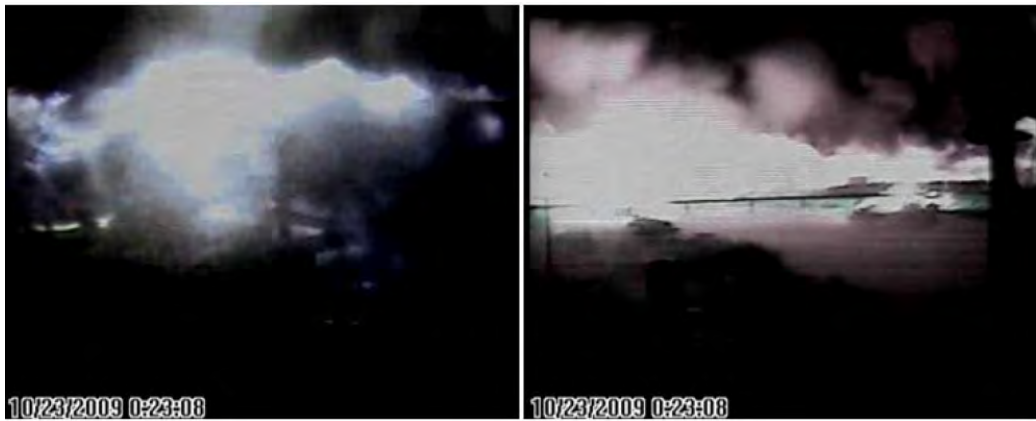
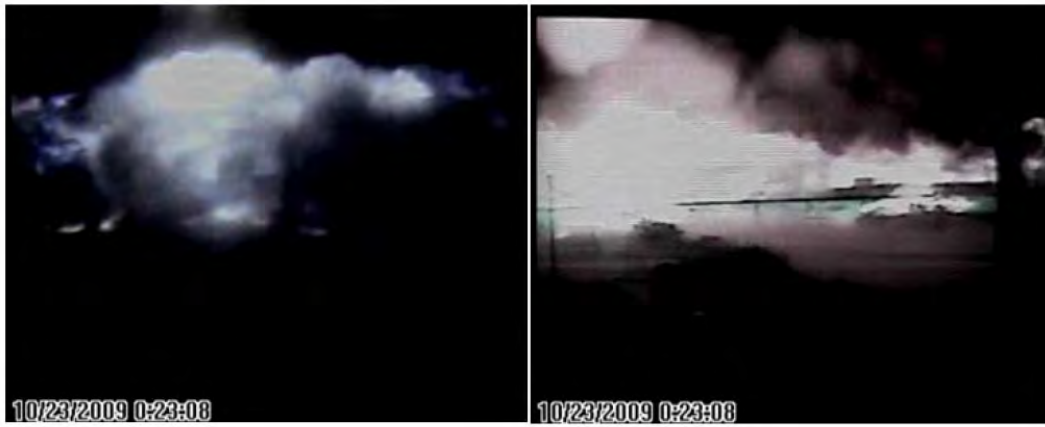
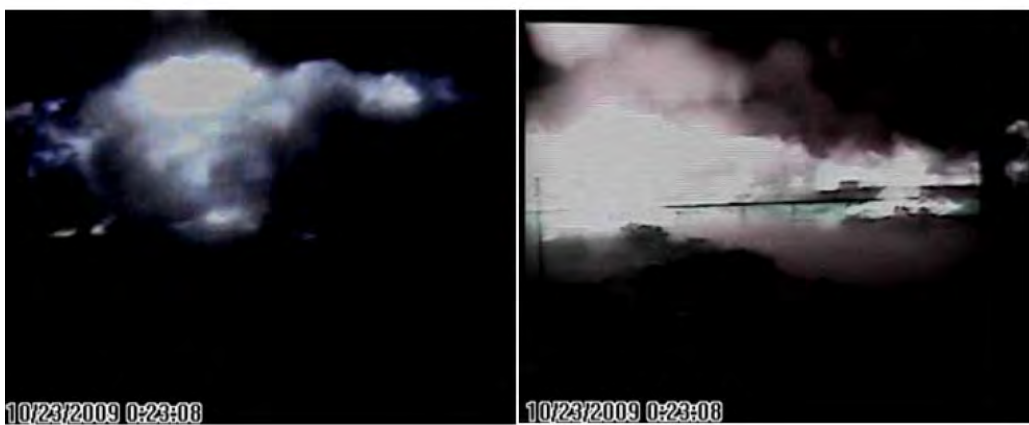
Following a meeting at the UK Health and Safety Laboratory (HSL) between author GAC and G. Atkinson, on 3 February 2016, it was decided that further analyses were necessary to try to resolve at least some of the anomalies. It was agreed that the first blast to reach the gatehouse at 23.03 frame 21 originated from the south end of the culvert (at 23.02 frame 17) shown in Figure-S 3.2. Figure-S 3.11 shows the explosion. It was also agreed that a major explosion also took place in the bamboo area, probably around the same time as the other explosion identified in frames 23.07.21 to 23.08.08 (Figure-S 3.15).

Figure-S 3.15 Progression of the main explosion event [8, 6].

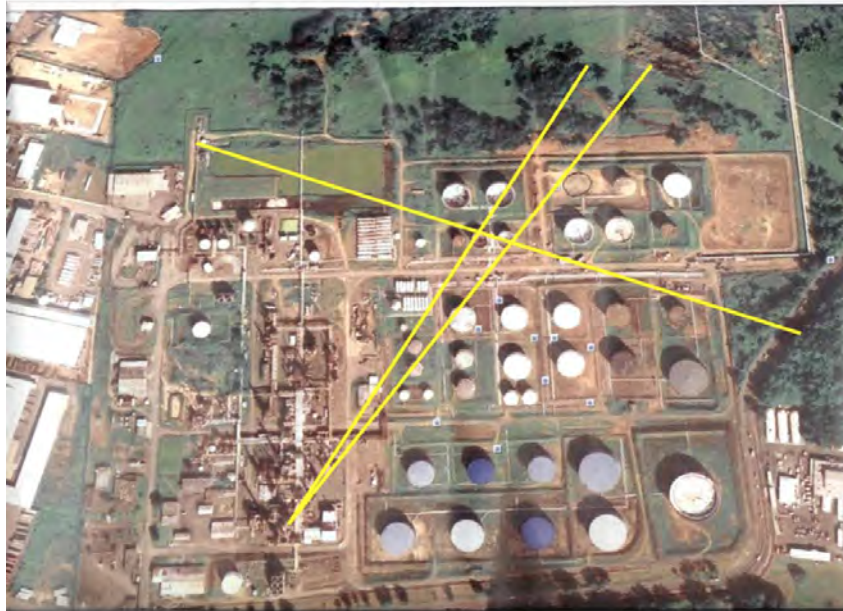
Attention turned to the severe explosion in the region of tanks 404, 405, 406 and 407. Triangulation from frames taken from FCC and northwest videos (Figure-S 3.16) indicate that the explosion originated in a region of congested pipework between tanks 404 and 405 (Figure-S 3.17). A blast in this area could account for damage to tanks 406 and 407 and to the fence line and trees to the north of the site (see [6]). Further evidence supporting a major explosion in this area came from the arrival of blast at the FCC camera and at the gatehouse. The FCC camera lost its imaging 1.24 s after the video image of the explosion, indicating a distance of 430 m from the blast origin, assuming a sound speed of 350 m/s. This is the exact distance between FCC camera and congested pipework. The correspondence of distance between the gatehouse and pipework, 560 m, compared with 630 m derived from glass breakage and sound speed, is not as close, but perhaps still within reasonable error.

**Figure-S 3.16** Triangulation of the explosion shown in frames 23.07.21 to 23.08.8 [6]. .

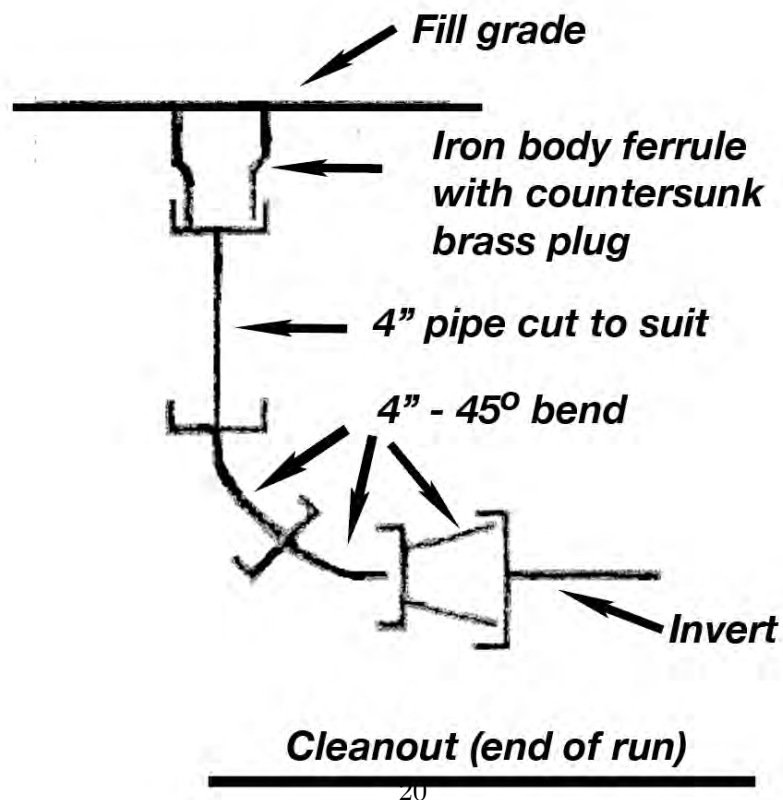
**Figure-S 3.19** Close up of clean-out section of drain system [8].

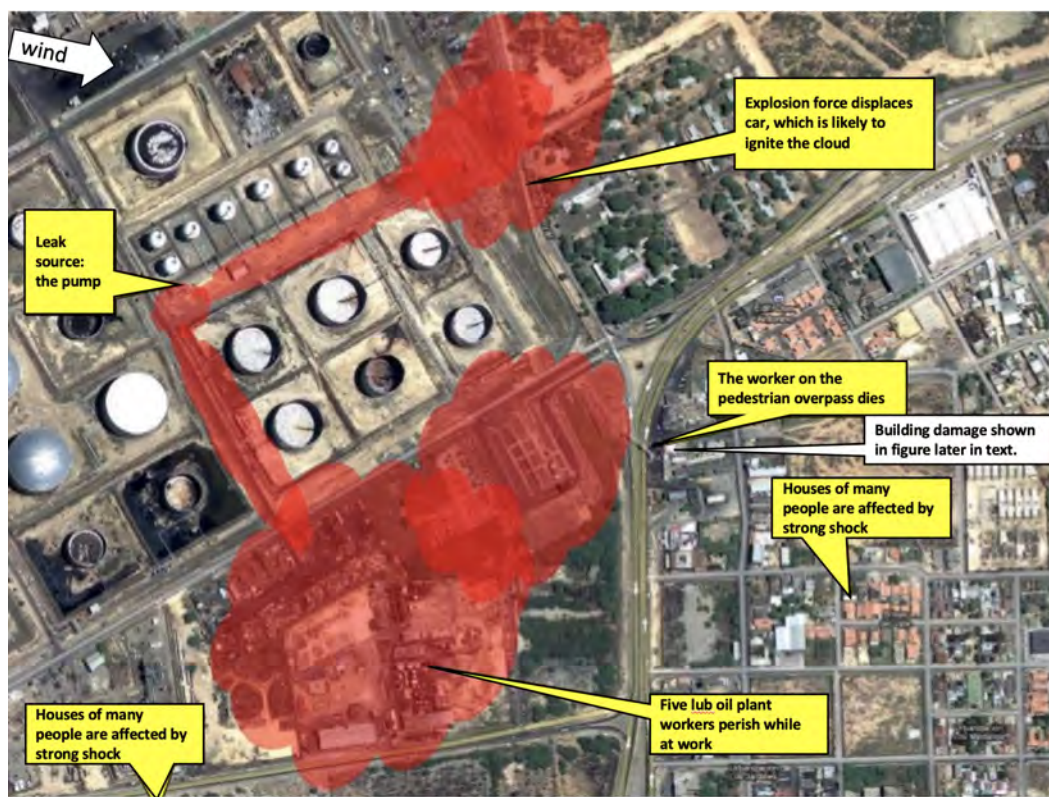
An operational decision was made to continue using a leaking olefin pump and to rely on the wind to disperse the vapors. The leak started days before the explosion, and the wind conditions reinforced the decision. At about midnight on the night of the incident, however, the wind slowed, became NW to SE, and vapors started to accumulate in the refinery. The flow rate of the leak also increased. The leak rate has been reported in the PDVSA report [9] as  $\sim 8 \text{ m}^3/\text{min}$ . The cloud drifted around the low points surrounding the tank and traveled at least 600 m towards the SE, engulfing the lube oil plant and houses in the town to the east. It is thought that a car traveling down the Avenida Bolivar Road, to the east of the refinery, ignited the cloud (Figure-S 4.1).

**Figure-S 4.1** Rough extent of the flammable cloud. Note location of car reported to have ignited the cloud and location of pedestrian overpass (footbridge) [9].

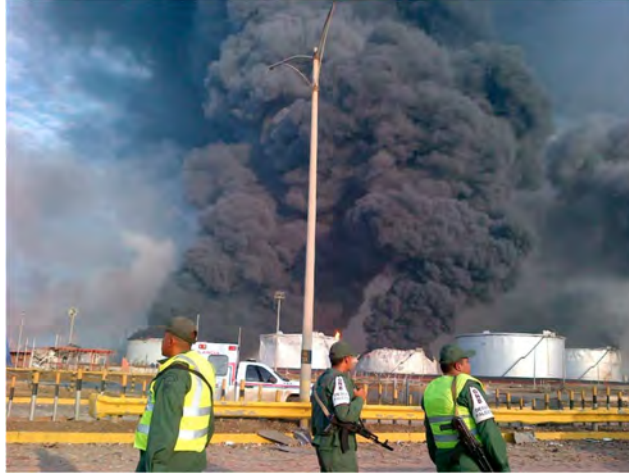
The olefin storage spheres to the north, close to the leaking pump and storage tanks further to the north, were largely undamaged. Yet oil storage tanks to the south were severely damaged. The lube oil area was totally destroyed, and there was significant damage to buildings just over the road from the lube oil plant (Figure-S 4.3). Figure-S 4.4, Figure-S 4.5, and Figure-S 4.6 show various crushed storage tanks.

**Figure-S 4.4** Crushed storage tank. (Appeared on website of *Christian Science Monitor*, 16 September 2013. )

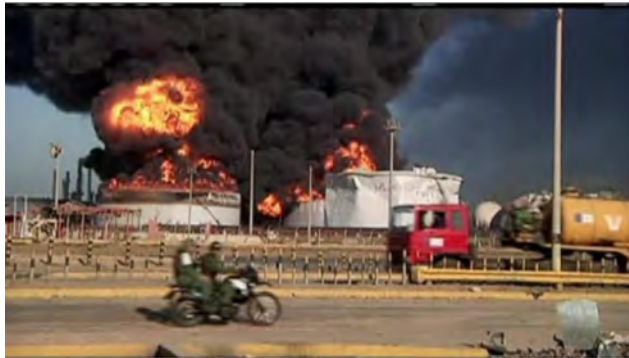
**Figure-S 4.5** Crushed storage tanks. (Appeared on website of *Christian Science Monitor*, 16 September 2013. )

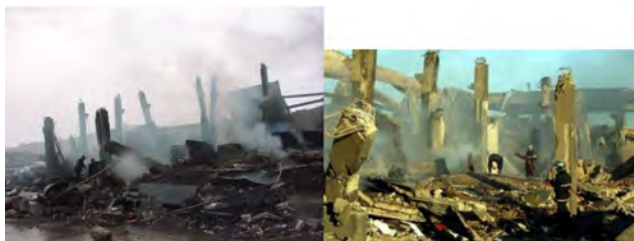
**Figure-S 5.3** The remains of the Maintenance Building. Note that some of the reinforced concrete supports have been drawn inwards (towards the center of the flammable cloud) (Figure taken from Reuters.).

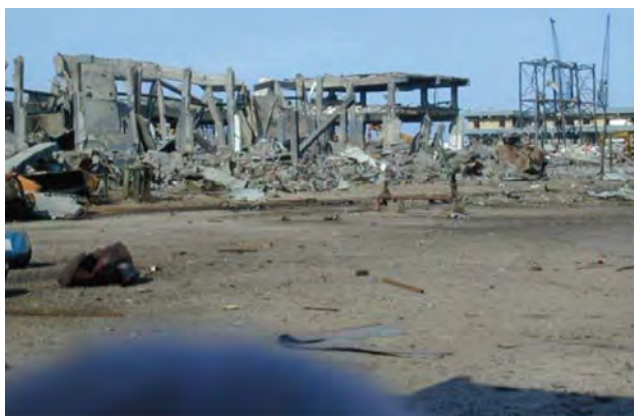
**Figure-S 5.4** Another view of the wrecked Maintenance building. Note also the crushed drums in the foreground left [12].

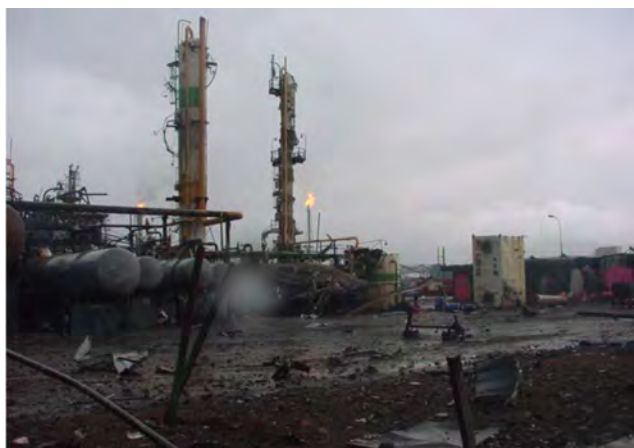
**Figure-S 5.5** Panorama of the west side of Unit 40 south end looking SE. The remains of the maintenance building are behind this photograph. Note the bent poles. (Private communication to GAC, 2004).

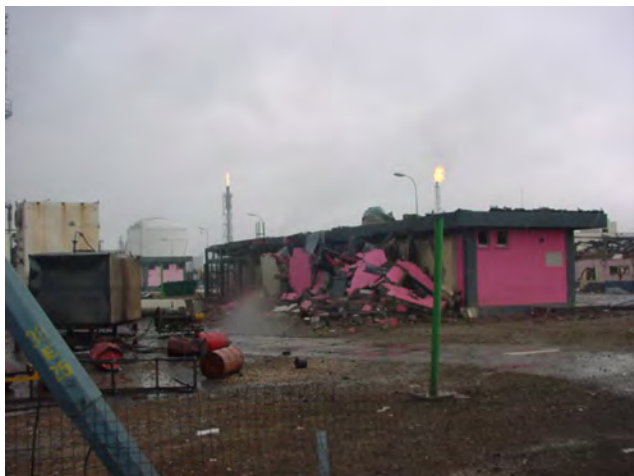
**Figure-S 5.6** Panorama of the south side of Unit 40, electrical building, looking SE. Note the bent lamppost 38 E 25 and fence drawn inwards. (Private communication to GAC, 2004).

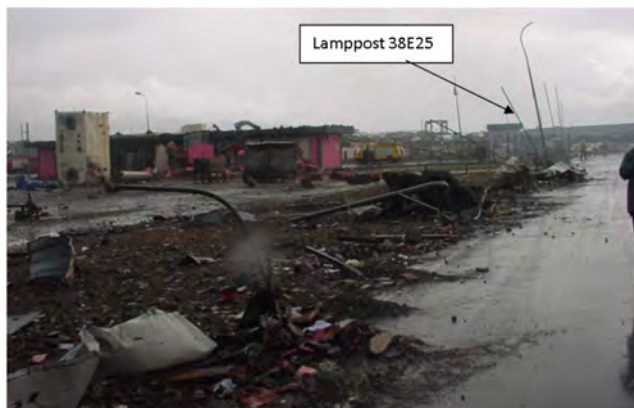
**Figure-S 5.7** Panorama of the west side of Unit 40 south end, electrical building. Note the bent lampposts all drawn inwards, i.e. towards the centre of the flammable cloud. (Private communication to GAC, 2004).

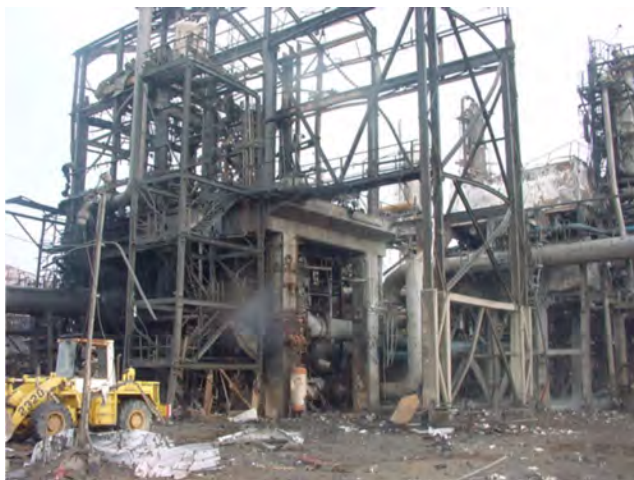
**Figure-S 5.8** West side of Unit 40. Note that the tower by the yellow truck has been drawn

towards Unit 40, similarly the lamppost (in front of the truck). (Private communication to GAC, 2004).

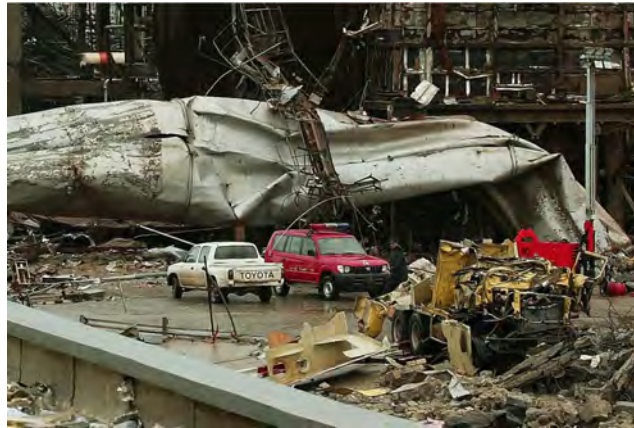
**Figure-S 5.9** Unit 40 and the heavy duty car crushed; overpressure above 5 atm away from congestion. (Private communication to GAC, 2004).

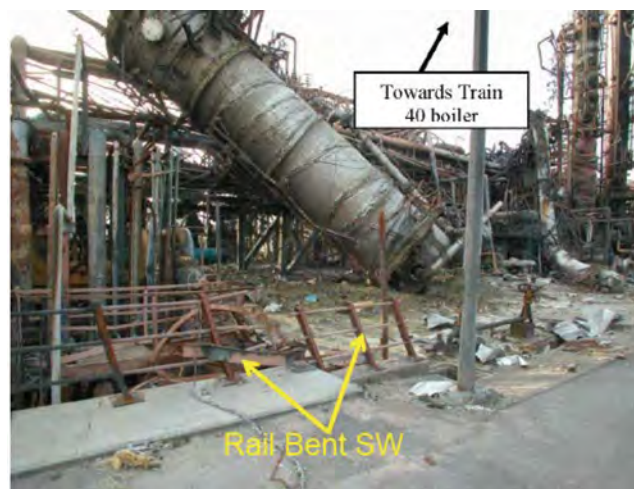
**Figure-S 5.10** View of collapsed flash drum and bent railing Unit 40. (Private communication to GAC, 2004, also [12]).

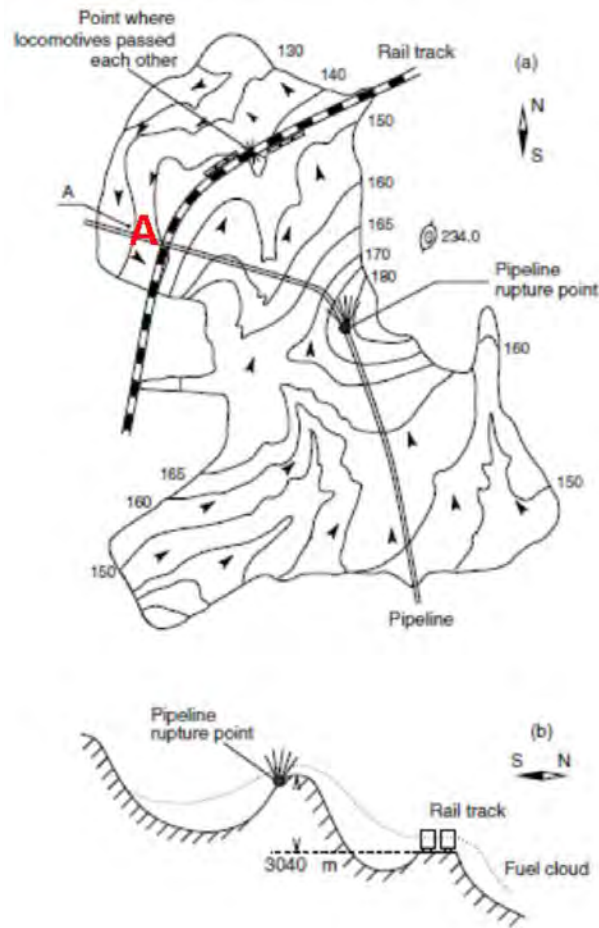
**Figure-S 7.1** Ufa explosion event: (a) Sketch of demolished area (direction of tree fell is shown by arrows); (b) terrain profile (not to scale). View of accident site from region of point A is shown in Figure-S 7.2. (Figure reproduced with permission from [15]).

The pipeline was ruptured near the head of the valley (Figure-S 7.1, [15]) about 900 m from the railway track. The total area of this breach was  $0.77 \text{ m}^2$ , twice the cross-section area of the pipe.

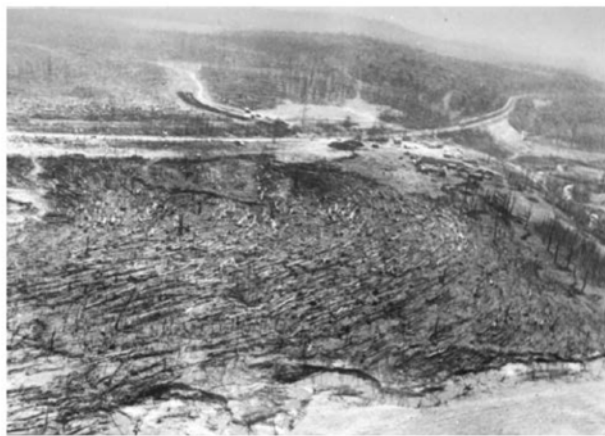
**Figure-S 7.2** Accident site viewed from region of point A in Figure-S 7.1. On the right of the railway is the remainder of one of the trains. (Reproduced from [15] by permission).

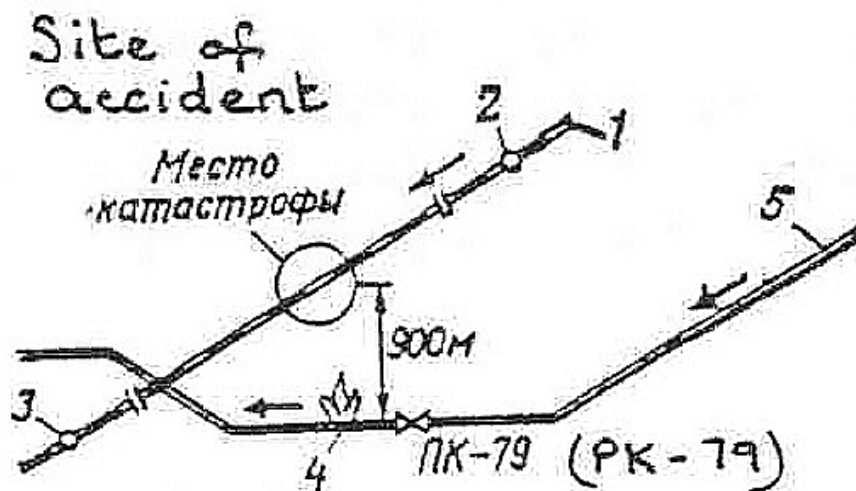
Windows were broken in a local hospital, 15 km from the site. A photograph of the site (Figure-S 7.3) from Figure 10 in [15] was taken several days later. The tree fall in the valley below the railway track reflects the vortex character of the flow in this region (Figure-S 7.1).

**Figure-S 7.3** Site of accident (G.M. Makhviladze, private communication).

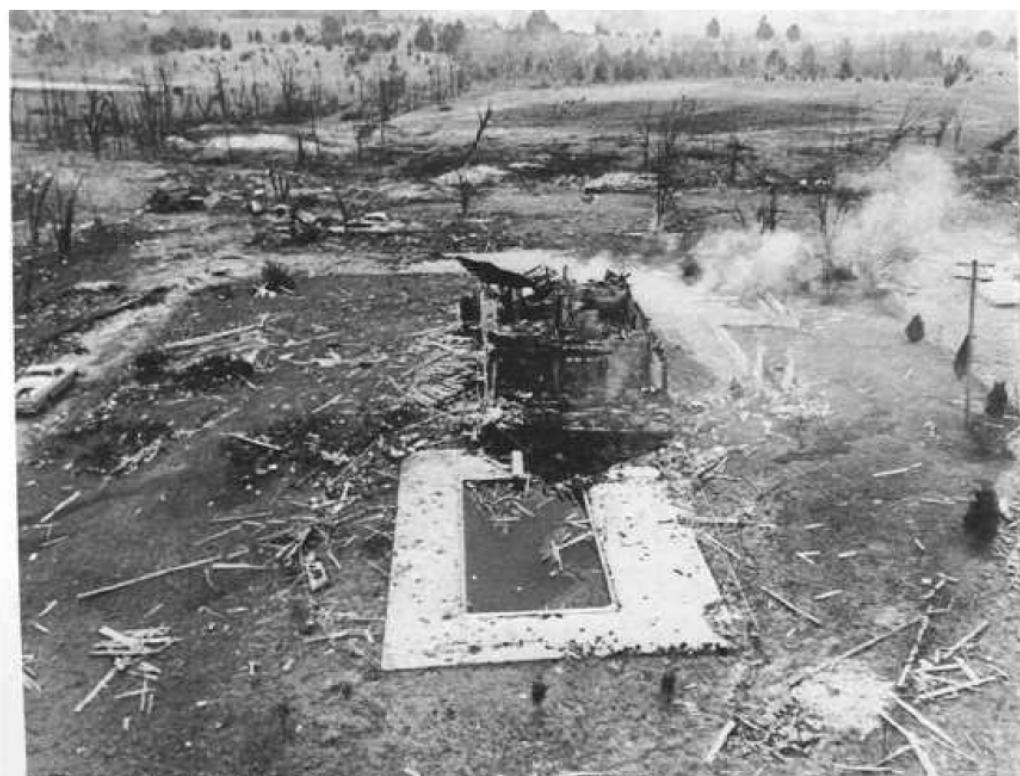
The incident was investigated by the US Bureau of Mines [17], which concluded that the most likely ignition source was a freezer unit located inside a concrete warehouse approximately 30 m from the Menner property (Figure-S 8.2). This warehouse was completely destroyed. The terrain around the rupture was gently sloping, which would have allowed the heavier-than air propane to disperse into the valley. The area of the valley described as being filled with the mist, approximately corresponded to the area of burning and scorching observed following the incident.

**Figure-S 8.2** Area identified as origin of the detonation [18].

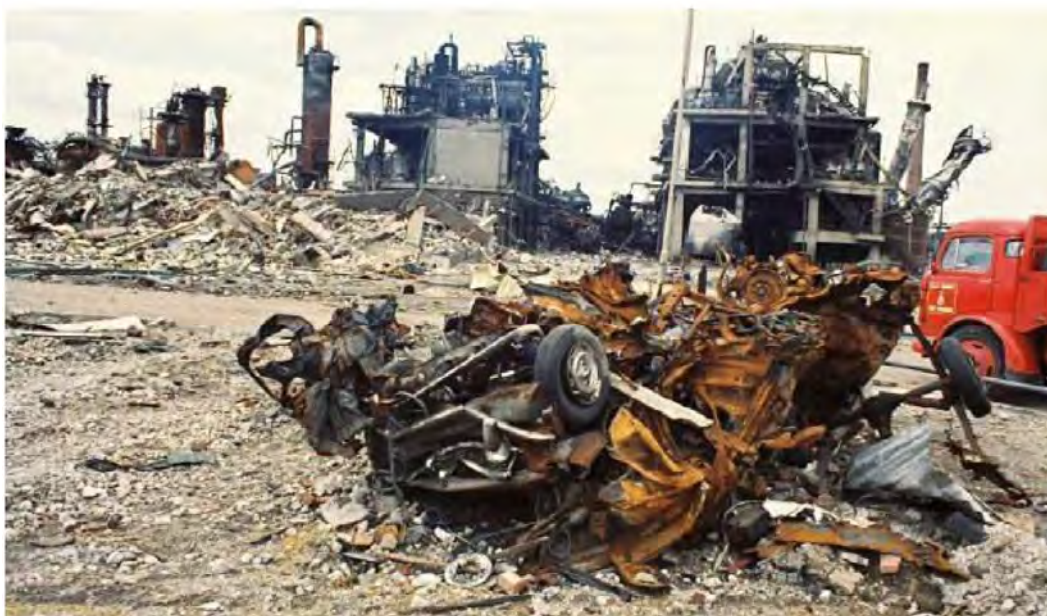
**Figure-S 10.2** View of damaged items [23, 24].

There have been many studies of this incident and the main conclusion is that a detonation of cyclohexane vapor occurred. The most likely mechanism is believed to be a DDT in the region of congested plant. Figure-S 10.1 – Figure-S 10.3 show general views of the damage.

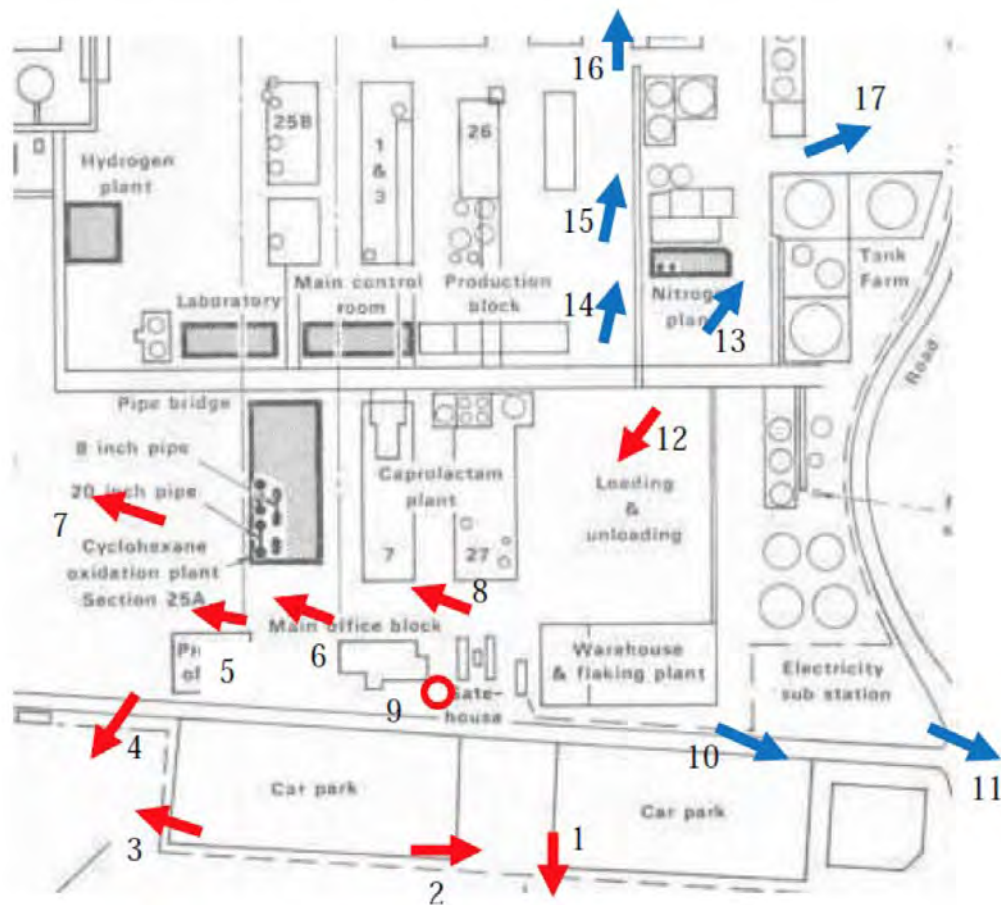
Figure-S 10.4 Direction of fallen of lamp posts [23, 24].

Figure-S 10.4 shows the direction of fallen of lamp posts around the site. Two of these lamp posts are shown in Figure-S 10.5 and Figure-S 10.6. The blue arrows are lamp posts that are outside the vapor cloud, and these generally point away from the cloud. There is no clear pattern of direction indicated by the red arrows, which are lamp posts inside the detonation. The random nature of direction indicators is to be expected of a large turbulent cloud ignited within seconds of the release. There was no opportunity for the cloud to become pancake shaped and to develop the inward net drag during detonation.

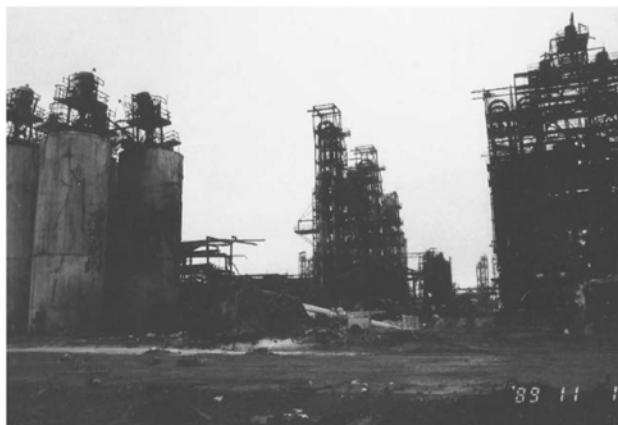
The presence of ethylene ignited in a congested area and the force of the resulting explosion suggest DDT. There is, however, no direct evidence of this except that Figure-S 11.4 from the FEMA report [25] shows uniformly crushed silos, consistent with detonation damage. Figure-S 11.5 shows the damage and metal fatigue.

**Figure-S 11.4** Silo holding areas to the northwest of the main blast area. The blast wave partially flatten the silo sides (taken from [25]).

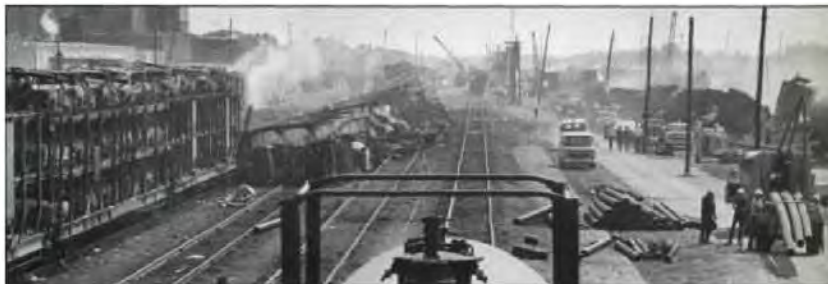
**Figure-S 12.2** Damage area (taken from [26]).

Several of the photographs (see Figure-S 12.2, Figure-S 12.3, Figure-S 12.4, Figure-S 12.5) show evidence of high overpressure, for example, the dented rail cars and crushed vehicles on the rail trailers. The crushed vehicles, shown in Figure-S 12.6 on the rail trailers, are typical of overpressures  $>5$  bar. By comparing an aerial photograph of the site in Figure-S 12.1 with a Google Earth picture, we see that the edge of the main explosion damage on the rail yard is around 300 m from the release point, marked A in Figure-S 12.1. This suggests that either the ignition was in the congested region of boxcars and trailers, or that ignition occurred when the cloud reached an ignition point at the cloud edge, as suspected above. In the second case, a flash fire would have propagated through the cloud and then flame acceleration and deflagration could have occurred in the congested area. DDT may have occurred in the remaining cloud.

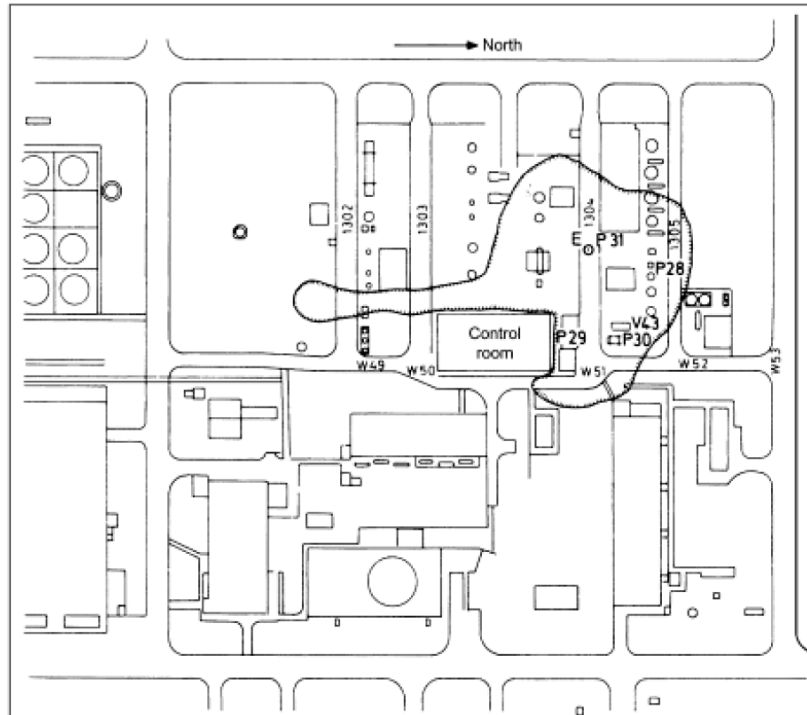
No directional indicators were recorded, but damage estimates suggest overpressures well over 1 atm (see Figure-S 13.4). This is supported by FLACS simulations [29]. For stoichiometric ethylene mixtures in clouds greater than about 3.5 m height, however, they predicted very high overpressures. Some investigators suspect detonation in the SE corner of the site, considering the fuel and extent of congestion, although evidence is scant. (See Figure-S 13.1, Figure-S 13.2, and Figure-S 13.3).

**Figure-S 13.1** Simplified site plan of Beek showing estimated dimensions of the vapor cloud. (Reproduced by permission from [30]).

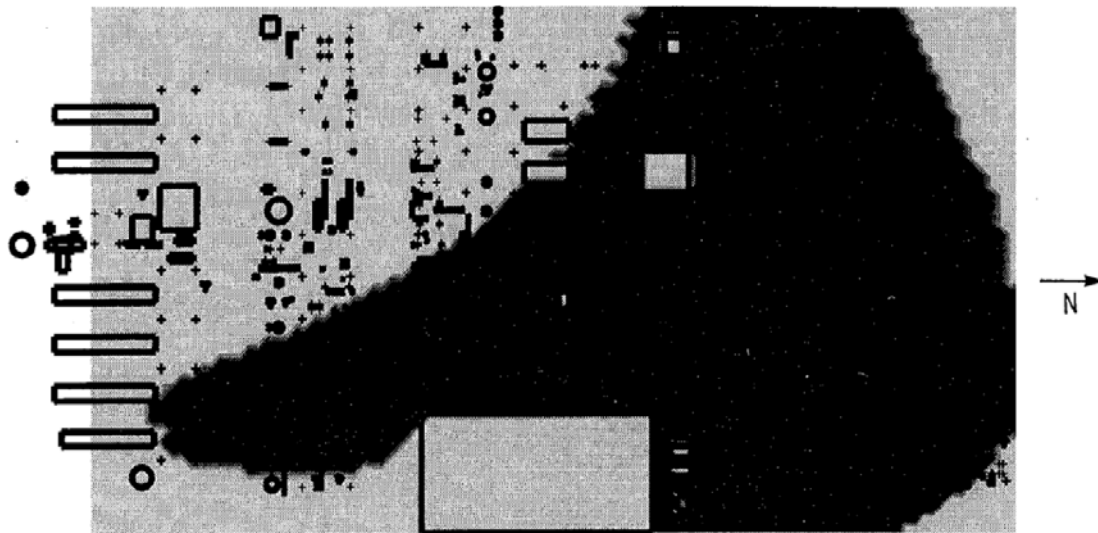
Figure-S 13.3 Naphtha cracker unit with cloud contour. (Reproduced with permission of [29].)
