# **“Preventing the Next Luton”: A Novel Risk-Based Approach to Fire Safety and Operational Resilience in Airport Car Parks**

This manuscript supports the author's poster presentation at the SFPE Fire Safety Conference on Performance Based Design 15<sup>th</sup> to 17<sup>th</sup> April 2026.

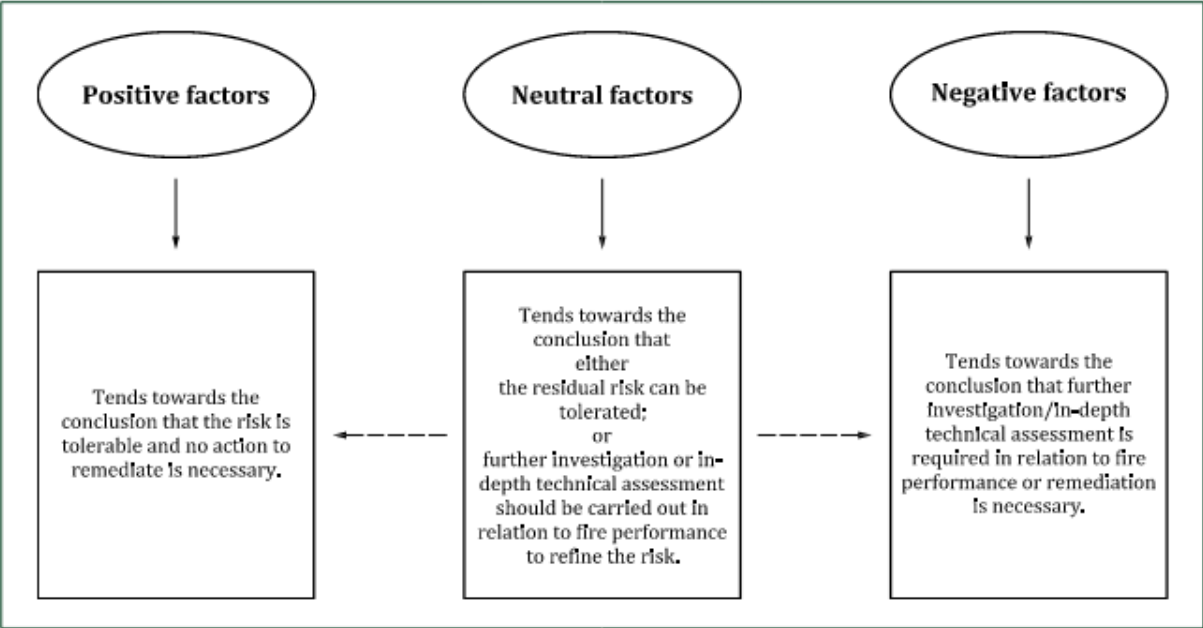
Figure 1. PAS 9980 Figure 5 – Possible outcome of impact factor weighting

Figure 1, extracted from BS 9980, gives guidance for assessors in how to assess whether a common impact factor trends towards positive, neutral or negative.
