The Lightspeed Rangefinder

USC Rocket Propulsion Lab

Submitted to the University of Southern California in partial fulfillment
of graduation requirements for honors degree

May 2021

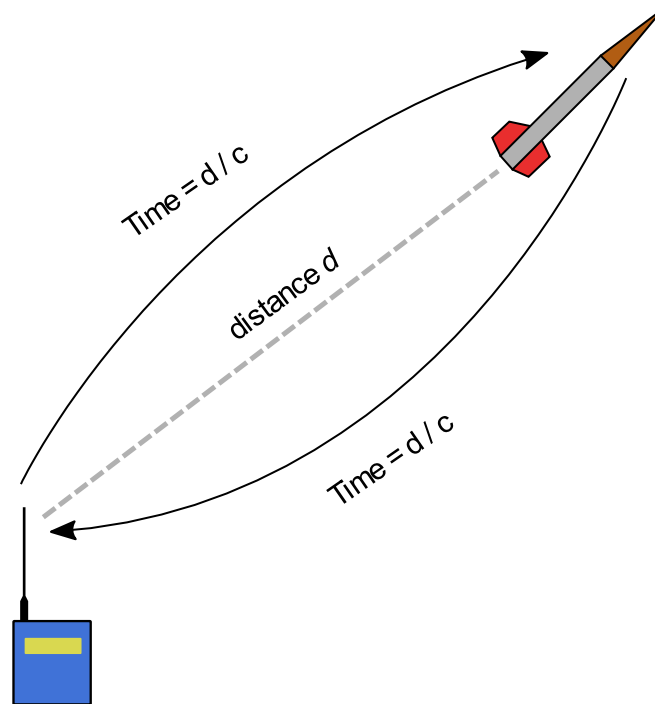
Figure 2.1. Rangefinder Operation.

First, the ground station sends a radio signal up to the transponder mounted on the rocket. The radio signal moves at the speed of light, so it takes time $\frac{d}{c}$ to reach its destination, where c is the speed of light and d is the distance from the ground station to the rocket. Then, the transponder unit inside the rocket sends a response transmission, which takes the same amount of time to travel back to the ground station. The total time taken for this process is $2\frac{d}{c} + k$, where k is a constant amount of delay created by the radio system. k can be calibrated out since it is constant, and since the speed of light is constant, the ground station can calculate the distance to the rocket by measuring the time taken for this process.

Measuring distance using radio may sound complicated, but at its core, the process relies on basic laws of physics. The rangefinder operates through a simple ping-response process, as illustrated in Figure 2.1.

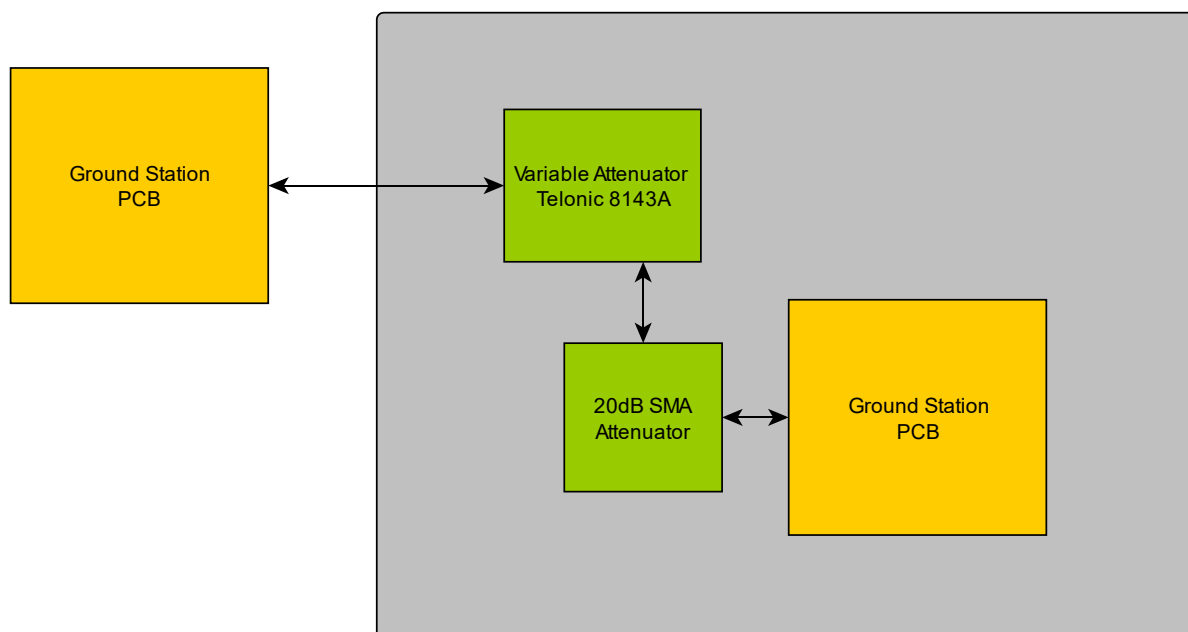
Figure 4.3.1. Sensitivity test setup

Two Ground Station V1 boards were used in this testing because they showed the best sensitivity in testing, and because their output power is controllable between +1.5dBm and +31.0dBm. One ground station unit was placed in a box coated in aluminum foil (to reduce the chance that spurious emissions would connect the two radios) and connected through a fixed, then a variable attenuator to the other ground station unit outside the box (Figure 4.3.1). Signals were then sent between these radios as outlined in the Procedure section.

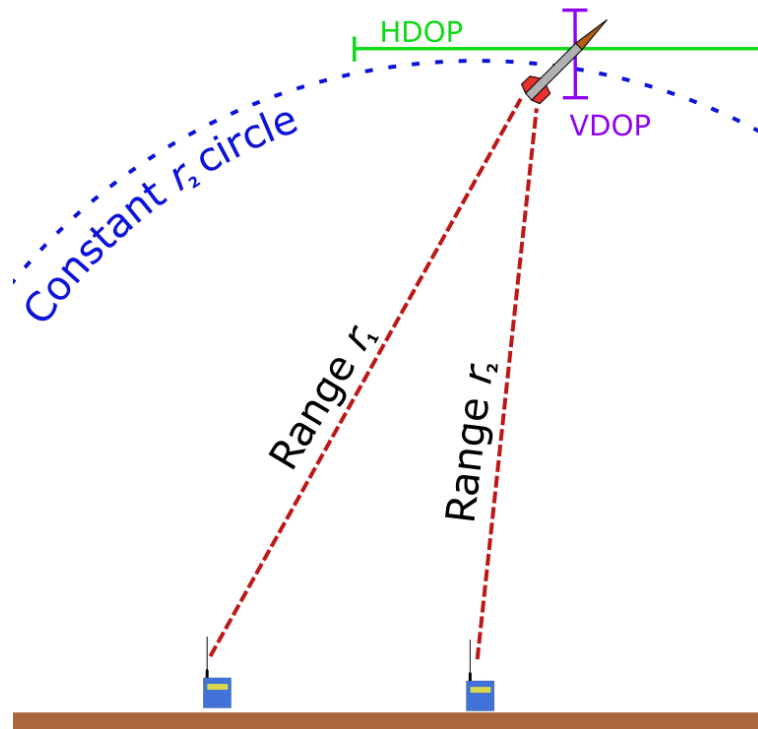
Figure 5.1. Diagram of ranging and dilution of precision.

Figure 5.1 demonstrates the concept behind HDOP and VDOP (Vertical DOP), simplified to 2D. Consider that if r_2 is held constant, r_1 determines the calculated position of the rocket. With the rocket far above the ground stations, a small error in r_1 would produce very significant changes in the rocket's horizontal position, but only small changes in its vertical position. For this reason, the HDOP in this configuration is much higher than the VDOP. If the ground stations were to be spread out wider on the ground, this would improve HDOP, but at the cost of increased VDOP.

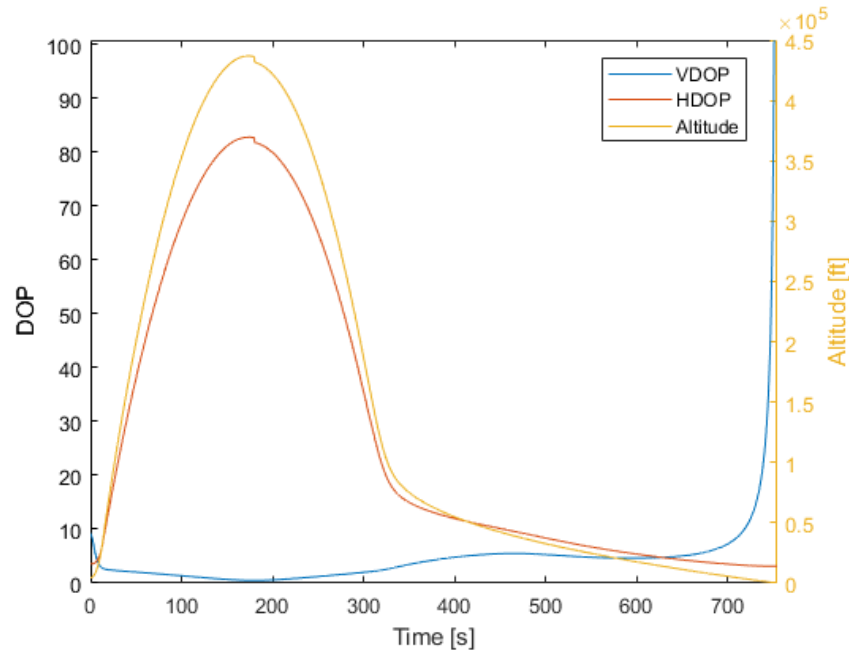
Figure 5.2. Vertical and horizontal DOP plotted for a simulated flight.

To test the rangefinder's viability on high-altitude flights, we plotted the DOP values for a simulated flight of RPL's upcoming space shot, Domepiercer, which was projected to reach an apogee of about 440,000 ft (134 km). In this simulation (Figure 5.2), we assumed that there were 4 ground stations in a square arrangement 2 mi (3.2km) on a side, centered on the launch site. This was simply an initial guess and will certainly be refined in the future, especially since Test 6 showed that ground station placements of almost four times this distance are feasible.
