The Lightspeed Rangefinder

USC Rocket Propulsion Lab

Submitted to the University of Southern California in partial fulfillment
of graduation requirements for honors degree

May 2021

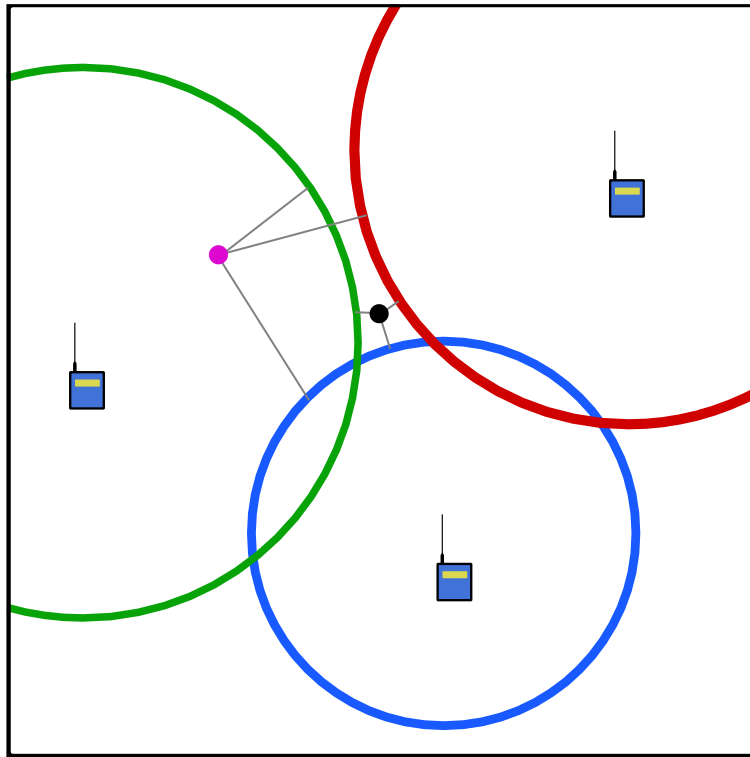
Figure 2.3. A 2D trilateration problem.

An example of the trilateration process, simplified to 2D for explanation's sake, can be seen in Figure 5. Each circle represents a range measurement, and measurement error has caused them to not overlap at a single point. One point the algorithm might consider might be the pink dot, but this has relatively high error to each measurement (error is represented by the sum of the squared lengths of the gray lines). The black point, in contrast, has very low error, so it would be very close to what the algorithm would finally select.

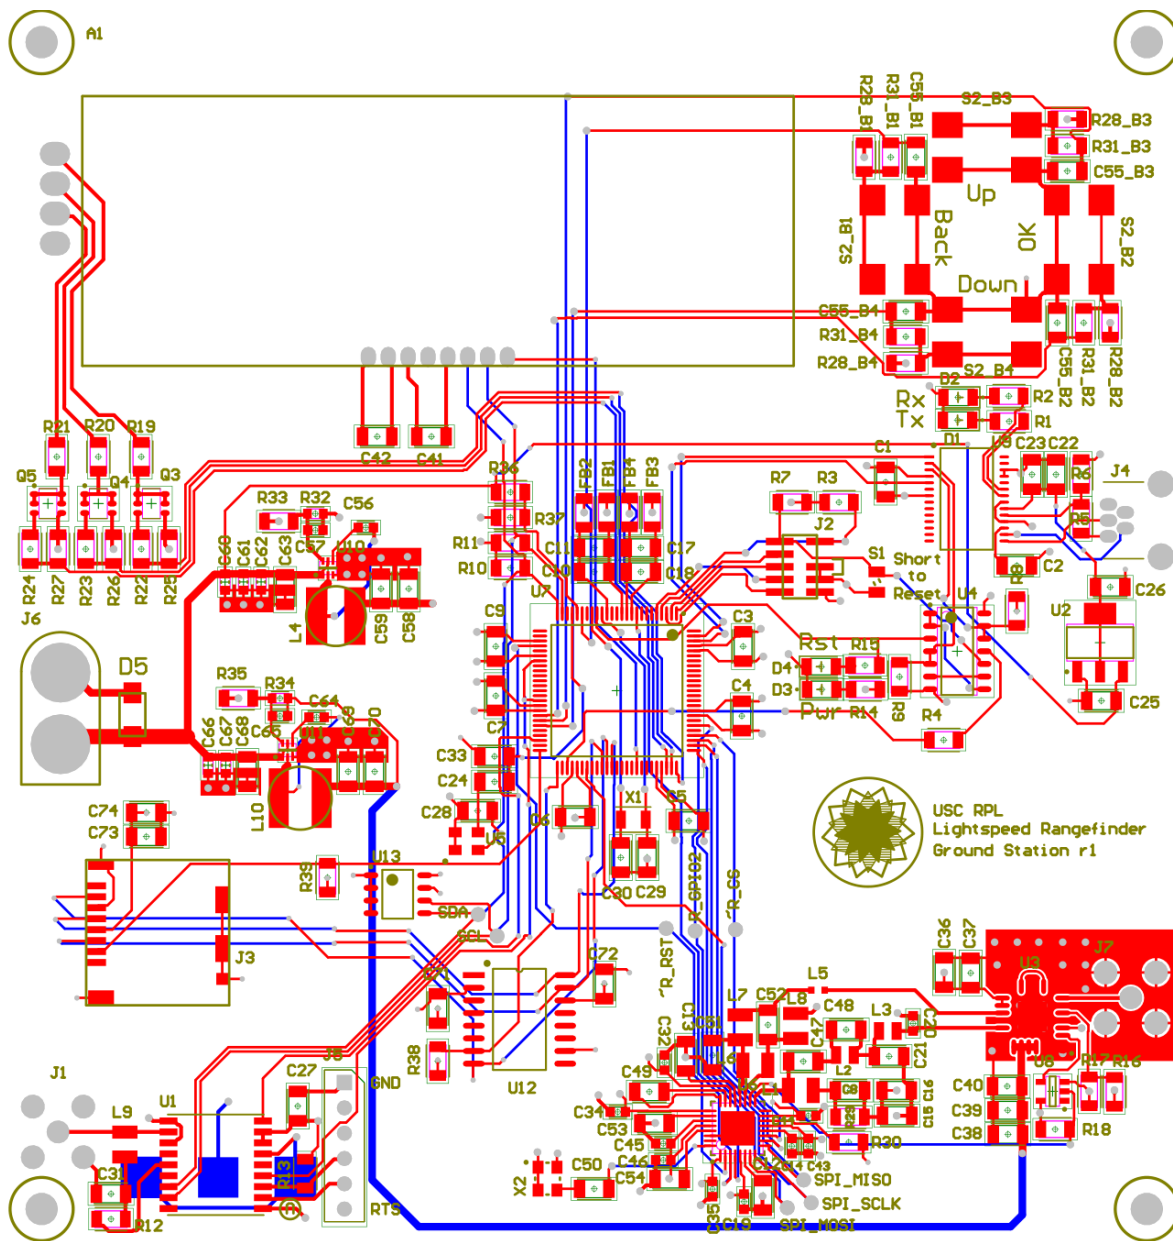
Figure 3.7. PCB layout of the ground station.

With this improved radio design in hand, it was time to construct the rangefinder ground stations. Besides the radio system, GPS, and CPU that we had designed, each ground station needed user interface elements, such as a display and buttons. It would also need memory for storing data, for which we added both an SD card slot and a 64MiB flash memory IC (the same module as used on RPL's flight avionics unit). Finally, since wall power wasn't available, each ground station would need its own 3.3V power regulator, as well as a 3.9V regulator to power the SKY65366 RF amplifier. For power in the field, we elected to add an XT60 connector for standard hobby lithium batteries because they were ubiquitous, cheap, and stored a substantial amount of energy. Over two months were spent designing and reviewing these schematics, and finally, a PCB was routed from them (Figure 3.7).

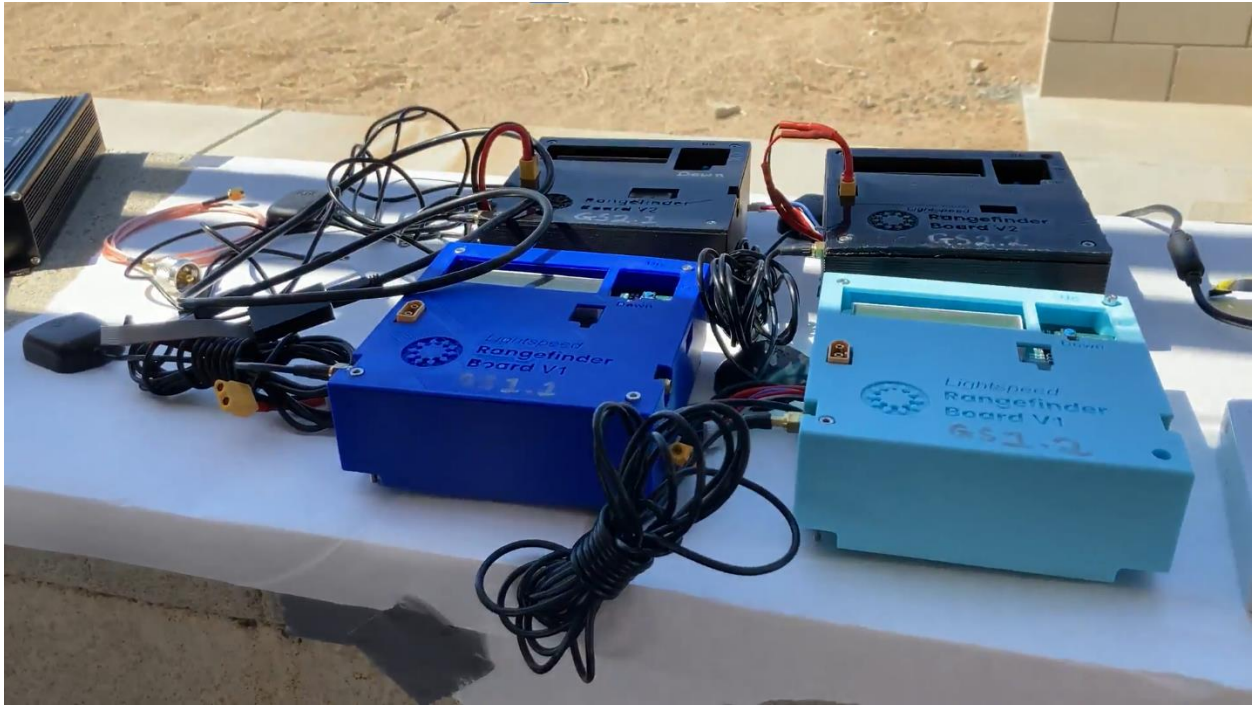
Figure 3.21. Four beautiful, completed rangefinder ground stations.

With all ground stations and the transponder complete, we were finally ready for more in-depth testing. First, we performed several static, long-range tests on the ground (Test 6). Then, a single, long-duration burn-in test was run to ensure that all four ground stations could operate simultaneously for a long time without any conflicts or errors. Finally, after the construction of enclosures for each ground station to keep the elements out (Figure 3.21), we were ready to do a subscale test launch of the system (Test 7)!

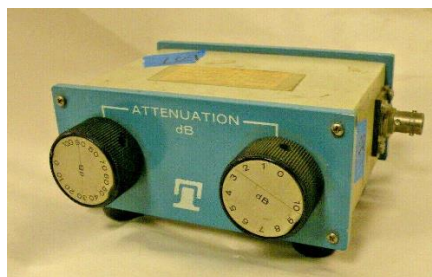
Figure 4.3.2. Variable attenuator.

A primary concern in our testing was eliminating RF leakage: specifically, where the attenuator was blocking the signal from traveling between the two ground stations, but the signal found an alternate route and was received anyway. Our testing showed that once the difference between transmit power and receive sensitivity exceeded roughly 115dBm, the signal would “escape” the coax cables and foil box and arrive at the receive radio. Tightening the lid of the box and adding additional layers of foil adjusted this threshold by a small amount, but did not make a massive difference. Unfortunately, due to equipment limitations, more accurate quantification of this effect was impossible. To prevent leakage, the transmit power of the transmitter unit was decreased to its lowest possible value (+1.5dBm), decreasing the power difference in most tests below where the threshold seemed to be. Additionally, for each test, the attenuator was decreased below the sensitivity value until the signal was completely blocked. Since this was possible on all tests after reducing the transmit power (it hadn’t been before), we concluded that RF leakage had been suppressed to a satisfactory amount.

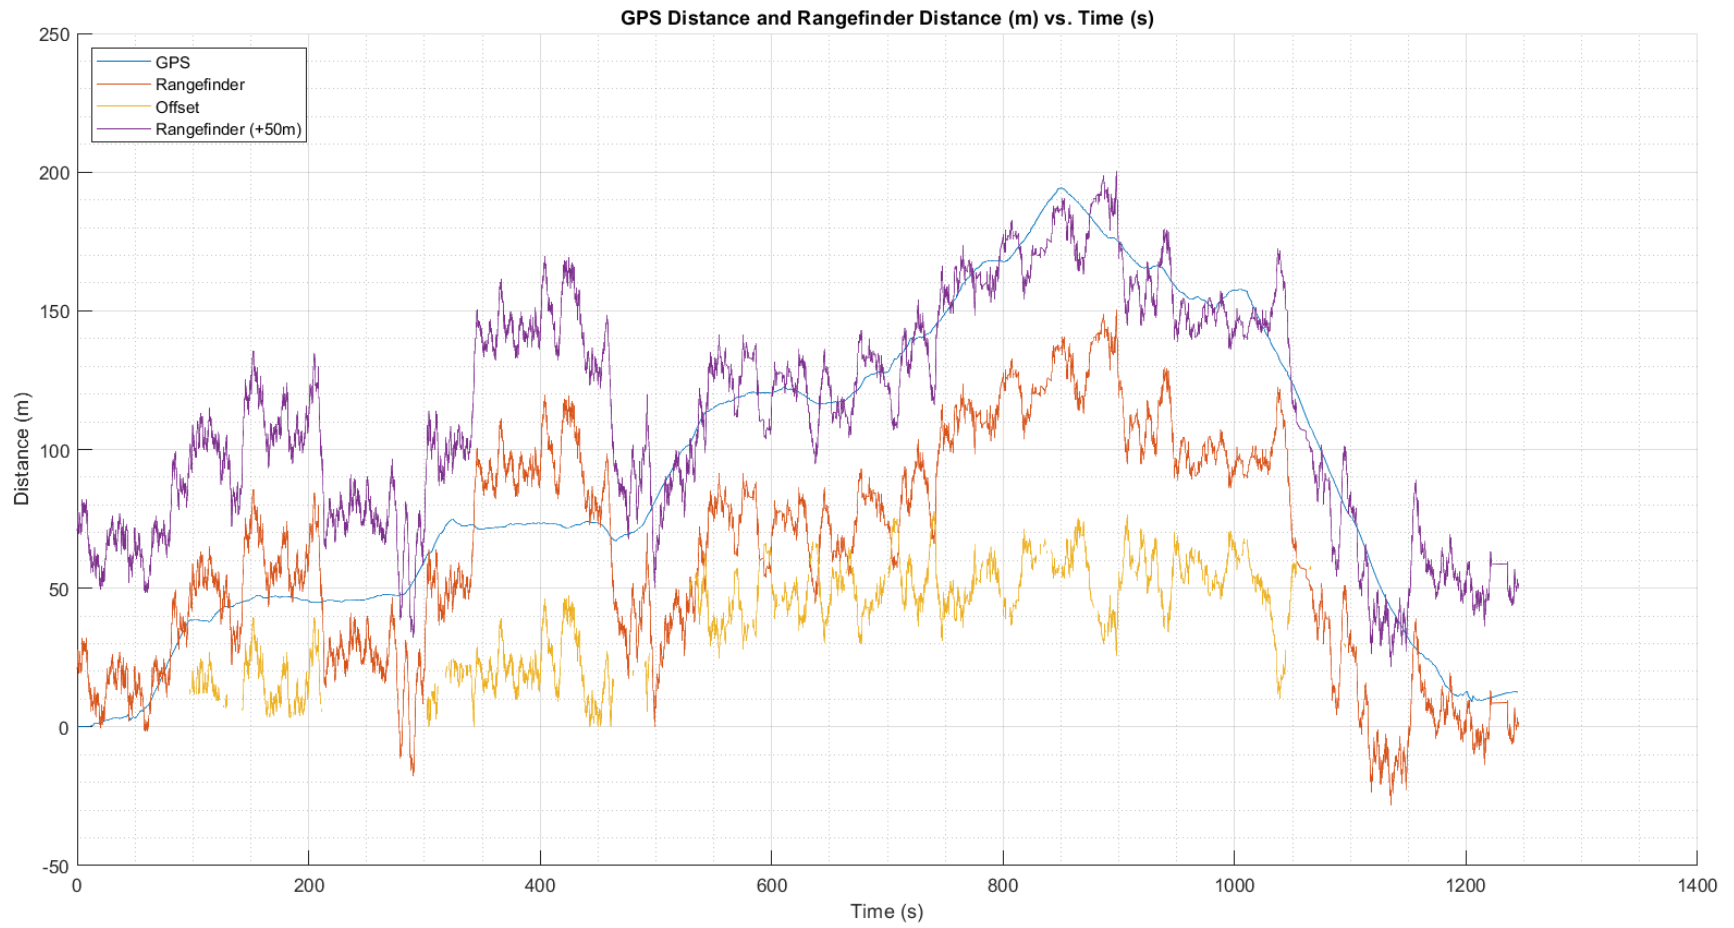
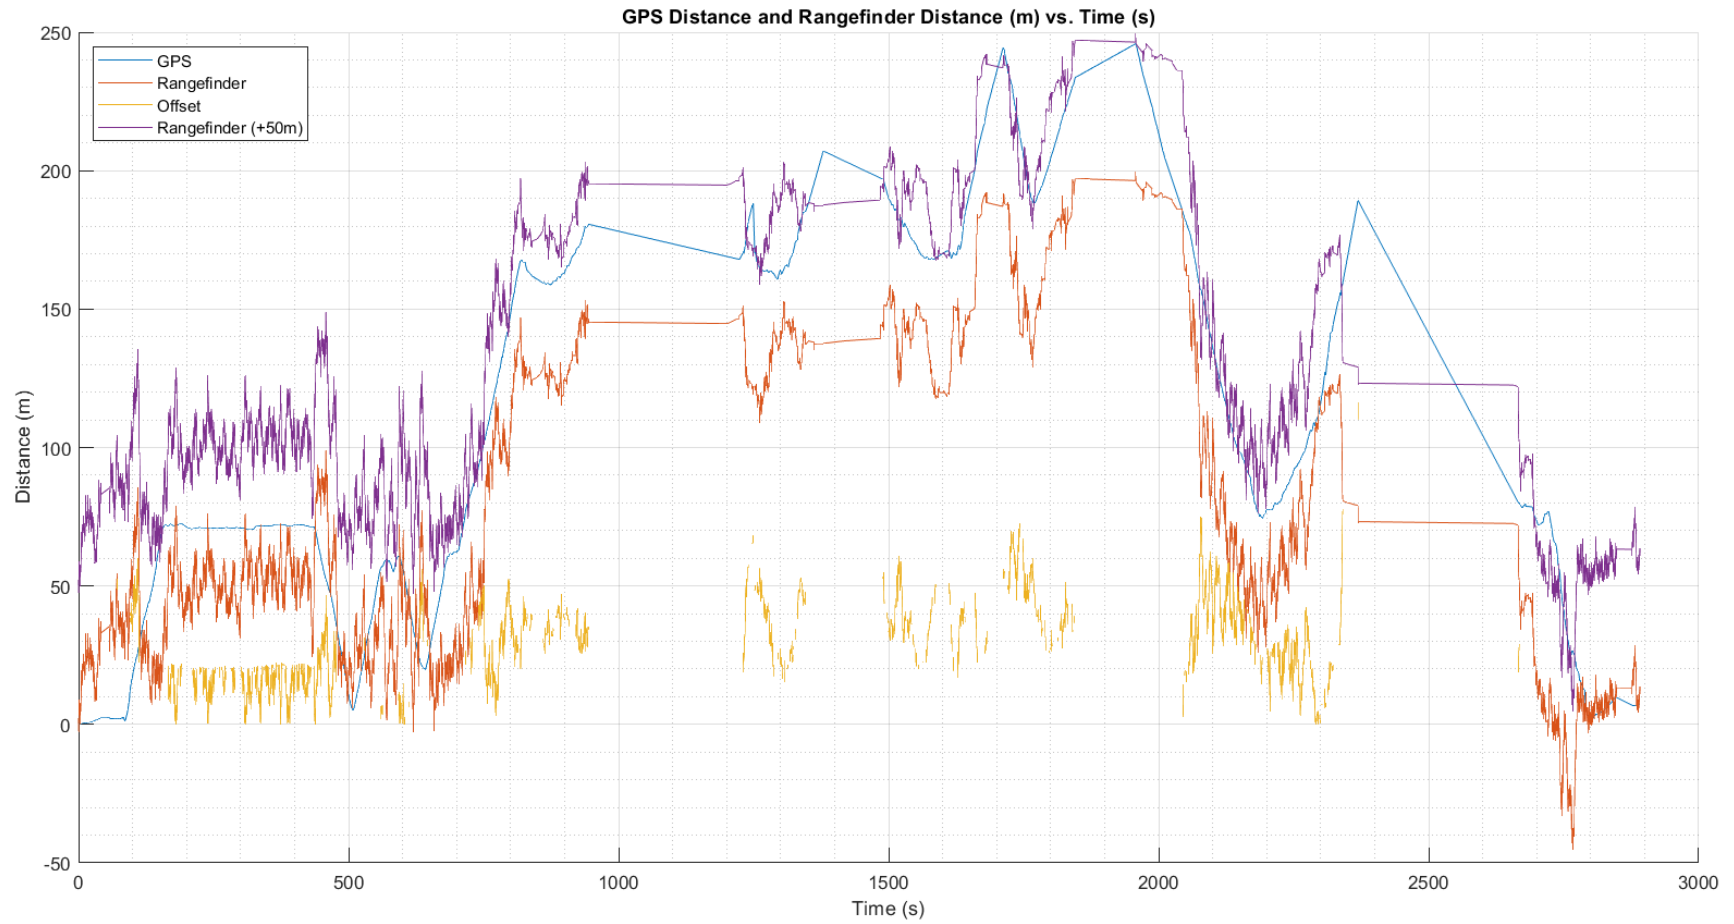
These graphs show a couple different values:

As is visible on the graph, the ranging data did not make sense when the real distance was less than roughly 75 m. This effect surprised us at first, but it turned out to be consistent across all of our trials: the measured distance would increase as physical distance increased up to about 75 m, then would “jump” to a much lower value, then increase again. We believe this is caused by inability of the LNA and receiver on the rangefinder to receive signals *above* a certain power, roughly -30dBm. When the units are relatively close together, the power of the received signal may overwhelm the receiver and prevent it from receiving the primary transmission. So, instead, it locks on to a weaker reflection of the signal that it can receive, leading to an artificially inflated distance value.

constant offset for delay time from the radio modules needs to be subtracted out. In this test, we believe that the offset used was slightly off from the correct value (likely due to the units being calibrated while close together), causing the distance to be skewed downward. As the “Rangefinder (+50m)” trace shows, adding a constant +50m offset causes the rangefinder trace to track the real distance very closely.

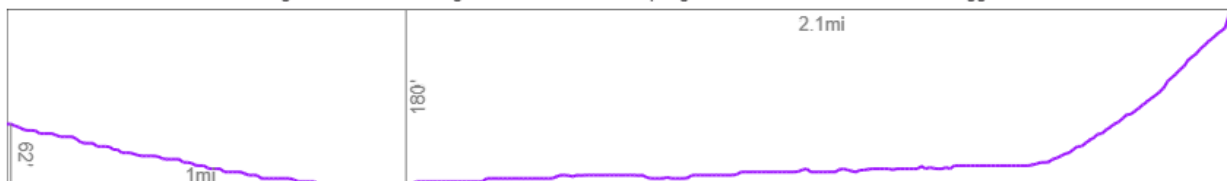
Figure 4.6.2. Plot of ground height between the launch site (left) and Ground Station Delta (right). <https://caltopo.com/>

cursor: 2166' at 3.13mi range: 1998' to 2178' gross: +200' -82' sampling interval 55' w/ 13.1x vertical exaggeration

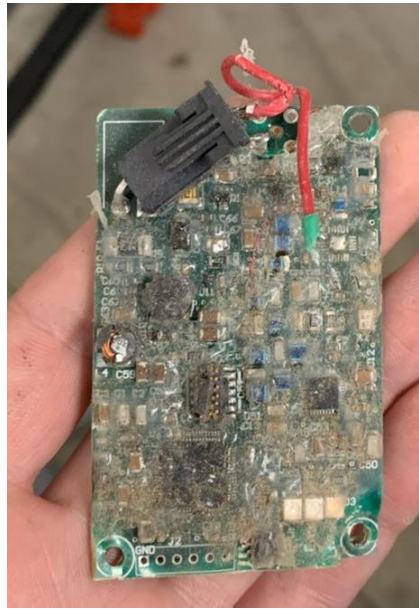
Figure 4.7.3. Transponder PCB after recovery from the crashed vehicle. Note that prior to flight the PCB was coated in silicone potting compound to protect it from G-forces and condensation.

While we on the ground were puzzling over connection loss, another problem occurred in the air. During descent, Lumineer's drogue parachute failed to deploy properly. This caused it to impact the ground very hard, damaging the avionics bay and making a post-mortem analysis of the issue, at least the electronics aspects of it, significantly more difficult. While we had intended to replace it anyway, the transponder PCB was damaged badly enough from impact that no more testing operations were possible for the semester (Figure 4.7.3).

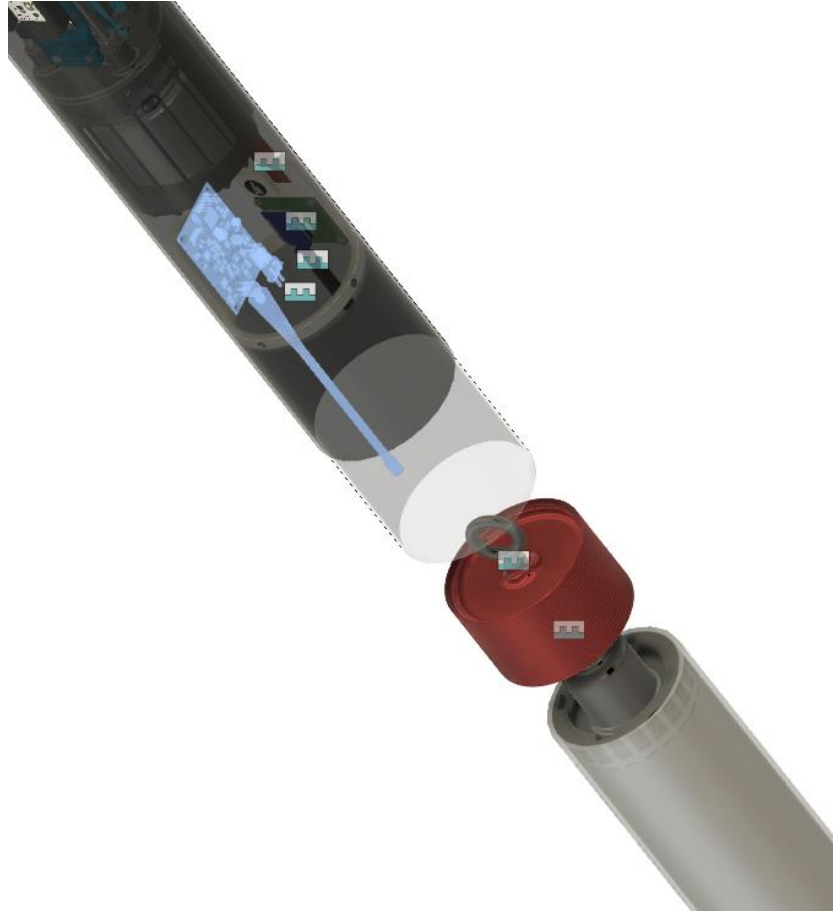
Figure 4.7.5. Exploded diagram of Lumineer's lower avionics bay.

Structures on the rocket itself could also have contributed to the issue. The fuselage of the rocket itself was made from fiberglass, which should not have affected radio signals significantly – RPL's own nose cones are made from similar materials for RF permeability. However, the paint and primer that the fuselage was painted with is more of an unknown, and could potentially have attenuated radio signals. More research into this is in progress. Structures inside the rocket could also have caused problems: A large, powered-down reaction wheel motor (containing sizeable permanent magnets) was located directly above the transponder and XBee, and the rocket motor (which used a large metal cylinder as its motorcase) was placed a few inches below the tip of the antenna. Though it is difficult to say definitively, these structures could have further blocked and attenuated radio signals, especially in the downwards direction. Going forward, we may attempt to create a mockup of the as-flown lower avionics bay using the same materials and test its effect on the amplitudes of radio signals in different directions.

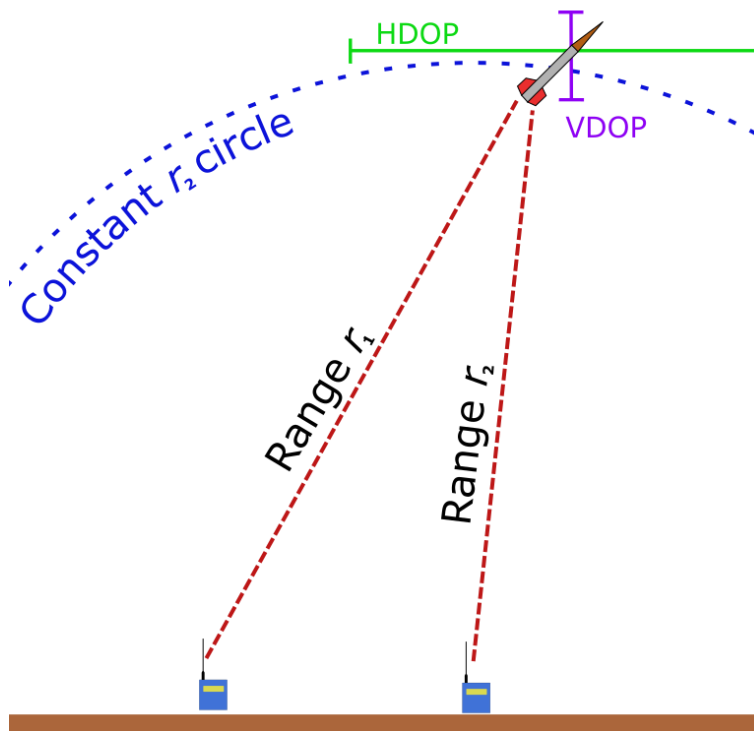
Figure 5.1. Diagram of ranging and dilution of precision.

Figure 5.1 demonstrates the concept behind HDOP and VDOP (Vertical DOP), simplified to 2D. Consider that if r_2 is held constant, r_1 determines the calculated position of the rocket. With the rocket far above the ground stations, a small error in r_1 would produce very significant changes in the rocket's horizontal position, but only small changes in its vertical position. For this reason, the HDOP in this configuration is much higher than the VDOP. If the ground stations were to be spread out wider on the ground, this would improve HDOP, but at the cost of increased VDOP.
